## Cavitation Damage in Pump Repaired

Power plant,  
Oklahoma

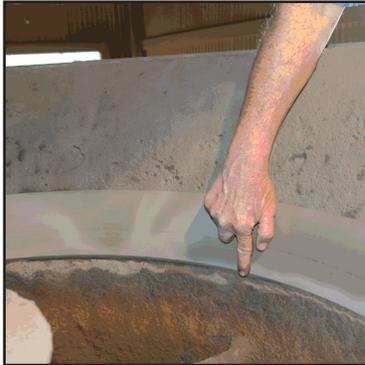
*Extent of cavitation damage to suction bell, above and below wear ring*

Severe cavitation erosion above and below wear ring. limited time to restore pump.
