Caterpillar 631 Engine Repaired with Belzona

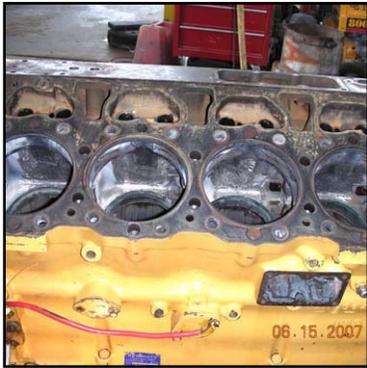
Caterpillar 631 engine block

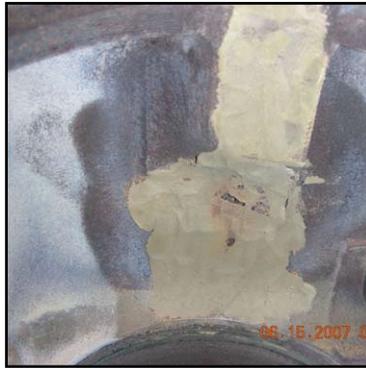
Failed "Brand X" repair

A previous repair with "Brand X" epoxy failed. The owner took it to his own shop and did the work

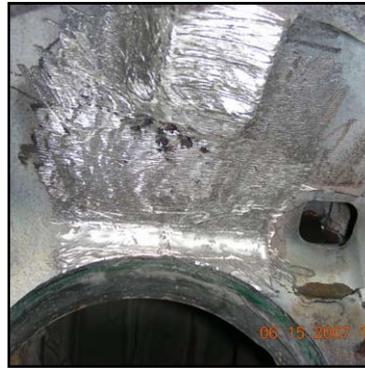
Prepared surface on one of the cylinders showing leaks

Traces of engine coolant appeared in the lubricating oil test samples indicating erosion in wall of cylinder block.

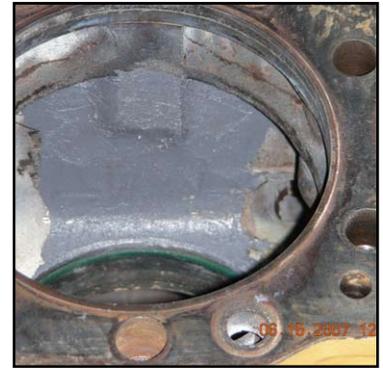
Completed repair on 1 cylinder

Belzona® 1311
(Ceramic R-Metal)

Application carried out in accordance with Belzona Know-How System Leaflet ENC-6
