Turntable Trouble Sorted With Belzona

Worn Spline and Gear Drive

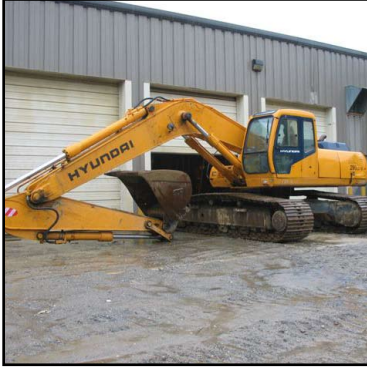
Excavator unable to rotate

Spline drive and gears were so old and worn that the main deck turntable on the excavator could not operate.

Application was carried out in accordance with Belzona System leaflet MPT-5.

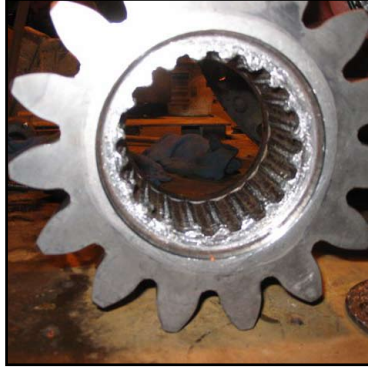
Worn gear

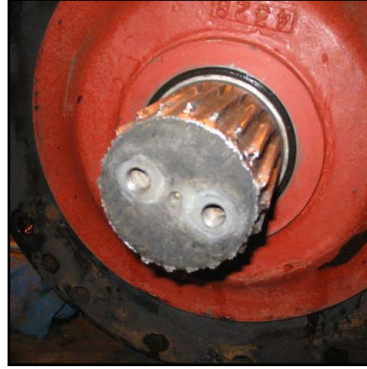
Worn drive

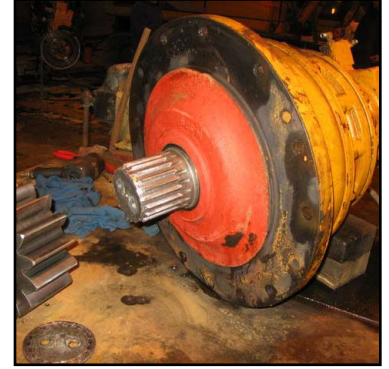
Worn gear and drive
