Leaky Cylinder Seats Refurbished with Belzona

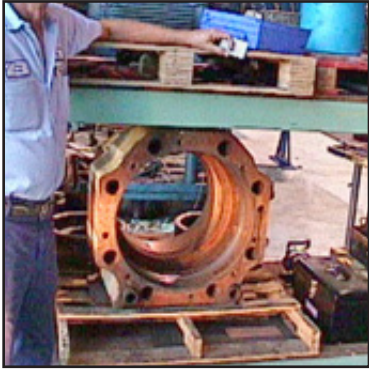
Units as received from ship

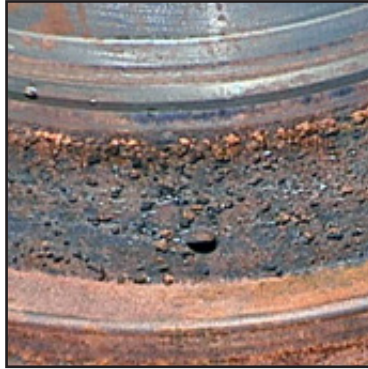
Pitting corrosion in water jacket area

Significant cavitation and general corrosion from cooling water and fretting wear at O-ring seats.
