Turntable Trouble Sorted With Belzona

Worn Spline and Gear Drive

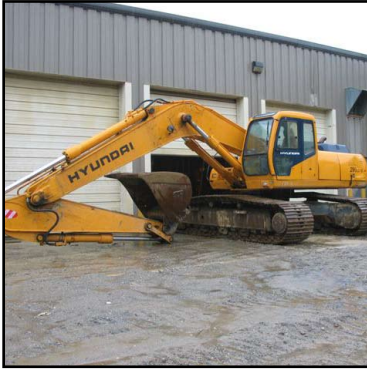
Excavator unable to rotate

Spline drive and gears were so old and worn that the main deck turntable on the excavator could not operate.

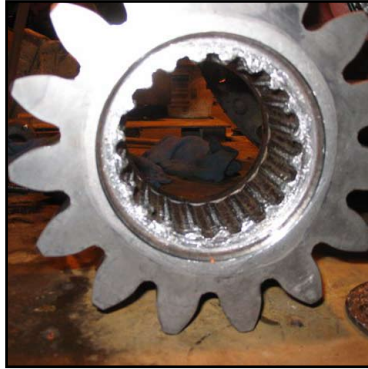
Worn gear

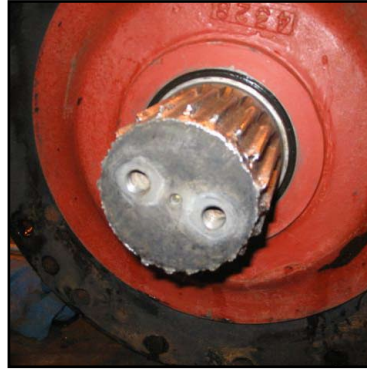
Worn drive

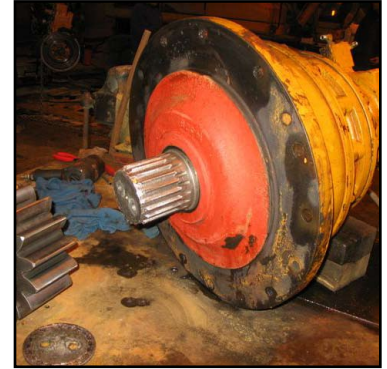
Worn gear and drive

Application was carried out in accordance with Belzona System leaflet MPT-5.
