Demonstrated Longevity in an FGD Repair

Coal-fired power plant,
Cumberland City, TN, USA

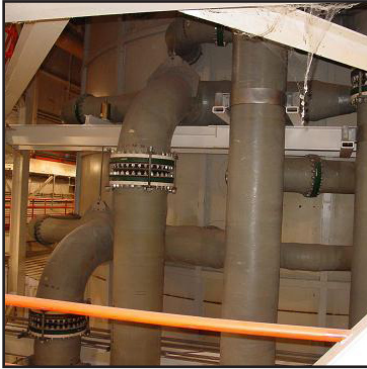
Exterior of the FGD at the spray level

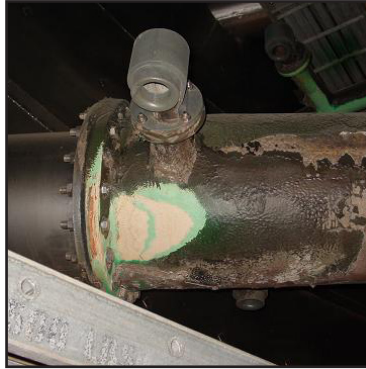
Severely damaged FRP pipe caused by lime slurry

Lime slurry from the four spray levels above had caused an existing polyurea coating to fail exposing the relatively soft FRP piping to the erosive forces of the lime slurry. Should the piping become holed, side streams would decrease the overall scrubbing efficiency resulting in increased operating costs.

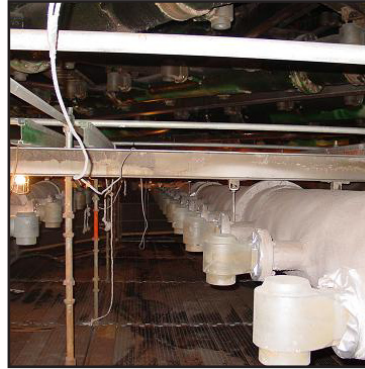
Completed Belzona application to one of six lime slurry header pipes

Belzona® 5891 and Belzona® 1391 were applied in accordance with a modified Belzona Know-How System Leaflet VPF-2.

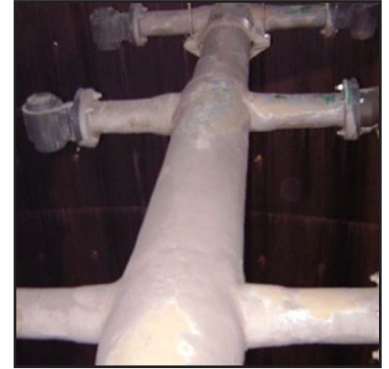
Belzona repair after seventeen months in service
