A Good Night with Belzona

Local municipality,
Slovenia

Belzona® 1111
(Super Metal)

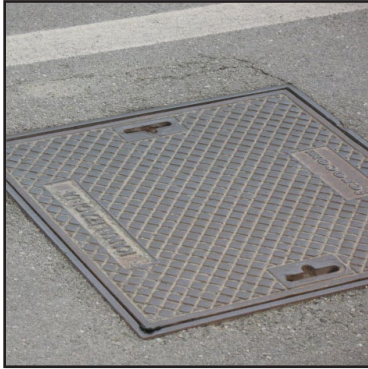
Manhole

Manholes on the street were causing a lot of noise due to uneven cover seat. Local people call them "Singing Covers".

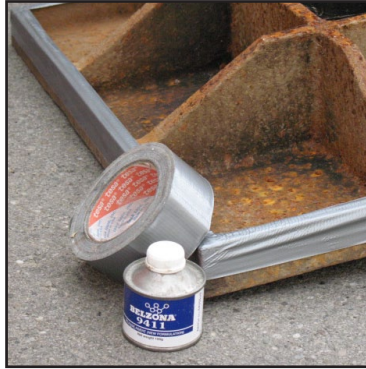
Applying Duct tape and Belzona® 9411

The manhole seats were roughened and then degreased. Cover plate ends were protected with Duct tape and Belzona® 9411. Belzona® 1111 was used to rebuild the manhole cover seat in accordance with Belzona Know-How System Leaflet GSS-8.

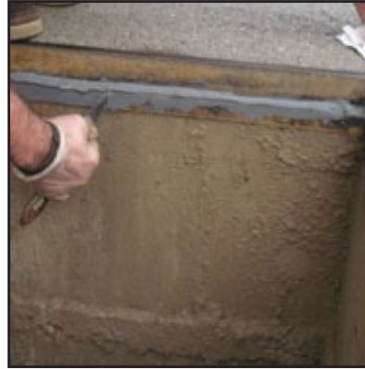
Rebuilding manhole cover seat with Belzona® 1111

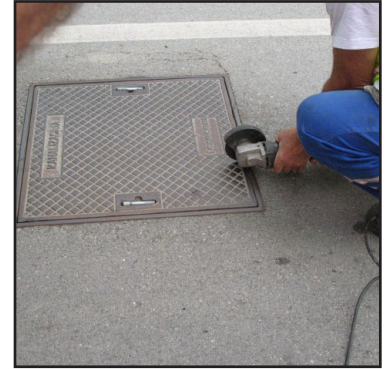
Manhole in place and position marked

Belzona® 1111 made a cost effective solution and a perfect fit of the manhole cover in its seat eliminating noise. Conventional replacement method takes time, a lot of work and different material (asphalt, reinforced concrete). The cost savings by using Belzona technology is about 200,00 EUR per manhole.
