Belzona® Rebuilds Cavitated Vanes

Power Plant,
Egypt

5 impellers of cooling pumps.

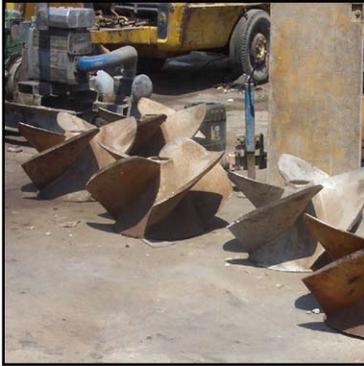
General view of the 5 impellers.

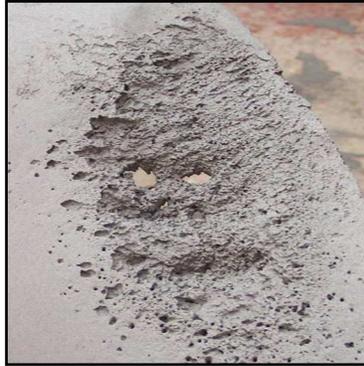
The cavitated vanes.

Severe cavitation caused holes, pittings, and deformation in the profile of the vanes.

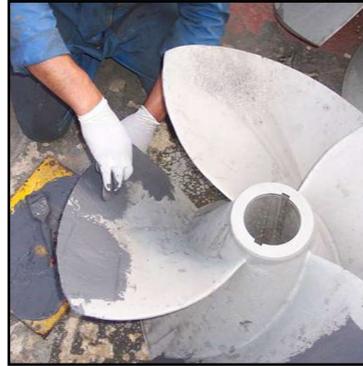
Rebuilding the vanes using
Belzona® 1311

Application was carried out in accordance with a modified version of Belzona® Know-How System Leaflets CEP-3 and -5.

Belzona rebuilt the cavitation and pitting damage in the vanes restoring the correct profile using a simple technique, saving replacement costs and also providing more resistance to future cavitation.

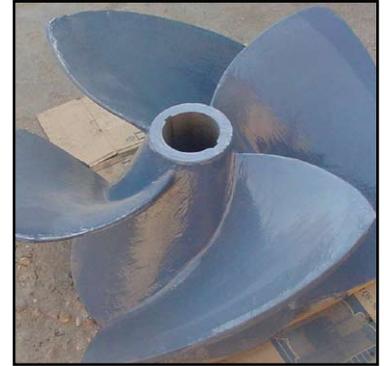
Finished Impellers coated with
Belzona® 1321
