Novel Knock-Out Drum Corrosion Solution

In order to combat corrosion within an ammonia acid gas KOD used in the **Tail Gas Amine Treatment System for sulfur recovery** in their refinery, a major US Oil & Gas asset owner was in need of a reliable coating solution. The protection system was required to ensure the integrity of the Sulfur Recovery Unit (SRU) that removes sulfur compounds from acid gas process streams before they are vented out to the atmosphere.

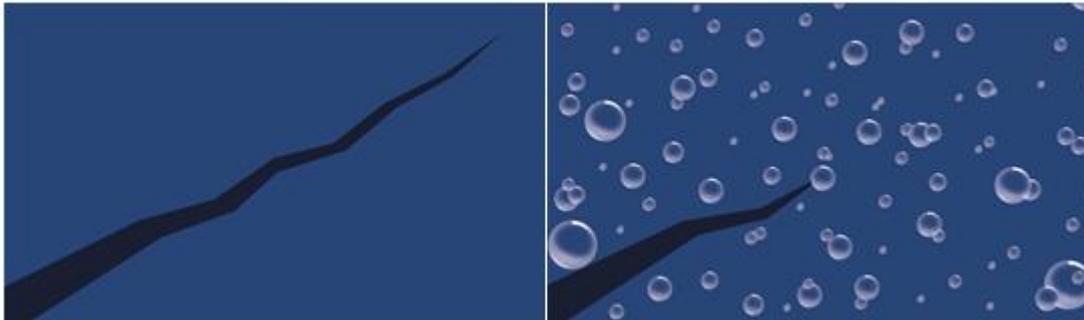
Crack propagation in other coatings (left) and Belzona 1523 and Belzona 1593 (right)

To provide increased impact resistance and flexibility in order to withstand high levels of temperature and pressure differences, rubbery domains that inhibit crack propagation have been incorporated into the polymeric structure of Belzona 1523 and Belzona 1593. Belzona 1523 exhibits a tensile strength of 13.7 MPa and elongation rate of 0.54% when cured and tested at 100°C, whilst with Belzona 1593 a tensile strength of 11.2 MPa and elongation rate of 0,31% when cured and tested at 160°C is recorded. Since the materials can be deformed when under high radial, circumferential and longitudinal stress, they preserve their integrity, move in sympathy with the substrate and absorb vibrations, reducing material ruptures, breaks and fissures.
