**Title: Belzona SuperWrap II Saves Failing Seawater Filter Vessel**  
**Alternative Title: Vessel Leak Sealed without Hot Work or Drainage**

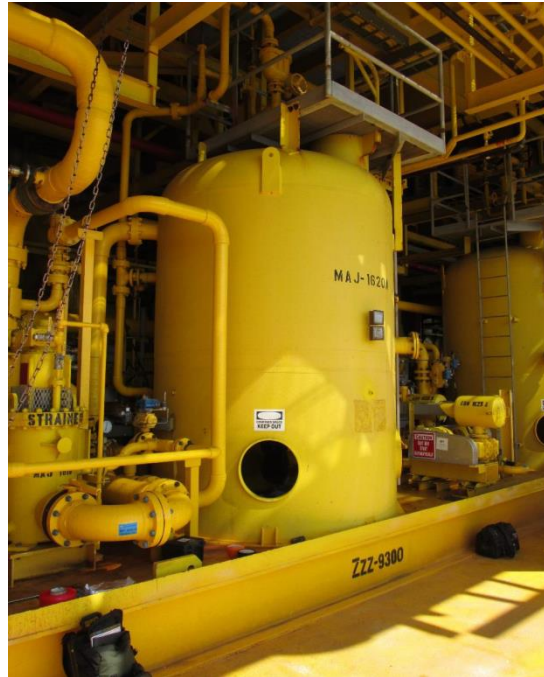
During March 2015, an offshore Oil and Gas platform contacted Belzona requiring a unique solution for the repair of a **seawater** bulk media filter vessel. Located in the Gulf of Mexico, USA, the bottom of the vessel was suffering from an internal leak due to dissimilar metal (stainless screen) inside the internally coated filter, experiencing internal corrosion at coating holidays. Furthermore, the damage involved a combination of both thin and a through-wall defect, posing a repair dilemma without emptying the entire vessel's contents.

*Caption: Leaking seawater filter vessel*

Suspended particles in the seawater can cause continuous abrasion to the vessel lining, which in combination with the highly corrosive salt water, creates an extremely destructive environment. In this instance, it had caused the vessel to leak due to a failure with the underdrain system. Consequently, the asset owner decided to use a bolt to arrest the leak, until a permanent compliant solution was implemented. Following investigation of alternatives, evidence suggested that competitor products were unable to provide a sufficient composite patch; therefore the customer selected Belzona SuperWrap II in order to complete the repair.

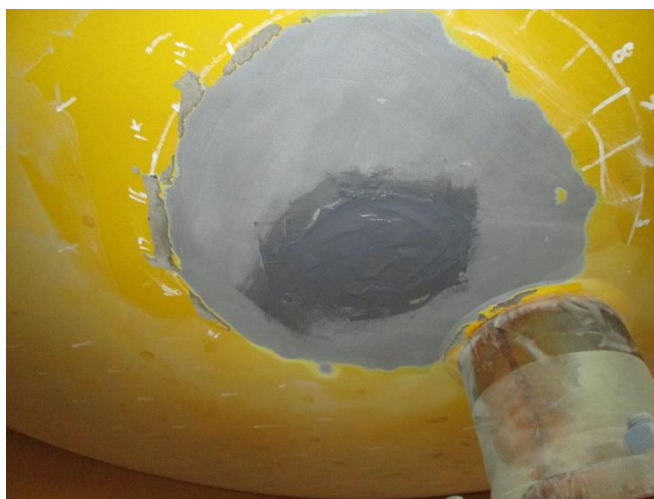
*Caption: Belzona SuperWrap II applied as per engineered design*

Following the thin and through-wall repair, the substrate was then cleaned to the requirements of SSPC SP 10 (Near-White Metal) by abrasive blasting. In reference to the design, three wraps (6 layers) of Belzona SuperWrap II were applied to the repair area to reinforce the bottom of the filter vessel. This composite wrap was chosen because of its application versatility and proven efficiency with repairing weakened and holed vessel walls. Using Belzona 1121 (Super XL-Metal) epoxy resin to create a mould of the vessel's surface, the Belzona SuperWrap II repair was consolidated by applying pressure against the template, creating a secure and tight seal around the defect.
