## Belzona Repairs and Protects Water Pumps at Historic Reservoir

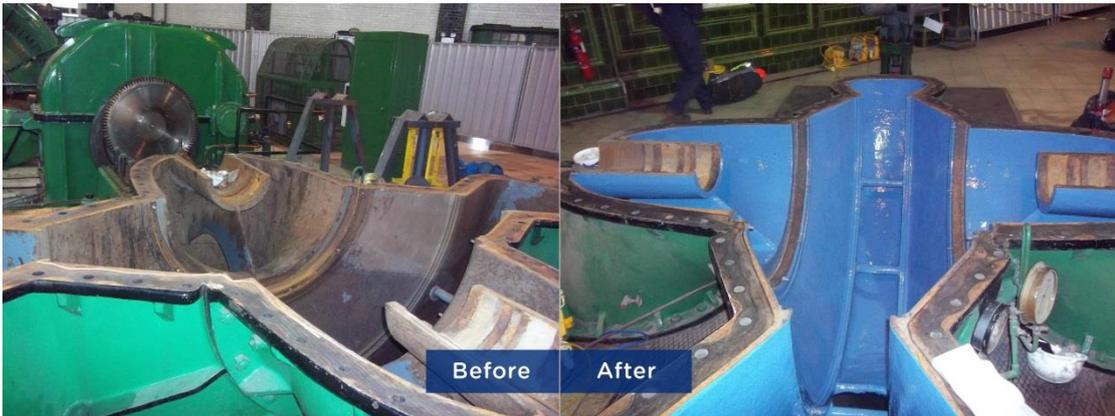
Image 1- Pump casing before and after Belzona application

By using modern polymer technology, Belzona was able to restore the centrifugal pumping equipment and ensure the historic Queen Mary Reservoir was back to running as smoothly and efficiently as possible.

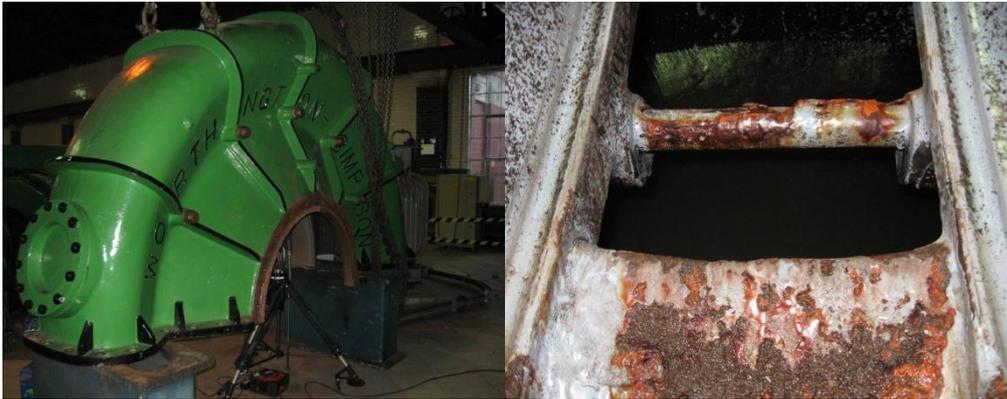
Due to the physical size and weight of the top half of the pump casing, it was not practical to turn the casing over, therefore, the casing was mounted on blocks (supported by the crane for safety) and scanned from underneath. During this inspection, each casing was identified as having Substrate Corrosion To Rust Grade D. This is the highest level of corrosion grade on the scale, indicating severe rusting of the cast iron and pitting. (ISO-8501-1)

Image -2 Pump casing mounted on blocks

Image 3- Pump casing severely corroded

Once the hydraulic profile was completed and all the equipment had been scanned, it was decided that several refurbishment applications should be carried out on three of the pump volutes, totalling a surface area of 282m<sup>2</sup>. Due to the extent of the damage (some areas of each volute exhibited up to 50% corrosion) complete metal repairs were prescribed followed by a protective coating. Rebuilding and protection were required to restore the heavily corroded cast iron substrate so the pump could continue to perform at its maximum efficiency. After inspecting the impellers, each of them consisting of a surface area of 44.5m<sup>2</sup>, it was decided that once each had undergone a thorough cleaning, they could be put back into service.

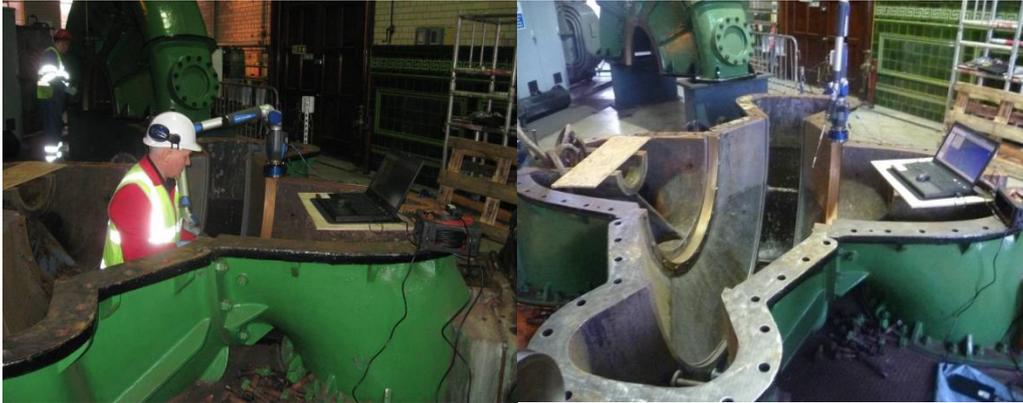
After years of frequent use, certain areas of the pumping equipment were suffering from cavitation damage, which in turn was seriously hindering the efficiency of the pumping system. This needed to be promptly addressed and so a thorough inspection including a hydraulic profile was arranged.

Image 4&5- Lower casing being scanned to capture hydraulic details

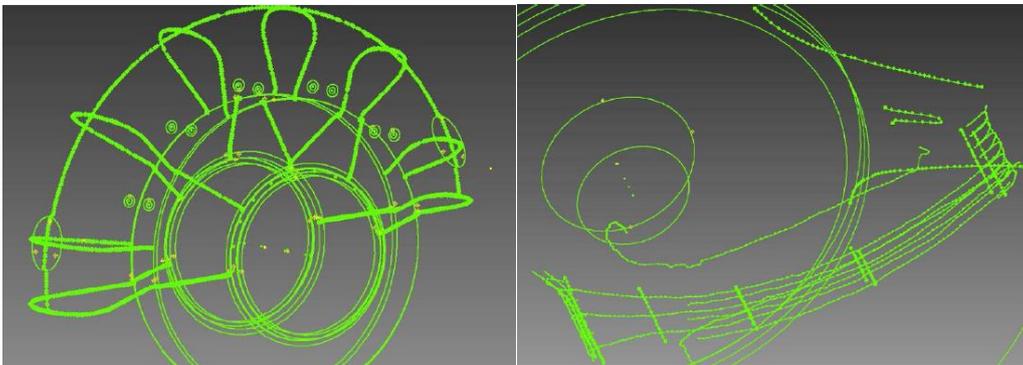
Image 6- Hydraulic profile of casing upper half    Image 7- Hydraulic profile of impeller vane

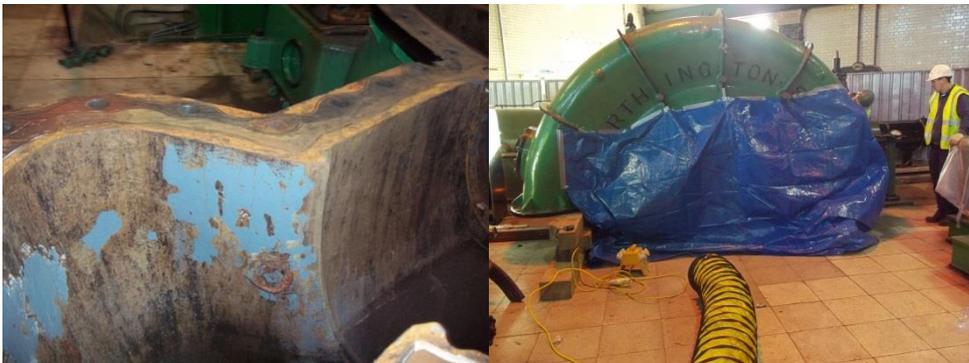
Image 8- Pump casing prior to removal of existing coating    Image 10- Sponge Blasting in progress

Firstly, all machined faces were protected from the blasting process before Sponge Blasting equipment was used on the upper and lower casings. This was used to remove the previous coating, create a substrate cleanliness of at least SA 2 ½ and produce a surface profile of no less than 75µm. The application area was then vacuumed and examined to make sure it was dust free and all the blast media was removed.

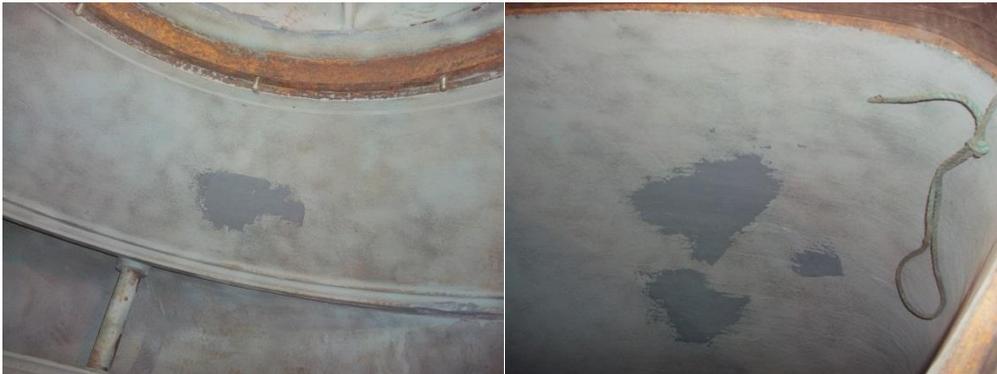
Images 9&10- Substrate rebuilt with Belzona 1111

Once the substrate had been tested for salt contamination, the application areas were masked out ready for the application of Belzona 1111 (Super Metal). Applied using a Belzona applicator, this material was used to rebuild the areas of undulation and pitting damage. A solvent free epoxy resin reinforced with silicon steel alloy, this repair composite provides robust corrosion resistance and will ensure the substrate will remain protected when it comes into contact with abrasive material.

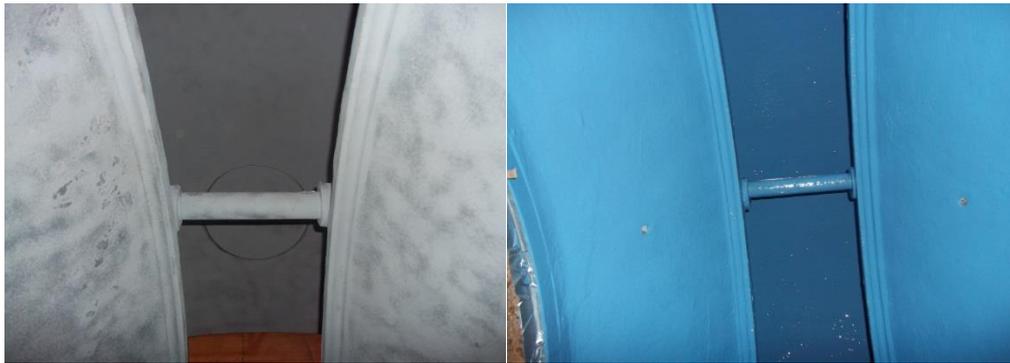
Image 11- Pump casing after Sponge Blast

Image 12- Completed application

After Belzona 1111 had cured and within the two-hour coating window, the first coat of Belzona 1341 (Supermetalgilde) in a grey colour was brush applied. This was followed by the second coat in blue to achieve a total dry film thickness of 400 microns. This coating was specified as it will provide long-term erosion and corrosion protection to the equipment and improve the efficiency of the pump. In fact, Belzona 1341 has been proven to increase efficiency by up to 7% on new equipment and up to 20% on refurbished equipment. It does this by using hydrophobic technology which repels process fluids and reduces the turbulent flow. Once cured, the coated surfaces were thoroughly checked over for any misses or pin holes.

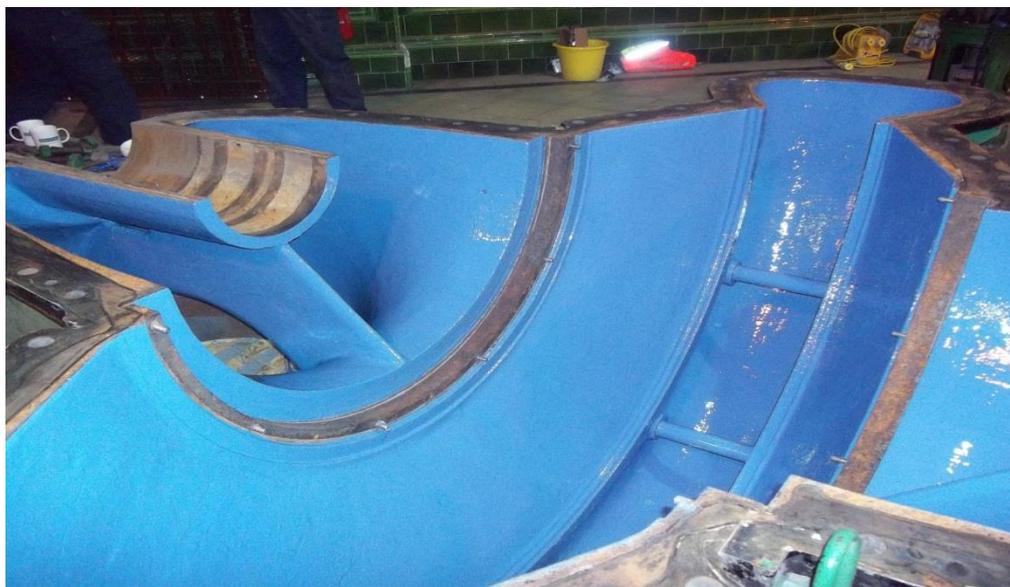
Image13- Completed application
