Main Cooling Water Pumps Protected with Belzona

Coal fired power station,
UK

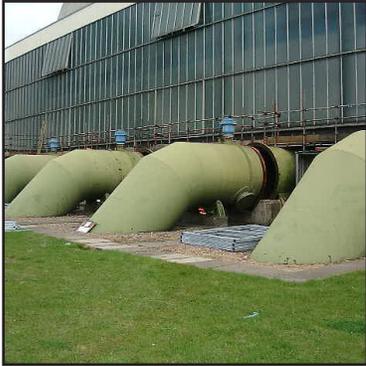
Scale of pumps can be gauged from the delivery tubes

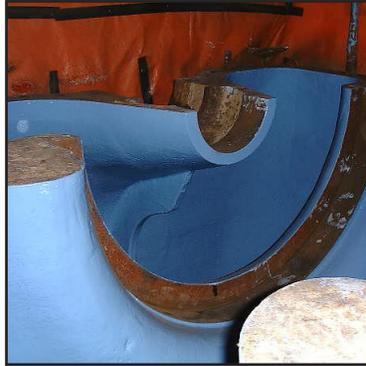
Suction side coated

Carried out in accordance with Belzona system leaflets CEP-1 & -3. Particular attention was paid to surface preparation with repeated steam cleaning and grit blasting used to remove salt contamination.

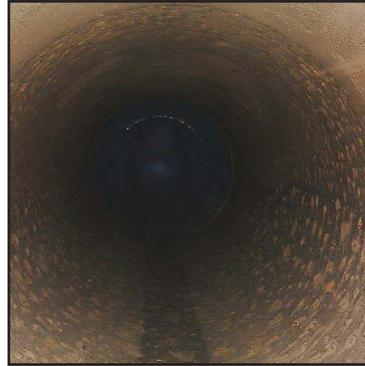
Degree of corrosion evident on the delivery tubes

Erosion corrosion particularly on main wearing rings, cut water and delivery tubes.

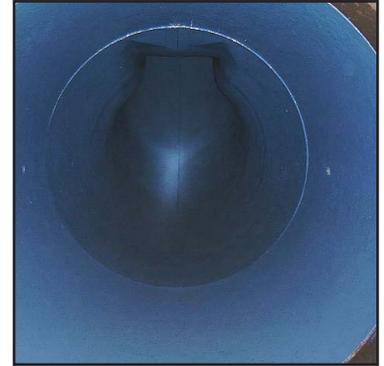
Completed coating
