## Belzona Protects Clarifier

Chemical Plant,  
Italy

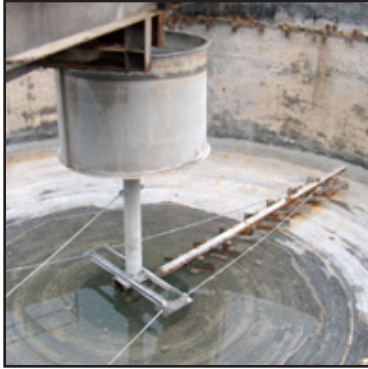
*Before Belzona*

Concrete damaged by erosion and abrasion led to underground leakages with contaminated water.

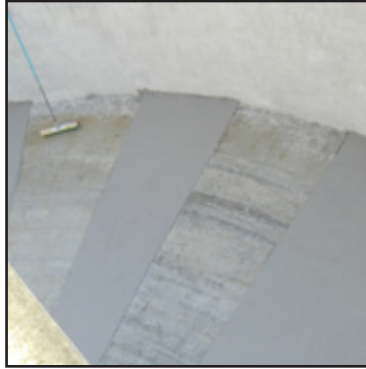
*Application of Belzona® 4111*

Application to wall carried out in accordance with Belzona System Leaflet TCC-5 using 100L Belzona® 5811. Tank floor screeded with Belzona® 4111 (1650Kg) in accordance with Belzona Know-How System Leaflet FPA-1.

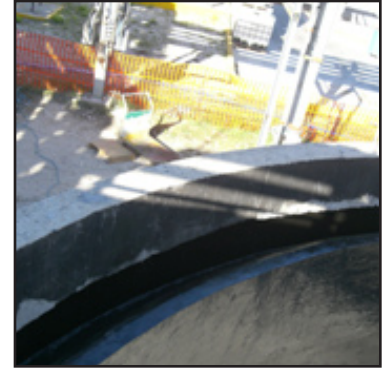
*Completed application*

Concrete was not a solution for the reconstruction of heavily damaged areas. The Belzona solution provided waterproofing, corrosion protection and abrasion resistance required on the floor.
