BELZONA PROTECTS POWER STATION CHIMNEY STACK

Coal Fired Power Station, Yorkshire, England

Top section of exhaust gas chimney stack.

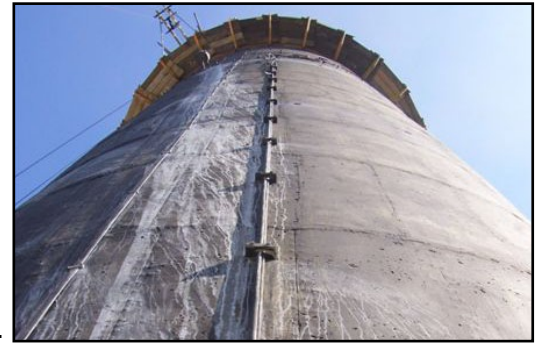
Existing coating was beginning to degrade due to exhaust gases and ultra-violet (UV) breakdown combined with inclement weather.

1. Existing coating degrading
2. Application of Belzona® 5111
3. Completed application in 2008
4. Application revisited in 2010
