# IN FOCUS: Flange Protection

## SOLUTIONS FOR FLANGE REPAIR AND PROTECTION

Issue 109

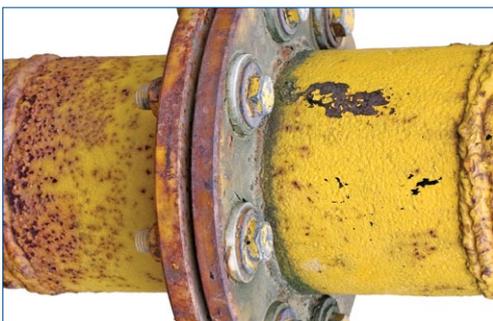
General corrosion on flange

Crevice corrosion is a common damage mechanism where there is a concentration of corrosive substances in a localised area. Indeed, the rate of corrosion is accelerated by the concentration of corrosive materials within a confined space. The crevice between two flange faces is the ideal environment for crevice corrosion. The flange face is predominantly prone to crevice corrosion when flanges are used in extremely corrosive environments.

Over time, the corrosion started in the gap on the inside diameter of a flange can extend to the gasket area. The concentration of corrosive materials between the gap of the

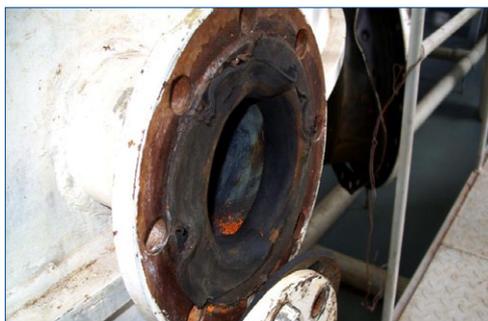
Highly corroded flange face

sealing surface and gasket material can influence the corrosion rate of the flange face. The gasket acts as a seal covering the area of the face from the corner edge to the end of the machined surface of the face. Corrosion of the sealing area can result in a loss of containment and release of product with potentially catastrophic consequences for the environment.

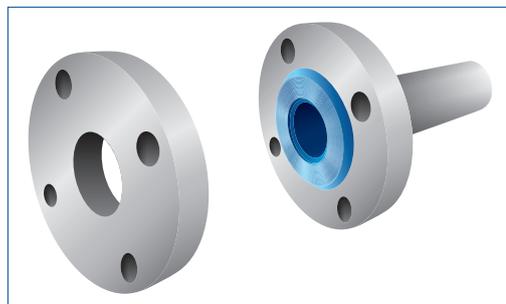
Flange face repaired with [Belzona Flange Face Forming Kit](#)

The [Belzona Flange Face Forming Kit](#) is a unique repair kit developed to aid the flange face forming technology in combating the common problems with mating surfaces of flanged joints such as heat distortion, corrosion and erosion. In conjunction with Belzona two-part epoxy repair composites (see product selector below), this flange repair kit provides a complete package solution which is simple and cost-effective to install.

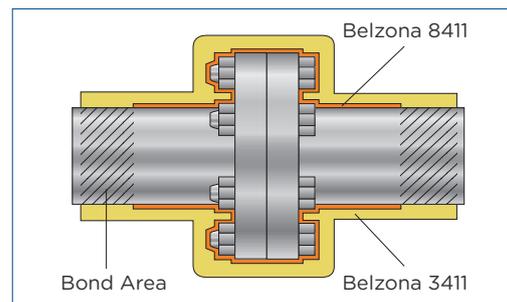
Belzona's flange encapsulation system

This tough and flexible system can be used to protect most flange shapes, sizes and configurations from corrosion and completely encapsulates the flange to exclude any moisture. Belzona 8411 also has release properties allowing the [Belzona 3411](#) topcoat to be peeled back from the joint to allow inspection.

When maintenance is required, the system can be simply cut open by using a sharp knife to cut through the membrane in the gap between the flange faces around the circumference of the flange. The membrane will be then be peeled back, exposing bolts and flanges. Once the required maintenance has been completed, the membrane will fold back to its original position and can be sealed with a further quantity of [Belzona 3411](#).

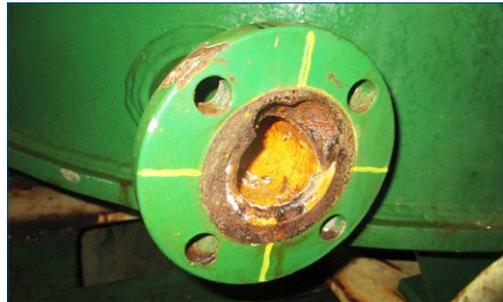
Flange face highly corroded

The existing lining had failed, leading to corrosion of the vessel internals and severe loss of metal on the adjacent flanges. The client was unable to use hot work and had a limited amount of time to carry out the application. Indeed, conventional cut and weld repair methods involve hot work and require replacement flanges which may not be available in emergency situations, especially in areas with limited access such as offshore platforms.

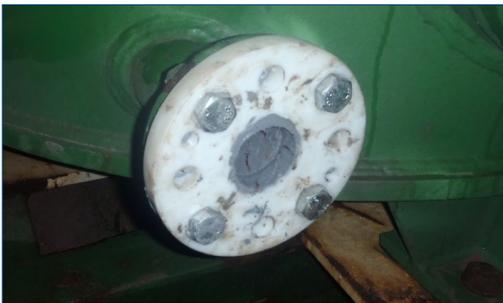
Former in place with Belzona material

The [Belzona flange face forming](#) solution was chosen for this repair as it does not require hot work or replacement flanges and it can be rapidly performed minimising downtime. After the surface on the flange face was prepared, the selected Belzona material was mixed and applied to the damaged surface and to the former, pushing the material well into the prepared profile. Both surfaces were brought together and once the correct level was achieved the former was bolted to the flange. Once the product was sufficiently

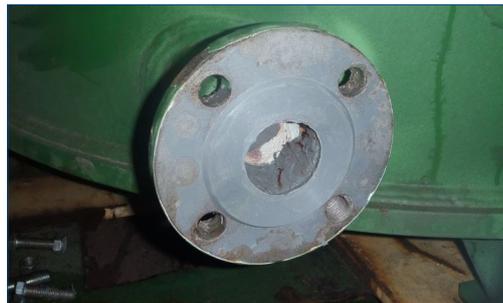
Flange face forming completed

cured the former was dismantled and bolts removed, leaving a perfectly formed sealing face on the original flange.

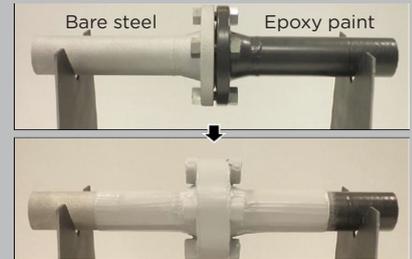
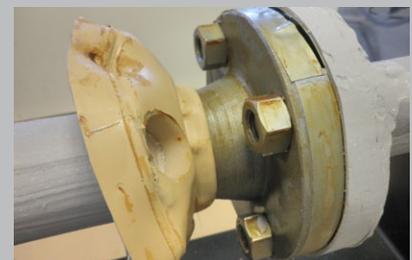
After 1,000 hours of exposure to the salt-fog atmosphere, no corrosion was reported under the encapsulating system. In comparison, the exposed steel part at the end of the flange showed a high level of corrosion.

The corrosion resistance of the Belzona 3411 system has been proved by the salt spray test, used to assess a coating's ability to resist attack from a continuous salt fog. The salt chamber converts a 5% sodium chloride solution into a hot fog at 35°C (95°F).

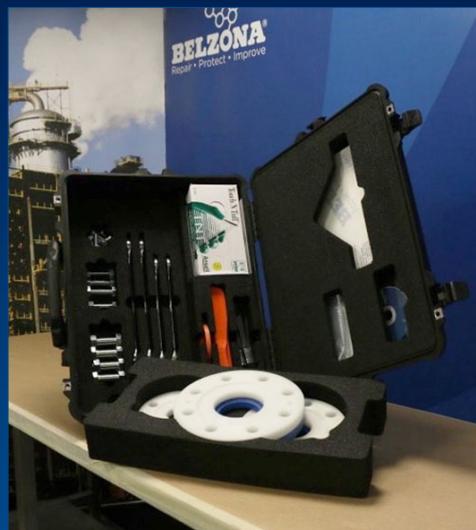
## BELZONA FLANGE FACE FORMING KIT

- Simple to use as all the necessary accessories are in one kit
- Contains 6 reusable plastic formers
- Lightweight allowing easy transportation to emergency situations and areas with limited access
- Minimised downtime as the kit eliminates the need for spare parts

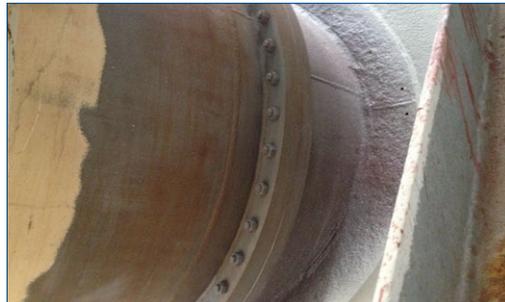
52" flange grit blasted

The application was carried out by the plant personnel in accordance with Belzona's application procedures. The customer saved several thousand dollars over the previous fiberglass system with easier installation. The unit was inspected 90 days after the installation and it looked as good as it did on day one. The client was very satisfied with the Belzona solution and is planning to use [Belzona 3411](#) on other flanges. ■

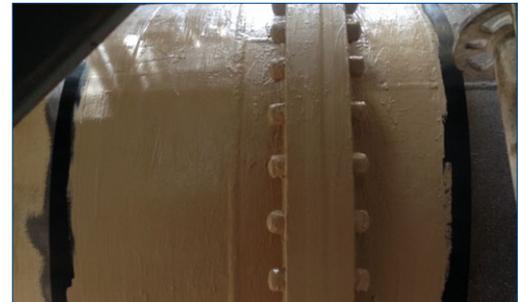
First layer of Belzona 3411 applied

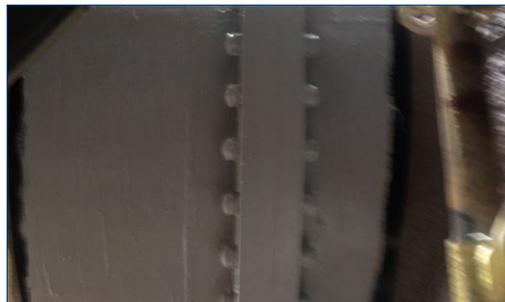
Completed application on the flange

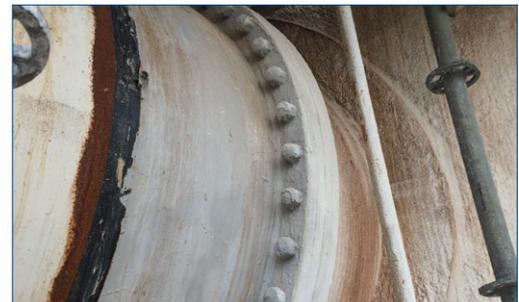
Flange in perfect condition after months in service
