Corroded Pipework: A Thing of the Past

Oil Refinery,
New Zealand

Belzona® 5851
(HA-Barrier)

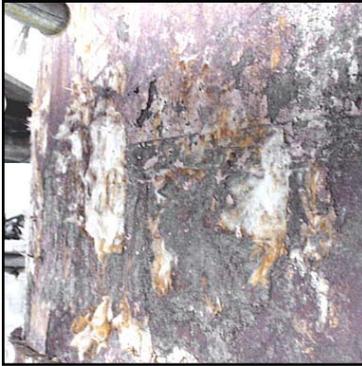
Prior to application, corrosion can easily be seen.
