Belzona Provides Solution to Water Injection Pump

Sugar Cane Mill in Australia

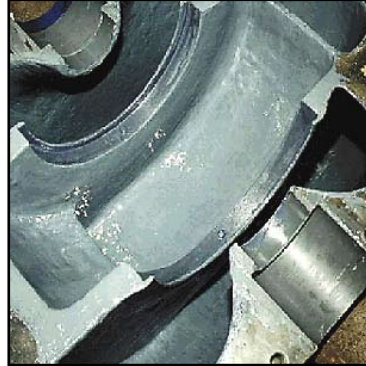
Rebuilt wear ring seat and stuffing box

Belzona® 1311 (Ceramic R- Metal)

The application was carried out in accordance with Belzona Know-How Leaflets CEP-1,2 and 3.
