Belzona Repairs Vacuum Pump Rotor

Sugar Cane Mill in Minnesota,
U.S.A.

Vacuum pump rotor

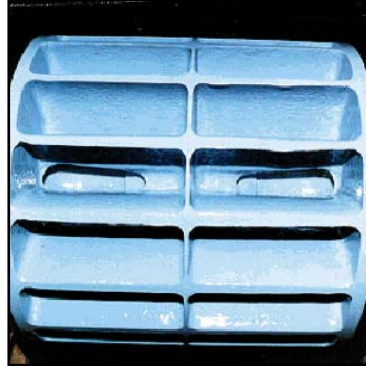
Refurbished rotor

Belzona® 1111 (Super Metal)
Belzona® 1341 (Supermetalgilde)

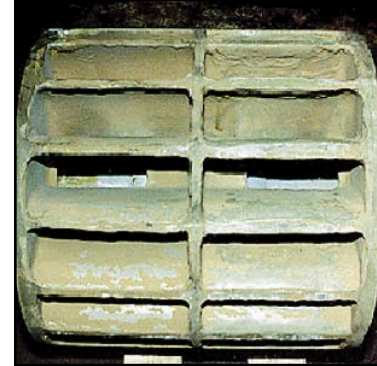
Rotor after many years in service

Belzona's repair system has proven resistant to cavitation. The repair has lasted over five years.
