Belzona For Mud Pumps

Offshore Oil Drilling Platform,
Gulf of Mexico

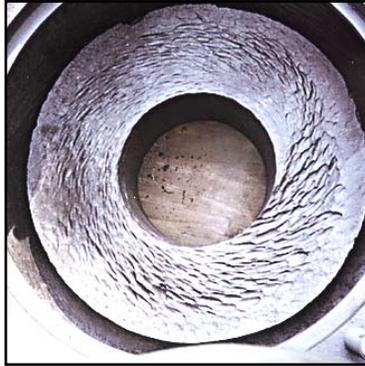
Severe wear on the pump casing.
