Belzona® 1811 Protects Beet Flume Weld Joints

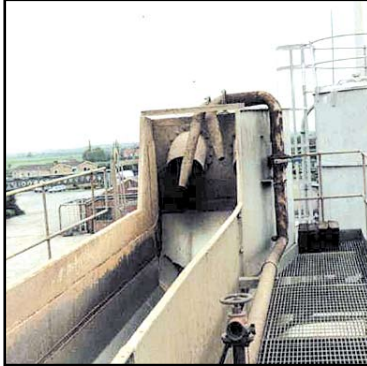
General view of the application site

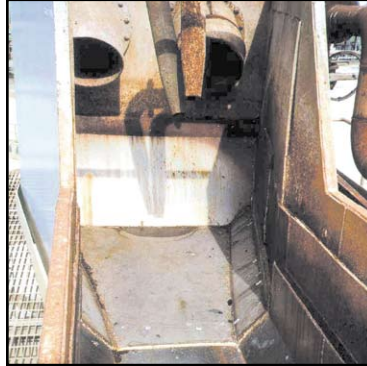
Equipment prior to surface preparation

Extensive abrasion and eventual failure of the weld seams connecting the steel plates that make up the flume.

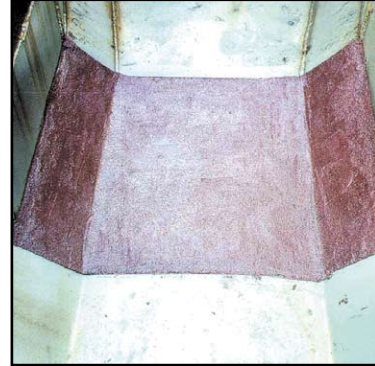
Application completed with the Belzona® 1811

The application was carried out in accordance with Belzona Know-How System Leaflet SHM-13.

Abrasion of the weld seams - if allowed to continue - would have led to impaired operating efficiency. Repair or replacement during the manufacturing campaign would have required significant downtime and resulted in a major loss of revenue. Belzona product lent itself to application within the confines of the flume channel. By applying Belzona to seams in the flumes most vulnerable areas during annual outage, only sacrificial wear of the product takes place during the campaign, thereby leaving the weld seams intact.
