## Belzona Protects Internal Base of Separator

Oil Refinery,  
Australia

Belzona® 1591  
(Ceramic XHT Metal)

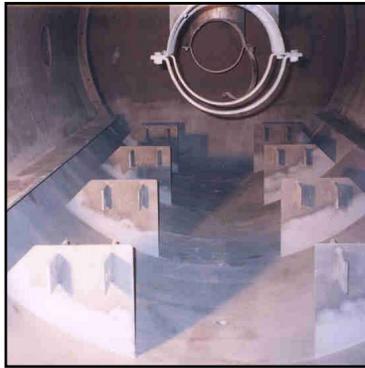
Base of vessel grit blasted.

Application was carried out in accordance with Belzona Know-How System Leaflet TCC-5. After thorough cleaning, the vessel was grit blasted and coated with the Belzona® 1591 taking care to initially stripe coat around the attachment bracket welds.

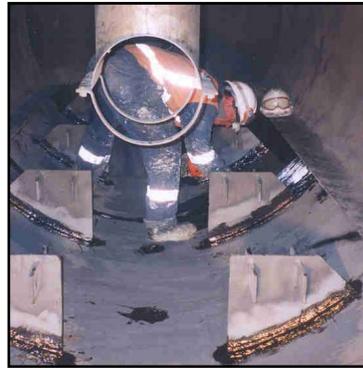
Stripe coating of welds carried out.

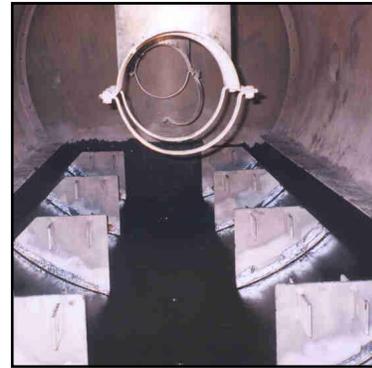
Completed application.
