Belzona Repairs Steering Gear

Cargo Ship,
Egypt

Rudder stock - upper housing and pintle housing.

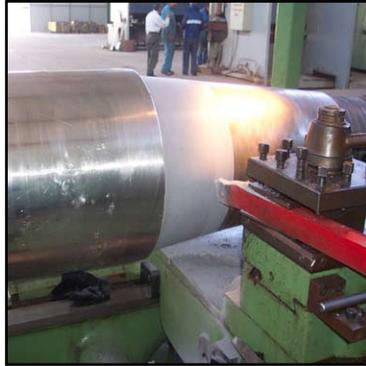
Rudder stock being machined back to its dimensions after repair.

Severe corrosion on the affected areas of the rudder stock and pintle housing areas.

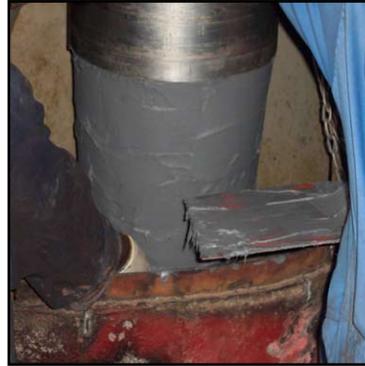
Belzona® 1121 was applied to both pintle and pintle housing.

Application was carried out in accordance with Belzona® Know-How System Leaflets SOS-3 and MPT-1.

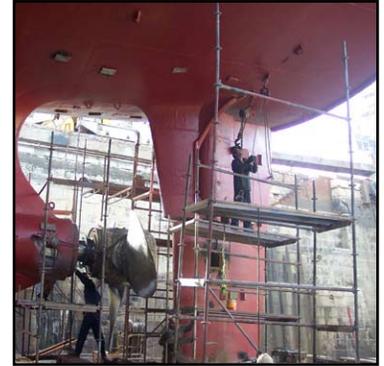
Rudder being installed.
