## Belzona Repair and Protection of Refrigeration Unit

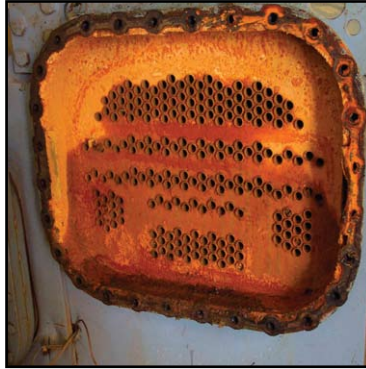
The corroded tube sheet.

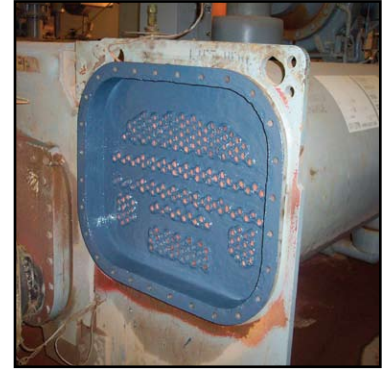
Completed application.
