## Belzona Protects Large Cooling Water Pump

1.5 meter diameter suction split casing pump handling a 20 meter head of sea water.

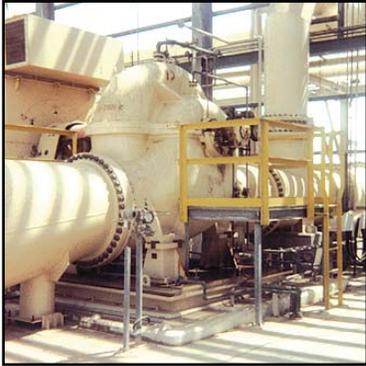
General view of the pump installation.

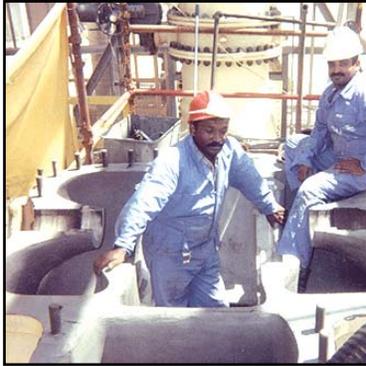
The size of pump is clearly evident.

Cavitation and general erosion-corrosion damage had reduced the pumps efficiency to unacceptable levels. The plant has a limited power supply and was looking for all ways to reduce demand.

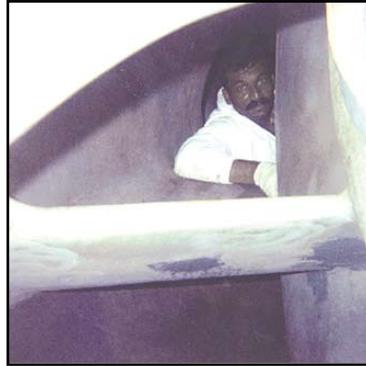
Rebuilding work underway.

The application was carried out in accordance with Belzona Know-How System Leaflets CEP -2, -3, -5, -10.

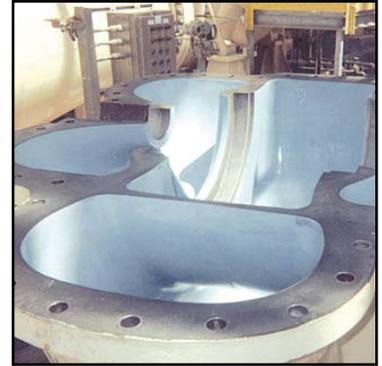
Completed application.

Belzona® 1341 not only restored the original efficiency, but provided reduced power demand. This was more important to the plant than cost because of the lack of power available.
