## Belzona Seals Condenser Expansion Joint

The #4 generator condenser expansion joint.

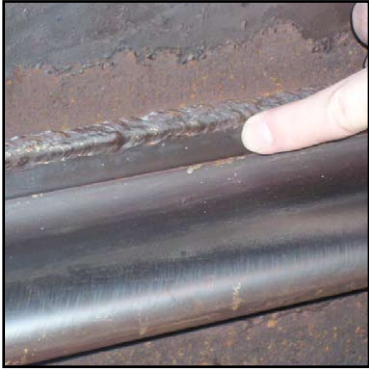
*Leaking Expansion Joint*

The efficiency of the unit was low because of the leaks in the expansion joint.

Application was carried out in accordance with Belzona Know-How System Leaflet HEX-5. The surface was prepared with a vacublast unit. After Conditioning, three coats of Elastomer were applied to the expansion joint and approximately one inch beyond the joint.

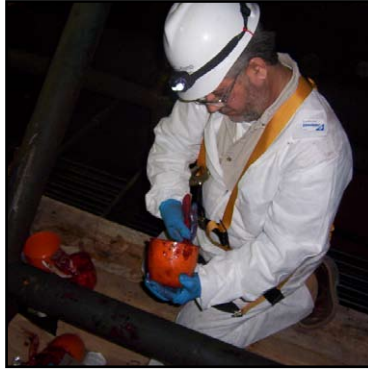
*Mixing Elastomer*

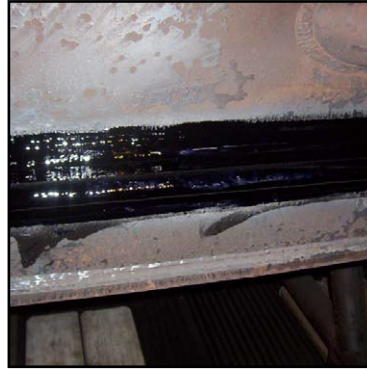
*First coat*
