Belzona® Repairs Francis Turbine Wicket Gates

Francis Turbine Wicket Gate

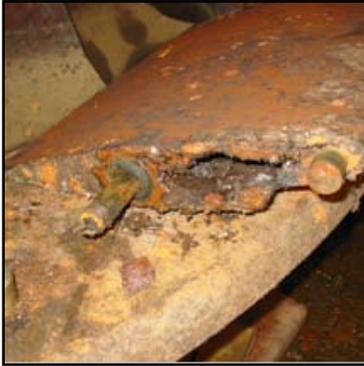
Damaged Wicket Gate Blade.

Impact by debris in the water in conjunction with erosion and corrosion had left this turbine in a terrible state of repair and in need of replacement

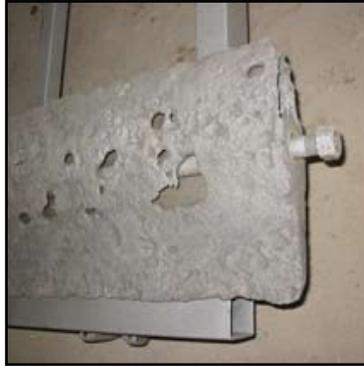
Blade After Grit Blasting.

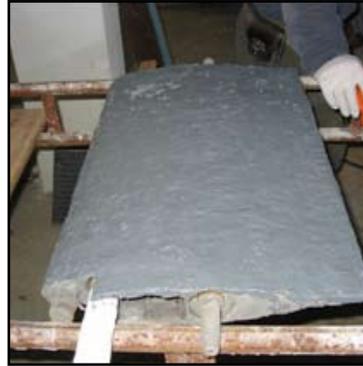
Blade After Rebuilding With Belzona® 1111

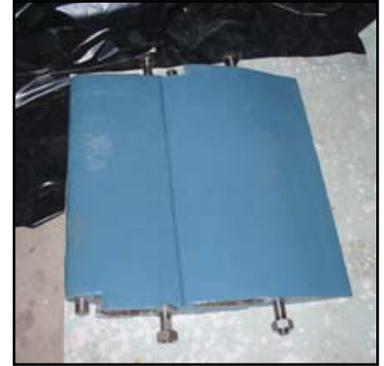
Blade After Coating With Belzona® 1341

After the overhaul and coating of both the wicket gates and the runner the client saw an increase in output of 10 - 15%. After one year only minor damage was seen due to impact with large objects in the water.
