Belzona Rebuilds and Protects Kort Nozzles

Tug boat kort nozzles.

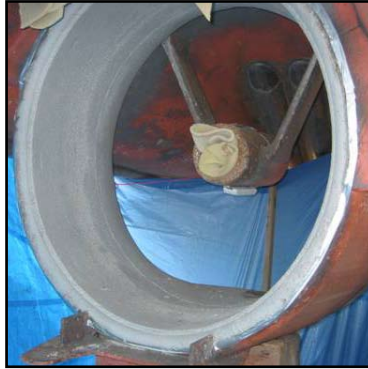
View of one of the blasted nozzles.

Kort nozzles badly eroded.

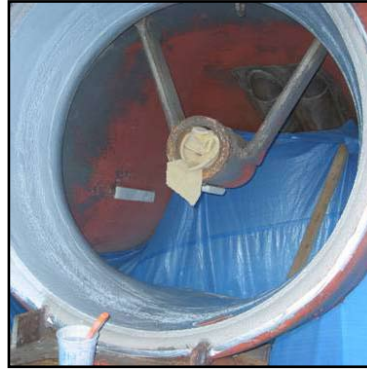
Application of first coat of Belzona® 1341 with additional coat to fill voids.

Application was carried out in accordance with Belzona Know-How System Leaflets SOS-1 & -2.

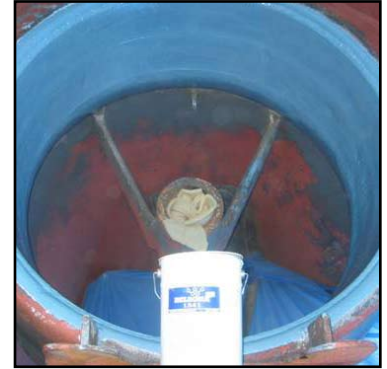
Second coat of Belzona® 1341 applied to complete the application.
