## Belzona® Repair to Power Plant Coal Belt

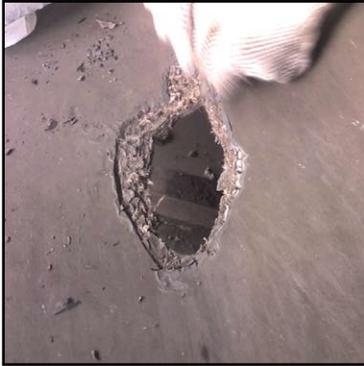
Hole in the belt being prepared

Belt developed a large burn hole. This rendered the belt unusable until fixed.

Belt was repaired according to Belzona System Leaflet SHM-1

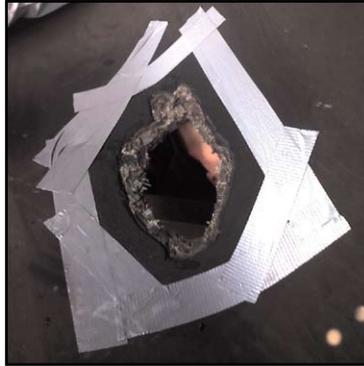
Preparation completed

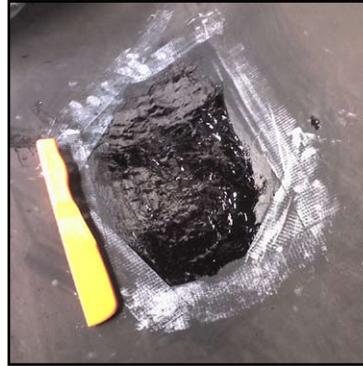
Completed application

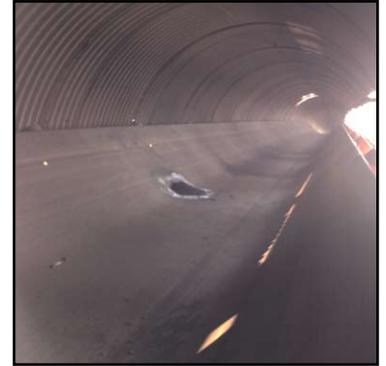
Completed application
