Belzona Unclogs Fouled Scrubber

Scrubber in the cogeneration plant of a sugar refinery.

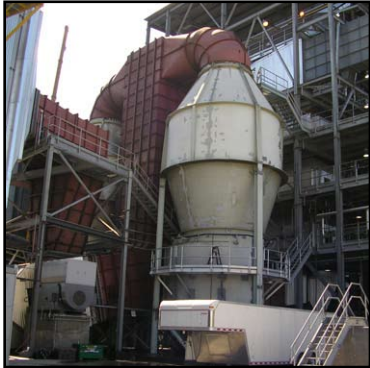
One of two scrubbers to be rescued with Belzona

Carbon steel vessel walls had become rough due to corrosion. Roughened walls then trapped sand and ash which lead to rapid fouling four to eight feet thick. This fouling rendered the scrubber ineffective and the electrostatic precipitator had to make up the deficit at a cost of \$50,000 per day.

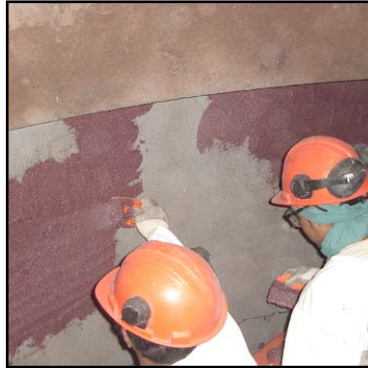
Belzona® 1811 (Ceramic Carbide) was applied to high wear areas to provide extra abrasion resistance

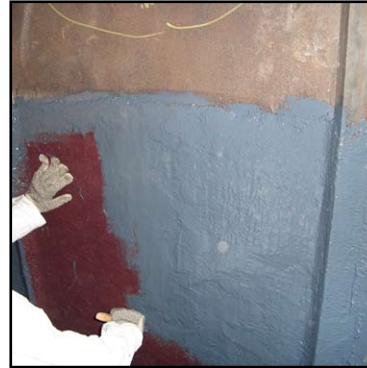
Belzona® 1391 provides a smooth surface and has the abrasion and temperature resistance required

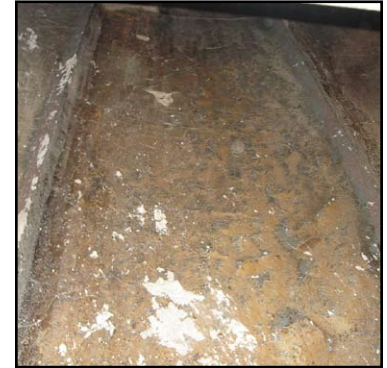
Belzona® 1391 eleven months later. Discoloration is caused by elevated temperatures but coating is 100% intact and fouling was totally eliminated
