Belzona Solves Acid Attack

Chemical Plant,
Cheshire, UK

Sump in chemical plant.

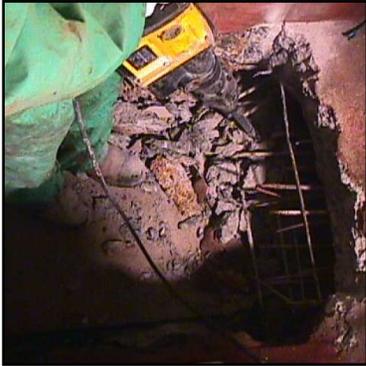
*The extent of the problem.*

Hydrochloric acid was seeping into a nearby water course. The problem was tracked down to a sump where hydrochloric acid had eaten through the concrete.

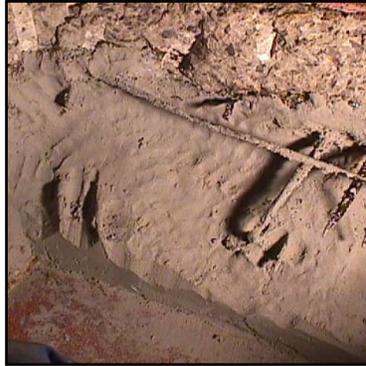
*Belzona fills the hole.*

After the original insert box was removed the large hole that had been made by the acid eating through the concrete, leaving only remnants of the reinforcing bar was discovered. With the use of heaters, the hole was repaired and sump protected with Belzona within the allowed three-day time frame. Still performing as expected – problem totally solved.

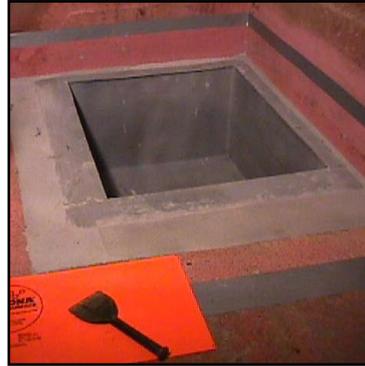
*Sump rebuilt.*

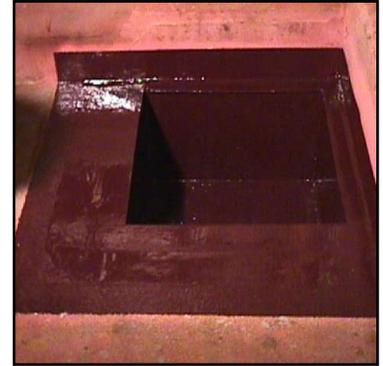
*Finished application.***STATISTICS****CUSTOMER**
