Repair solution doubles the service life of pump

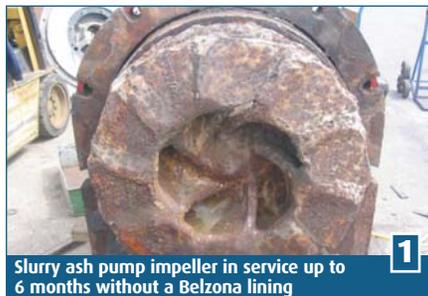
During a routine maintenance inspection, a centrifugal pump handling highly abrasive slurry fly ash was found to have severe erosion damage to its impeller and volute casing. Jamie Gallagher, Power industry specialist for Belzona explains, "The original pump components in excess of 500 Brinell hardness were still badly eroded. The impeller had approximately 10-15mm missing from the leading edge and the volute casing had cavities approximately 20mm in depth."

1 Slurry ash pump impeller in service up to 6 months without a Belzona lining

The component parts were rebuilt with a Belzona composite repair system back to the original profile and machined with diamond cutting tips. The impeller and volute case were then coated with a ceramic filled Belzona material, combining extremely hard, closely packed abrasion resistant materials in a polymeric binder in order to resist future abrasive attack.

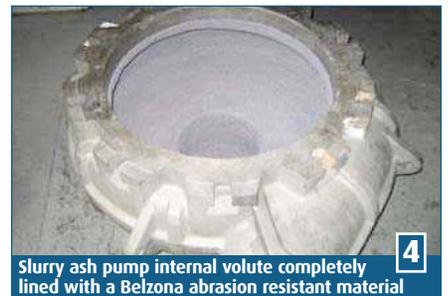
4 Slurry ash pump internal volute completely lined with a Belzona abrasion resistant material

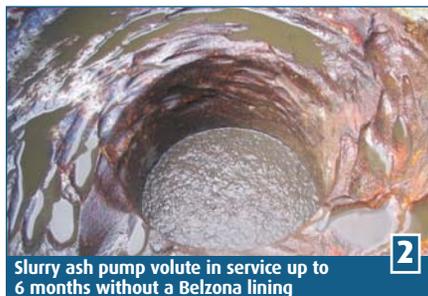
2 Slurry ash pump volute in service up to 6 months without a Belzona lining

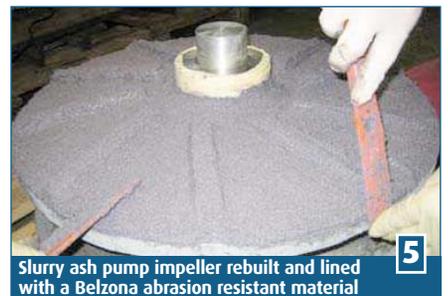
5 Slurry ash pump impeller rebuilt and lined with a Belzona abrasion resistant material

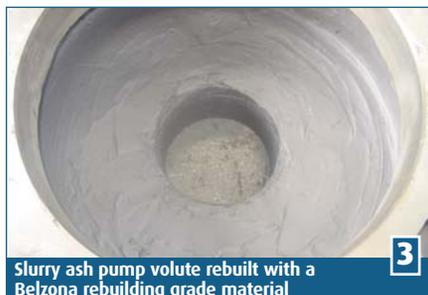
3 Slurry ash pump volute rebuilt with a Belzona rebuilding grade material

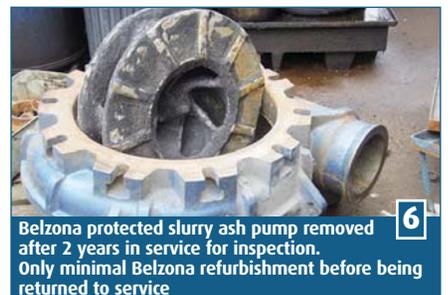
6 Belzona protected slurry ash pump removed after 2 years in service for inspection. Only minimal Belzona refurbishment before being returned to service
