SEPT/OCT 2008

THE INTERNATIONAL MAGAZINE FOR ENGINEERING AND MAINTENANCE PROFESSIONALS

IMPROVING PUMPING EFFICIENCY

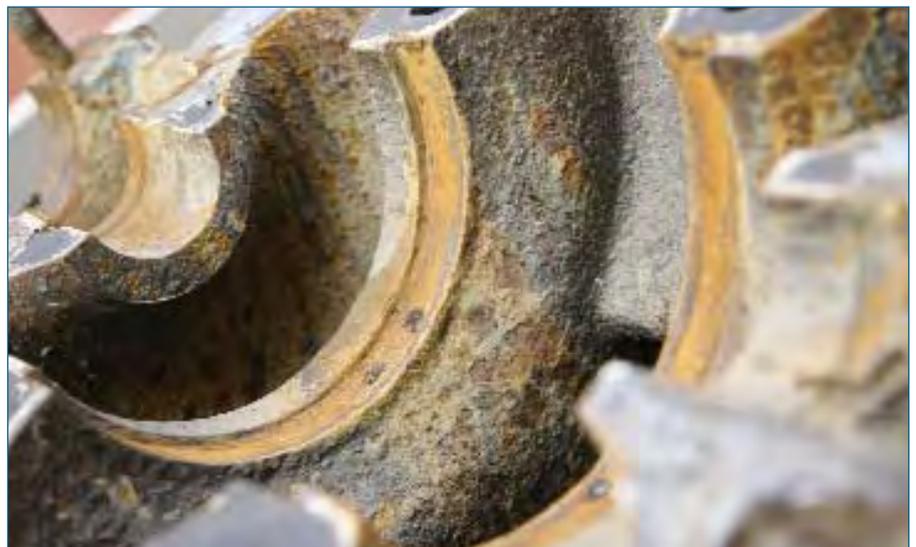
Worn and damaged pump awaiting repair

A major problem is increased turbulence caused by the detrimental effects of erosion corrosion. This leads to rough and pitted surfaces which in turn, increase drag, therefore reducing the efficiency of the system.

David Blackwell, Engineering Director for Belzona explained "It is not unusual for a pump which has been in service for a number of years to be operating at 15-20% below its design efficiency, due to the effects of erosion corrosion. By rebuilding and protecting these damaged areas with a Belzona corrosion and erosion resistant material it is possible to not only restore flow rates, but also increase the
