Polymeric Solution for Pump Cavitation

- Glenn Machado

August 1, 2009

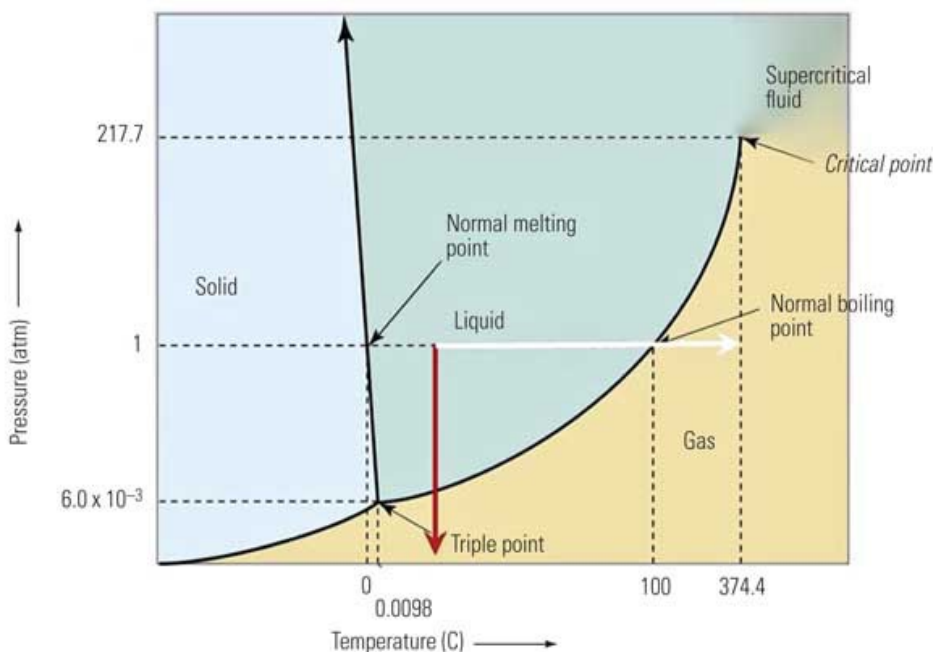
Figure 6. - Two ways to boil water. The curves on the graph represent equilibrium states. The curve bordering the liquid and gas phases is referred to as a vaporization curve. At normal conditions of pressure and temperature, a fluid is at 1 atm (14.7 psi) and 25C (77F). The white arrow illustrates a typical heating process that occurs at atmospheric pressure. The red arrow illustrates that saturation temperature (hence, boiling) of a liquid can also occur by reducing the liquid's pressure. *Source: Belzona Inc.*

The phase diagram of water in Figure 6 is a practical aid to understanding the theory behind cavitation. This diagram illustrates the three physical states of water at different

values of temperature and pressure. Water is most commonly boiled by heating it at a constant pressure, as we do when boiling a pot of water on a stovetop (white arrow). As temperature increases at constant pressure, water remains in a liquid phase until it reaches the normal boiling point (100C at 1 atm).

What is less intuitive is that water can also be boiled by dropping the pressure at a constant temperature (red arrow in Figure 6). This is exactly what occurs just behind the leading edge of a pump impeller vane. As water (or any other fluid) enters the pump, it is deflected by the vane. Above the leading edge of the vane, the fluid is compressed, creating a high local pressure area. Directly after the leading edge, there's a small area of decreased pressure. If this decrease in fluid pressure moves below the vaporization curve at constant temperature, the fluid will begin to boil, and vapor bubbles will form in the fluid. Behind this low-pressure area there is another high-pressure region. As the vapor bubbles entrained in the fluid move into this high-pressure region, they condense and collapse violently against the surface of the impeller vane. This rapid production of vapor bubbles, followed by their violent collapse, is described as cavitation (Figure 7).

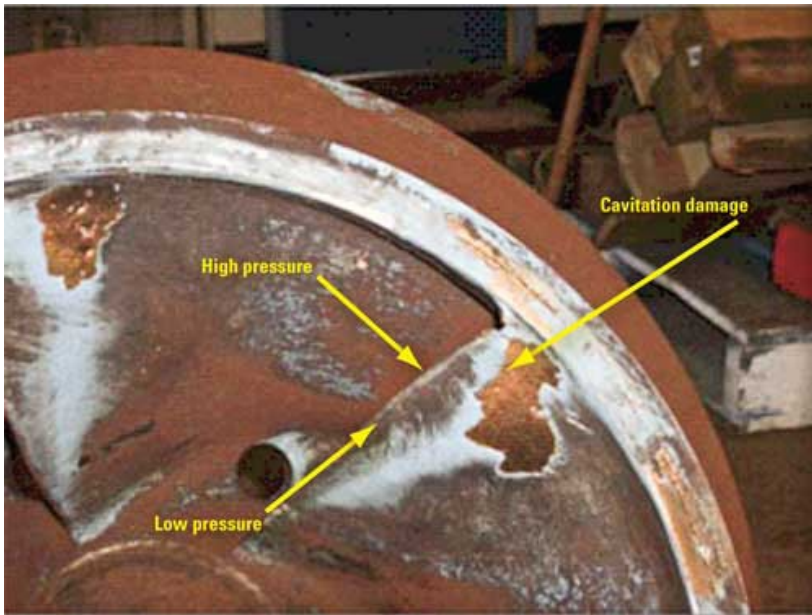
Figure 7 - How to damage a pump.

A cavitating fluid can cause extensive damage to a pump impeller even during normal operation. The imploding pressure caused by cavitation has been recorded as high as 145,000,000 psi, which exceeds the elastic limit of any exotic alloy. These vapor bubbles are responsible for the mechanical damage found on pump impellers placed in any type of service that causes cavitation. *Courtesy: Belzona Inc.*

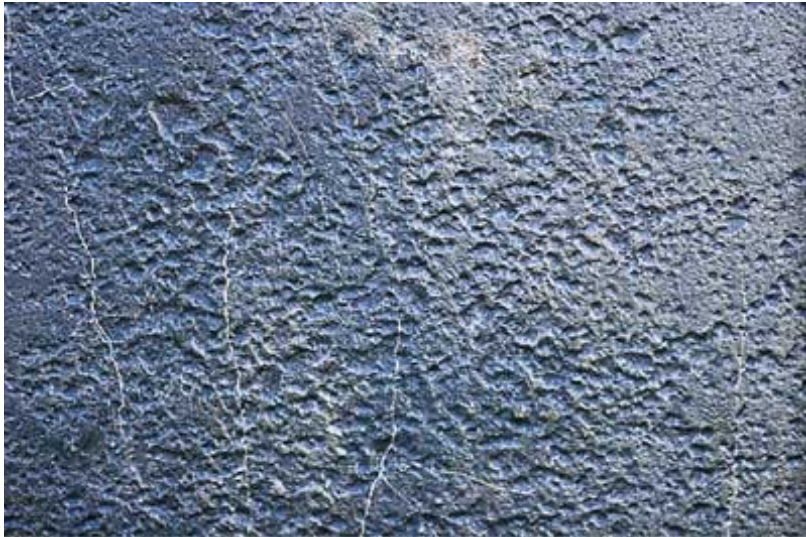
Figure 8 - Cavitation damage is severe. Close-up of damage to a pump impeller caused by cavitation. *Courtesy: Belzona Inc.*

CR fluid elastomer coatings on pumps have been in service for a number of years. In one particular case, the sides and the trailing surfaces of a large impeller had suffered from cavitation and significant metal loss (Figure 8) when a CR elastomer was applied by an authorized coating applicator.

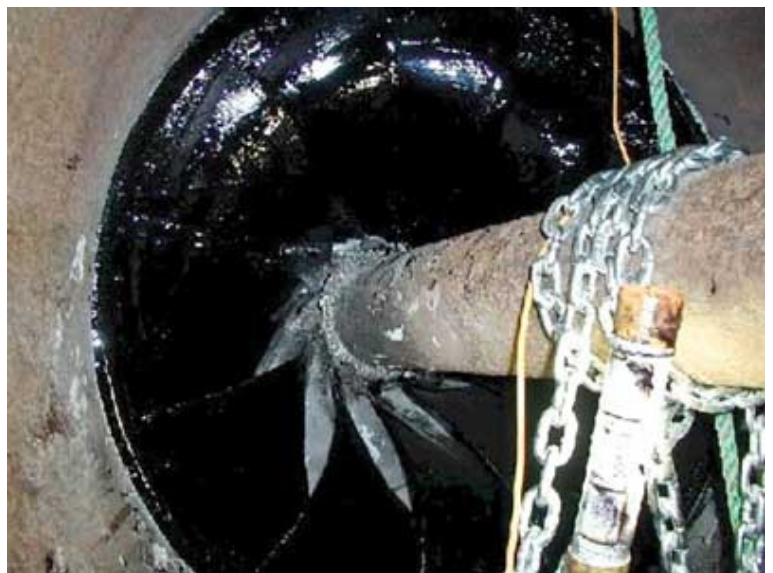
Figure 9 - Well-dressed impeller. A cavitation-resistant elastomer coating was applied to this pump impeller after the impeller was returned to OEM specifications. *Courtesy: Belzona Inc.*

6. Apply a CR coating to the entire impeller (Figure 9).
