High Temperature Linings for Sulfur Storage Tanks

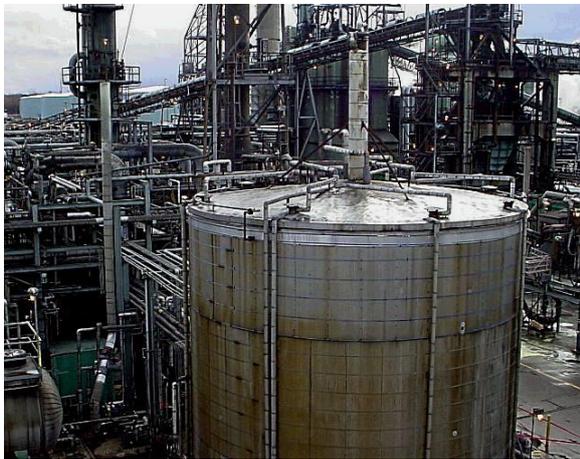
Sulfur Storage Tank

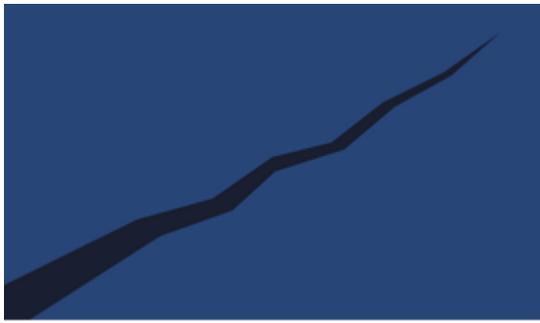
Crack propagation on conventional lining materials

The high cross-link density required for coatings to achieve their high temperature immersion resistance can make conventional materials rigid and susceptible to cracking during thermal cycling and substrate flexing. Belzona 1523 and Belzona 1593 overcome this by the incorporation of rubbery domains that offer flexibility and inhibit crack propagation.

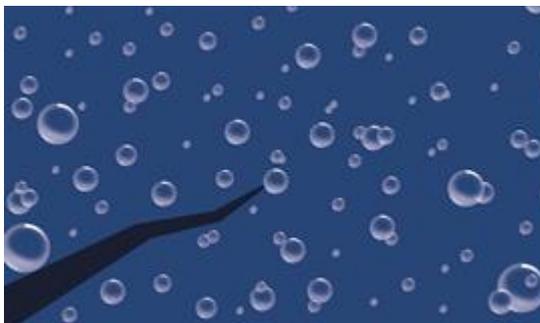
The rubbery domains incorporated to Belzona 1523 and Belzona 1593 inhibit crack propagation

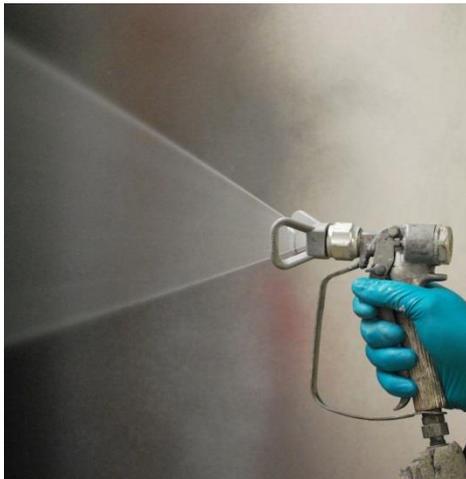
Belzona 1523 sprayed applied

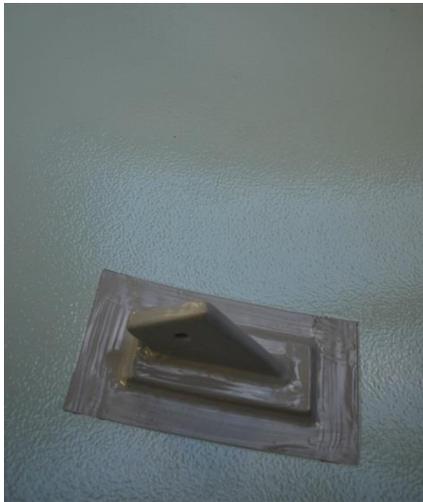
Belzona 1523 and Belzona 1593 completed application
