Title: Cooling Tower Repairs Reach Nearly a Decade in Service

Subtitle: Belzona extend cooling tower lifespan with corrosion resistant coating

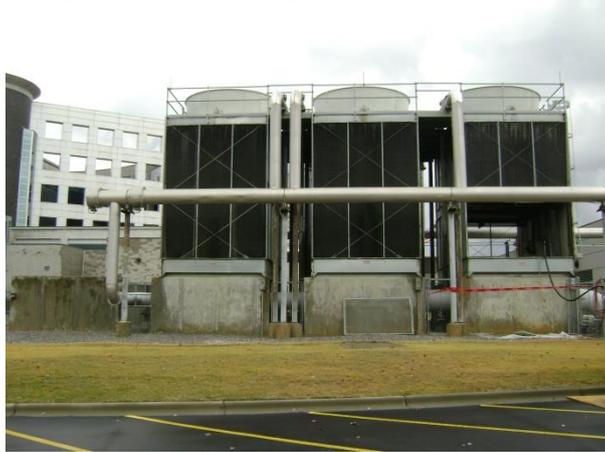
Air, water, chemicals and heat are all elements that combine to make cooling towers severely corrosive environments. Therefore, to negate this combination, galvanised metal is used, acting as a sacrificial barrier in areas of high exposure. However, the chemical components used within the water treatment system can significantly accelerate the consumption of the galvanised metal, leading to premature corrosion. The customer of a cooling tower distributor in Birmingham, Alabama, was noticing similar effects in three of their cooling tower basins. Earlier inspection had revealed deterioration of the galvanised metal throughout the cooling basins, resulting in leaking seams and excessive pitting.

The three Marley Cooling Towers in need of repair and protection

Boasting a regular working relationship with the local Marley Cooling Tower distributor, Belzona's Distributor was used exclusively for all their coating applications and, once again, was chosen to carry out the repair and protection of each tower. Ultimately, their customer required sealing of the pan seams, repair of the metal loss and the provision of a coating to prevent future corrosion. A combination of Belzona materials was chosen to complete the application, including waterproofing and corrosion resistant solutions, to ensure the restoration of a watertight and efficient system.

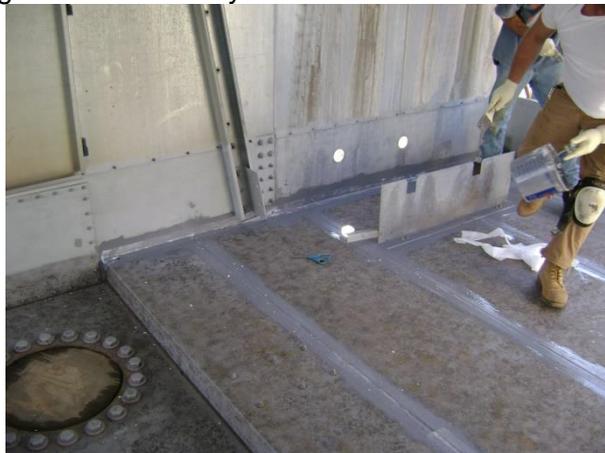
Repair of leaking seams using Belzona waterproofing membrane

Overall, the application took a total of five days, allowing the units to return to service quickly within their specified maintenance timeframe. Initially, the existing caulk was removed from the seams, before full abrasive blasting of the entire cooling pan surface. Following sufficient surface preparation, Belzona 3121 (MR7), a liquid-applied waterproofing membrane, was used to seal the external pan seams, in addition to any bolt heads. Subsequently, internal pitting damage was rebuilt with Belzona 1121 (Super XL-Metal), creating a smooth surface onto which a protective coating could be applied. In order to provide effective corrosion resistance under immersion, Belzona 5811 (Immersion Grade) was chosen to coat the entire cooling pan. Offering significant chemical resistance, the polymeric coating provided a seamless, long-lasting solution to a particularly corrosive environment.

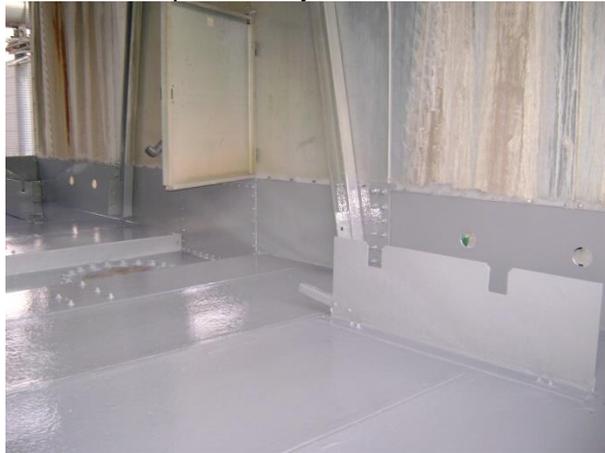
Completed application of chemical and corrosion resistant coating

In addition to their positive working relationship, Belzona's Distributor was selected because they offered a complete application package, inclusive of grit-blasting, which allowed them to specify an estimated application lifespan. After nearly a decade in service, recent inspection revealed the cooling towers repairs and protective coatings to still be in perfect condition. Not only had this exceeded their initial warranty of five years, but the customer noted that they were extremely satisfied with the application and will only use Belzona systems for any foreseeable cooling towers maintenance.
