Application Focus

Abrasive Attack - *Rotating Equipment*

Application Case Study

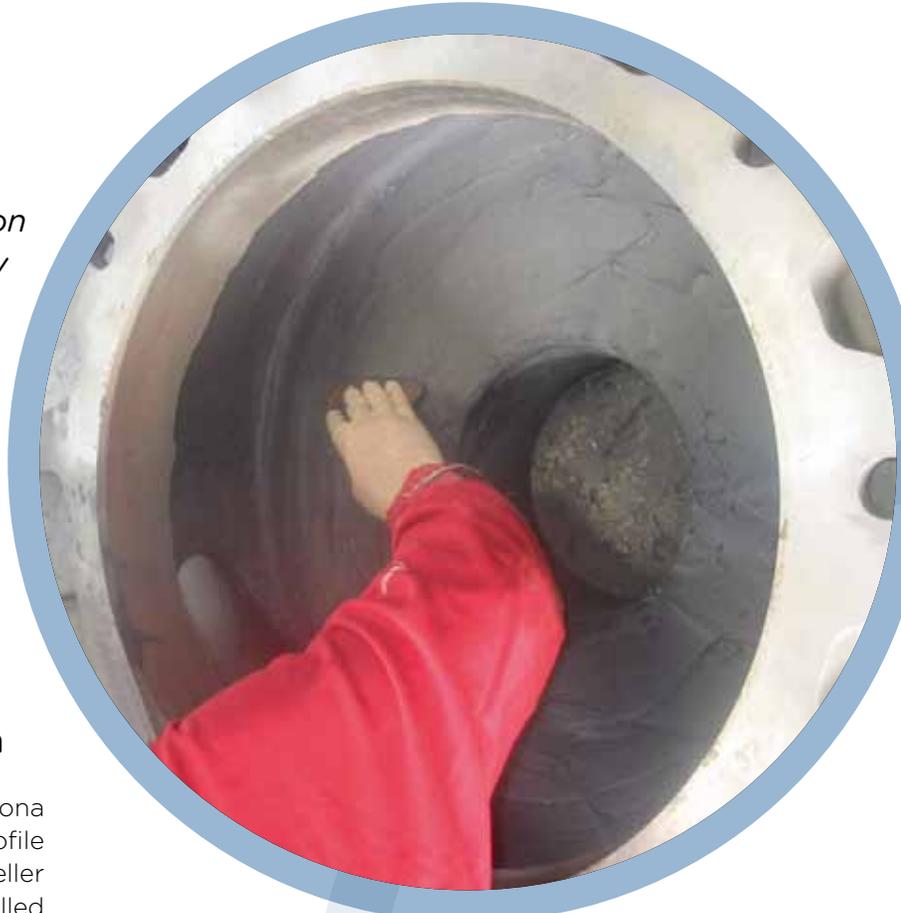
“A routine maintenance inspection of a centrifugal pump handling highly abrasive fly ash sludge was found to have severe erosion damage to its impeller and casing. Following further inspection, the impeller had approximately 10-15mm missing from the leading edge and the volute casing had cavities approximately 20mm in depth.”

The component parts were rebuilt with a Belzona composite repair system back to the original profile and machined with diamond cutting tips. The impeller and volute case were coated with a ceramic filled Belzona material, combining extremely hard, closely packed abrasion resistant materials in a polymeric binder in order to resist future abrasive attack.
