BELZONA'S FACILITIES MAINTENANCE NEWSLETTER

NOVEMBER 2010

Belzona Provides Long Term Protection of Observatory Roof, Dundee

TECHNICAL ARTICLE

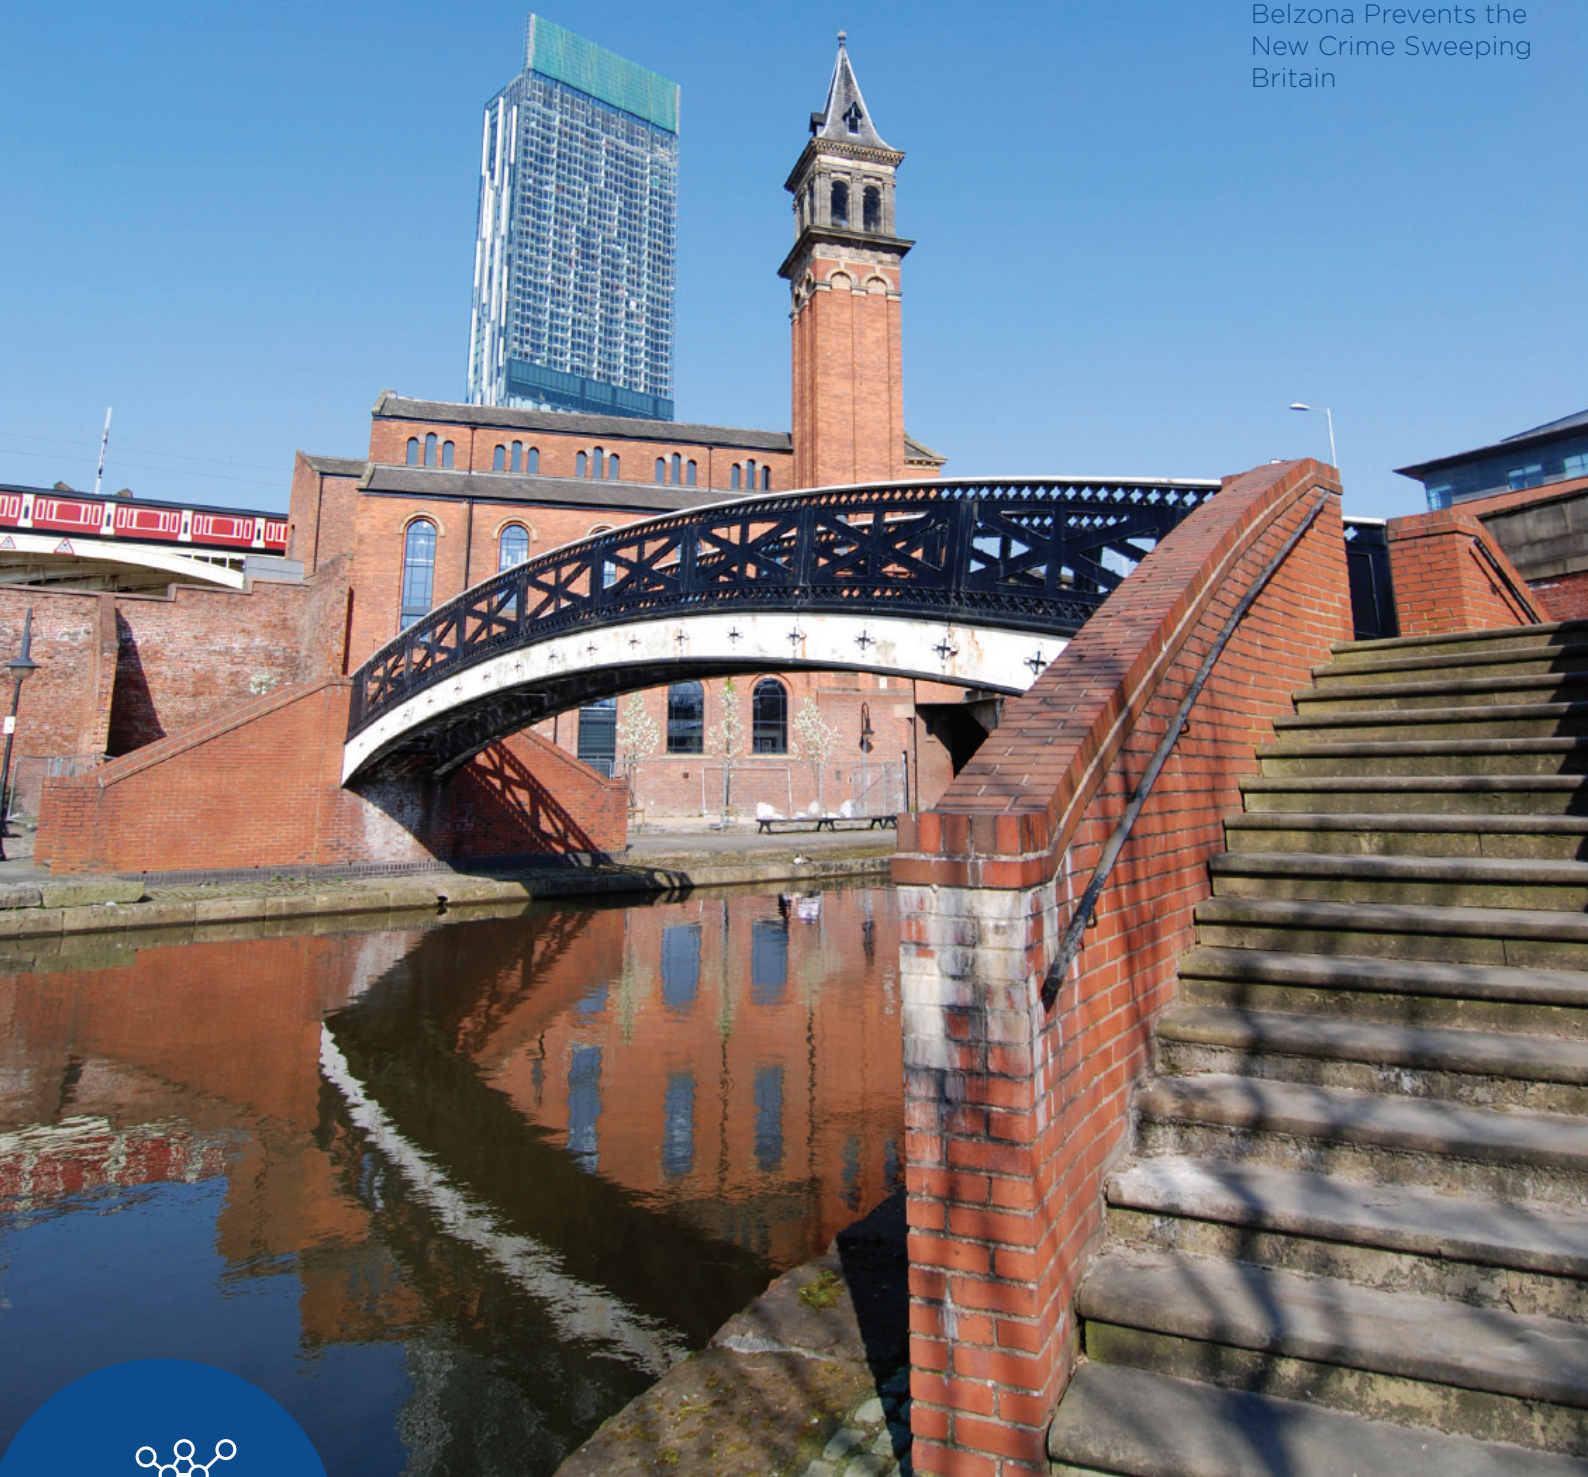
A photograph of the Mills Observatory in Dundee. The image shows the large, white, ribbed dome of the observatory, which is mounted on a stone base. Below the dome, there is a balcony with a metal railing. The main entrance of the observatory is visible at the bottom, featuring a stone facade with the words "MILLS OBSERVATORY" inscribed above the doors. The sky is overcast.

In 1974 the famous Mills Observatory in Dundee, Scotland was suffering severe maintenance problems caused by water ingress into the delicate dome structure. If the damage was left untreated, a number of further structural defects may have occurred which could result in costly implications including further expensive replacement costs, disruptive structural work, safety hazards and reduced life of structure.

Re-visiting again in 2010, the Belzona system is still in excellent condition providing complete weather protection to the roof structure, building fabric, interior décor and equipment.

A fully reinforced Belzona 3111 (Flexible Membrane) System was originally applied in 1974. This is a single component solvent free microporous coating for the long term repair and protection of all types of roofs. This versatile liquid applied material provides outstanding weatherproofing and waterproofing properties with excellent protection against infrared and ultra violet radiation and lends itself to application onto complex contours.

Following this original Belzona application, the roof was refurbished in 1988 with a single layer of Belzona 3111 (Flexible Membrane) to assure complete weatherproofing for future years. To provide enhanced appearance Belzona 5151

Re-visiting again in 2010, the Belzona system is still in excellent condition providing complete weather protection to the roof structure, building fabric, interior décor and equipment. At the same time, the self cleaning properties of the Belzona 5151 (Hi Build Cladding) have maintained this landmarks pristine appearance.

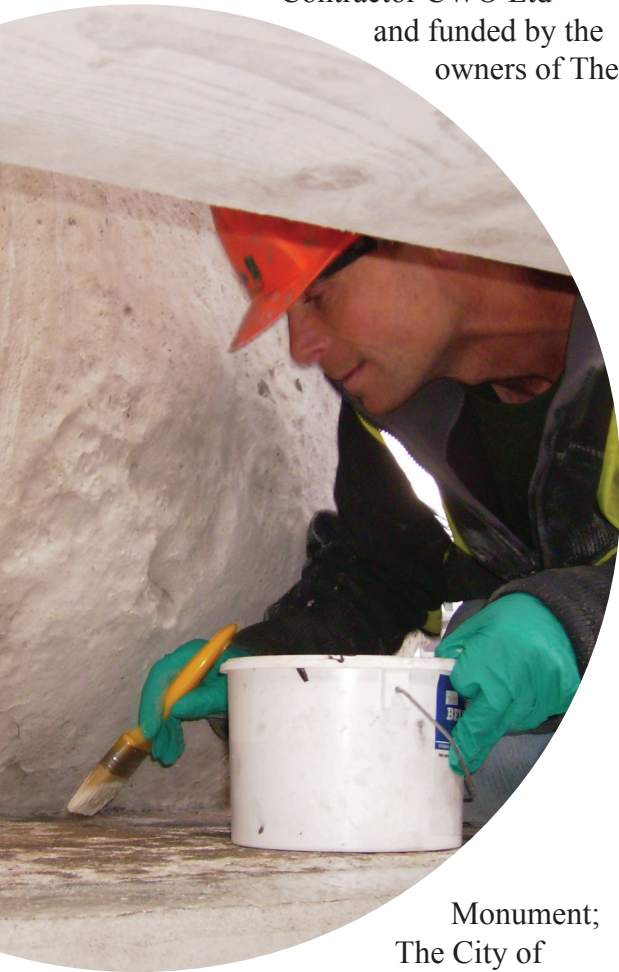
Belzona together with Blunt Construction Limited one of Belzona's Approved Specialist Applicators have recently completed a project by applying a Belzona high performance liquid applied membrane system as a lead alternative to help restore one of London's historic landmarks, The Monument.

to restore the famous structure built in 1678 and dedicated to the 1666 Great Fire of London.

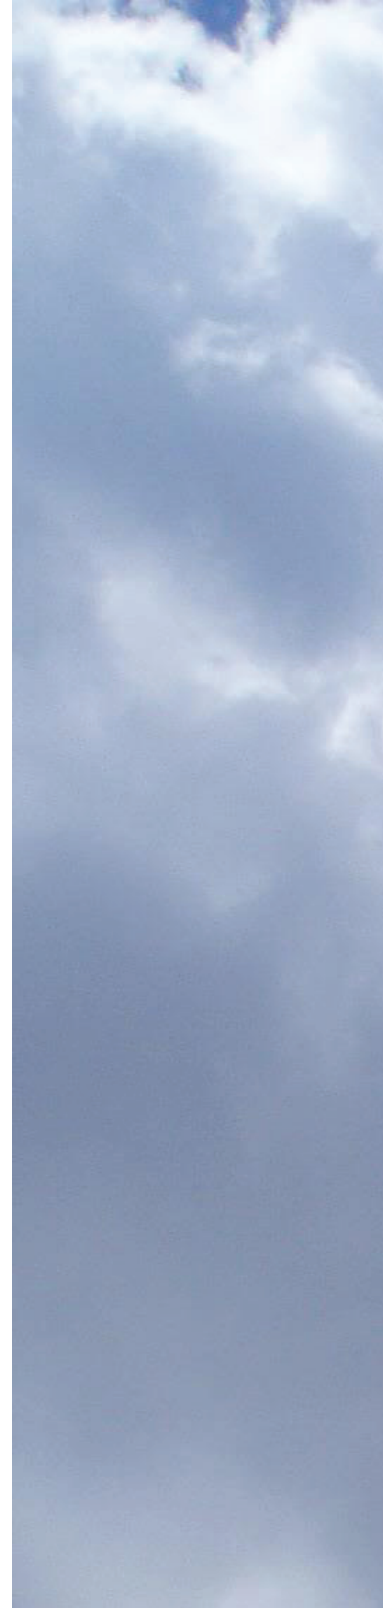
Once the surface was fully prepared, a first coating of Belzona 3131 (WG Membrane) was applied by brush, reinforced with a layer of Belzona 9351 Mesh. The liquid base of the Belzona 3131 (WG Membrane) binds to the reinforcing sheet to form a tough, flexible and elastic polymeric film which can tightly follow all contours and provides greater strength and resistance to cracking.

Membrane) was applied, again reinforced with Belzona 9351 mesh ensuring that the joints overlapped. This was repeated once again with the Belzona 9351 mesh. To complete the application, a further two coats of Belzona 3131 (WG Membrane) was applied, this time, specifically colour customised to match the rest of The Monuments Stonework.

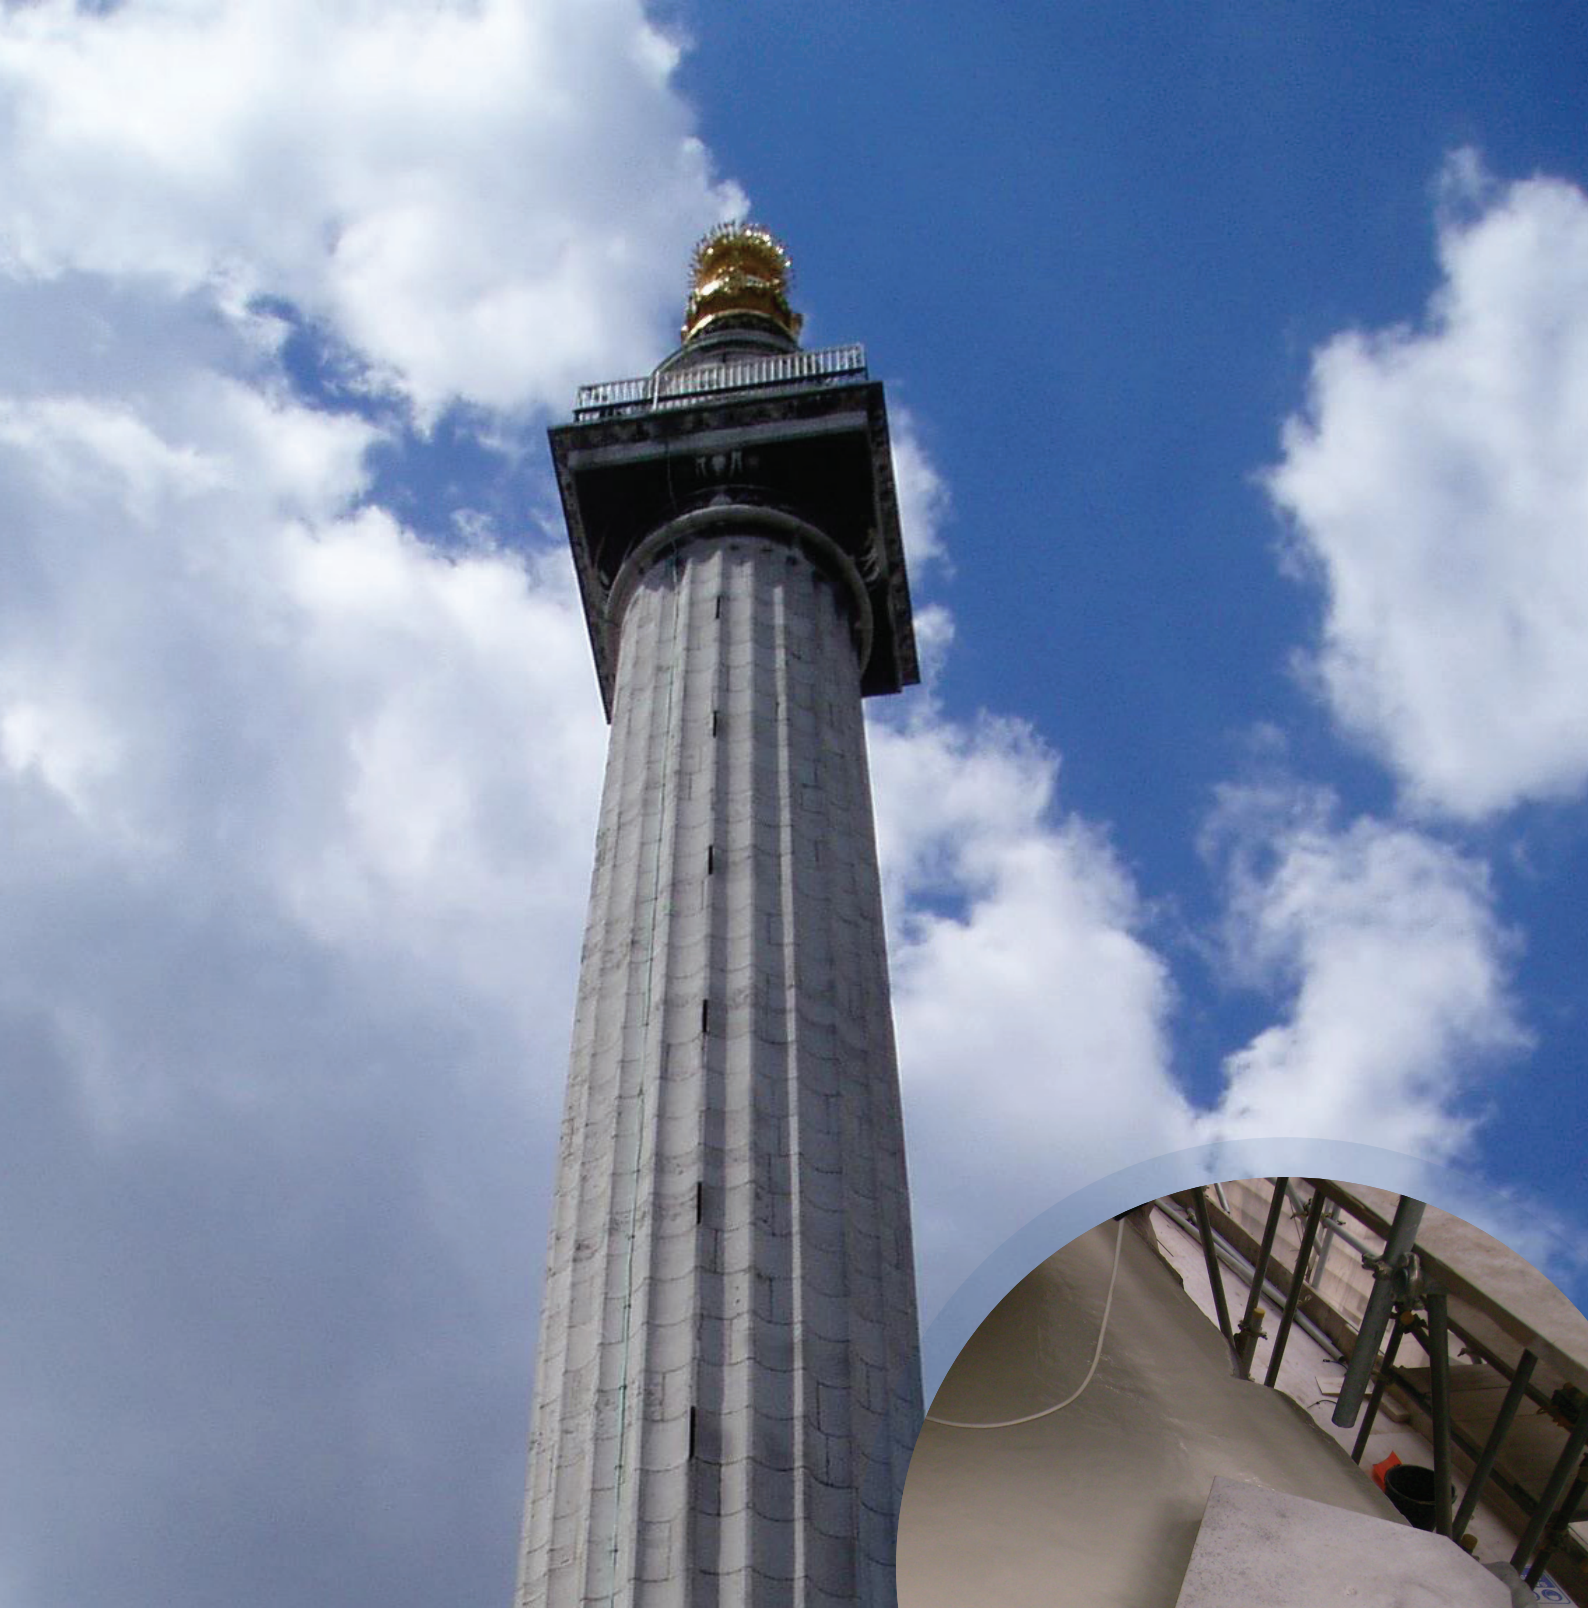
Blunt Construction's Specialist Applicators began preparations by carefully cleaning and light abrading to the existing Portland Stone surface. Following this, the surface was cleansed of dust ready for application of the product. One coat of Belzona 3931 (Porous Surface Conditioner) was applied to the prime stone surface ensuring that the coating was retained within the agreed area which would help ensure high adhesion of the Belzona 3131 (WG Membrane). Belzona 3131 (WG Membrane) was chosen as it would provide an alternative to lead that would fully encapsulate and protect the sandstone from future deterioration.

By using a cold applied cost effective repair and protection system, this innovative Belzona membrane also provides an excellent lead alternative with weatherproofing capabilities, subsequently preventing moisture ingress and future deterioration. This solution is at a fraction of the time and cost of using lead.

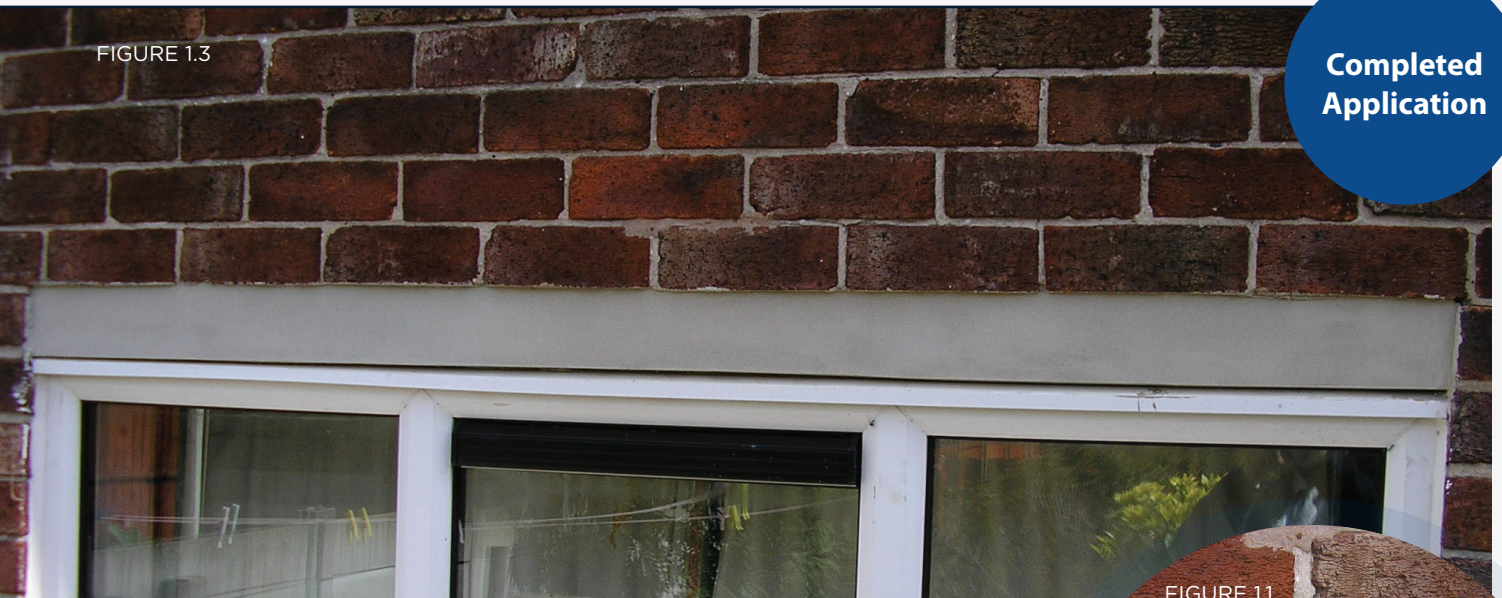
FIGURE 1.3

Completed
Application

The Belzona solution was chosen as the best way to affect a very quick and simple repair that could be done all at once without the need for formers to be left in place. The ability of Belzona to protect and resist further spalling was also a prime consideration of the client. Alternative was the use of traditional sand/ cement mortars that would have lacked future protective performance and would have required a much wider time frame to complete. This scheme saw 20 lintels of around 2 metres each complete in just less than three days. Figure 1.3 shows the end result.

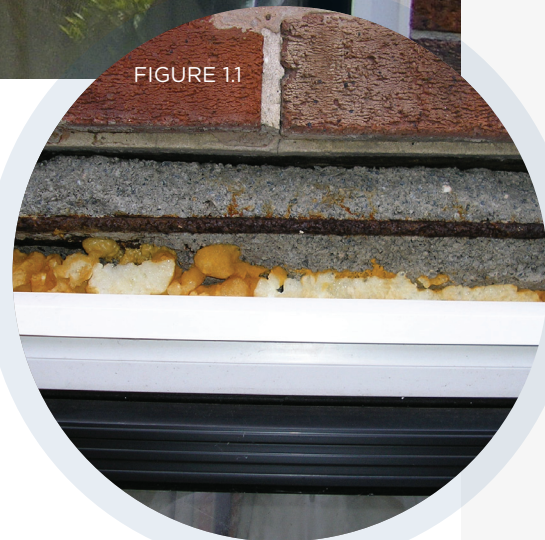
FIGURE 1.1

By way of a case study, Figure 1.1 shows the concrete lintels of a Housing Authority that had spalled badly due to environmental damage, revealing the reinforcement bars underneath. The Housing Authority was fitting new windows and their requirement was that the repairs were carried out quickly and effectively as the appearance was becoming unacceptable.

Belzona 4141 (Magma-Build) was an ideal product for this application in particular due to the shape and size of the repair areas and colour matching as near as possible to the substrate. As the application would have to be carried out on a vertical level, Belzona 4141 (Magma-Build)'s lightweight properties are designed specifically for these types of applications requiring no support work.

Before beginning the application, the damaged area had to be cleaned and prepared. All loose material from the lintel was removed either by hand or using a wire brush. Belzona 4911 (Magma TX Conditioner) was then applied to all areas that could be repaired. The Belzona 4141 (Magma-Build) product requires no specialist tools so was hand applied and moulded to the shape required. Figure 1.2 demonstrates the Belzona 4141 (Magma-

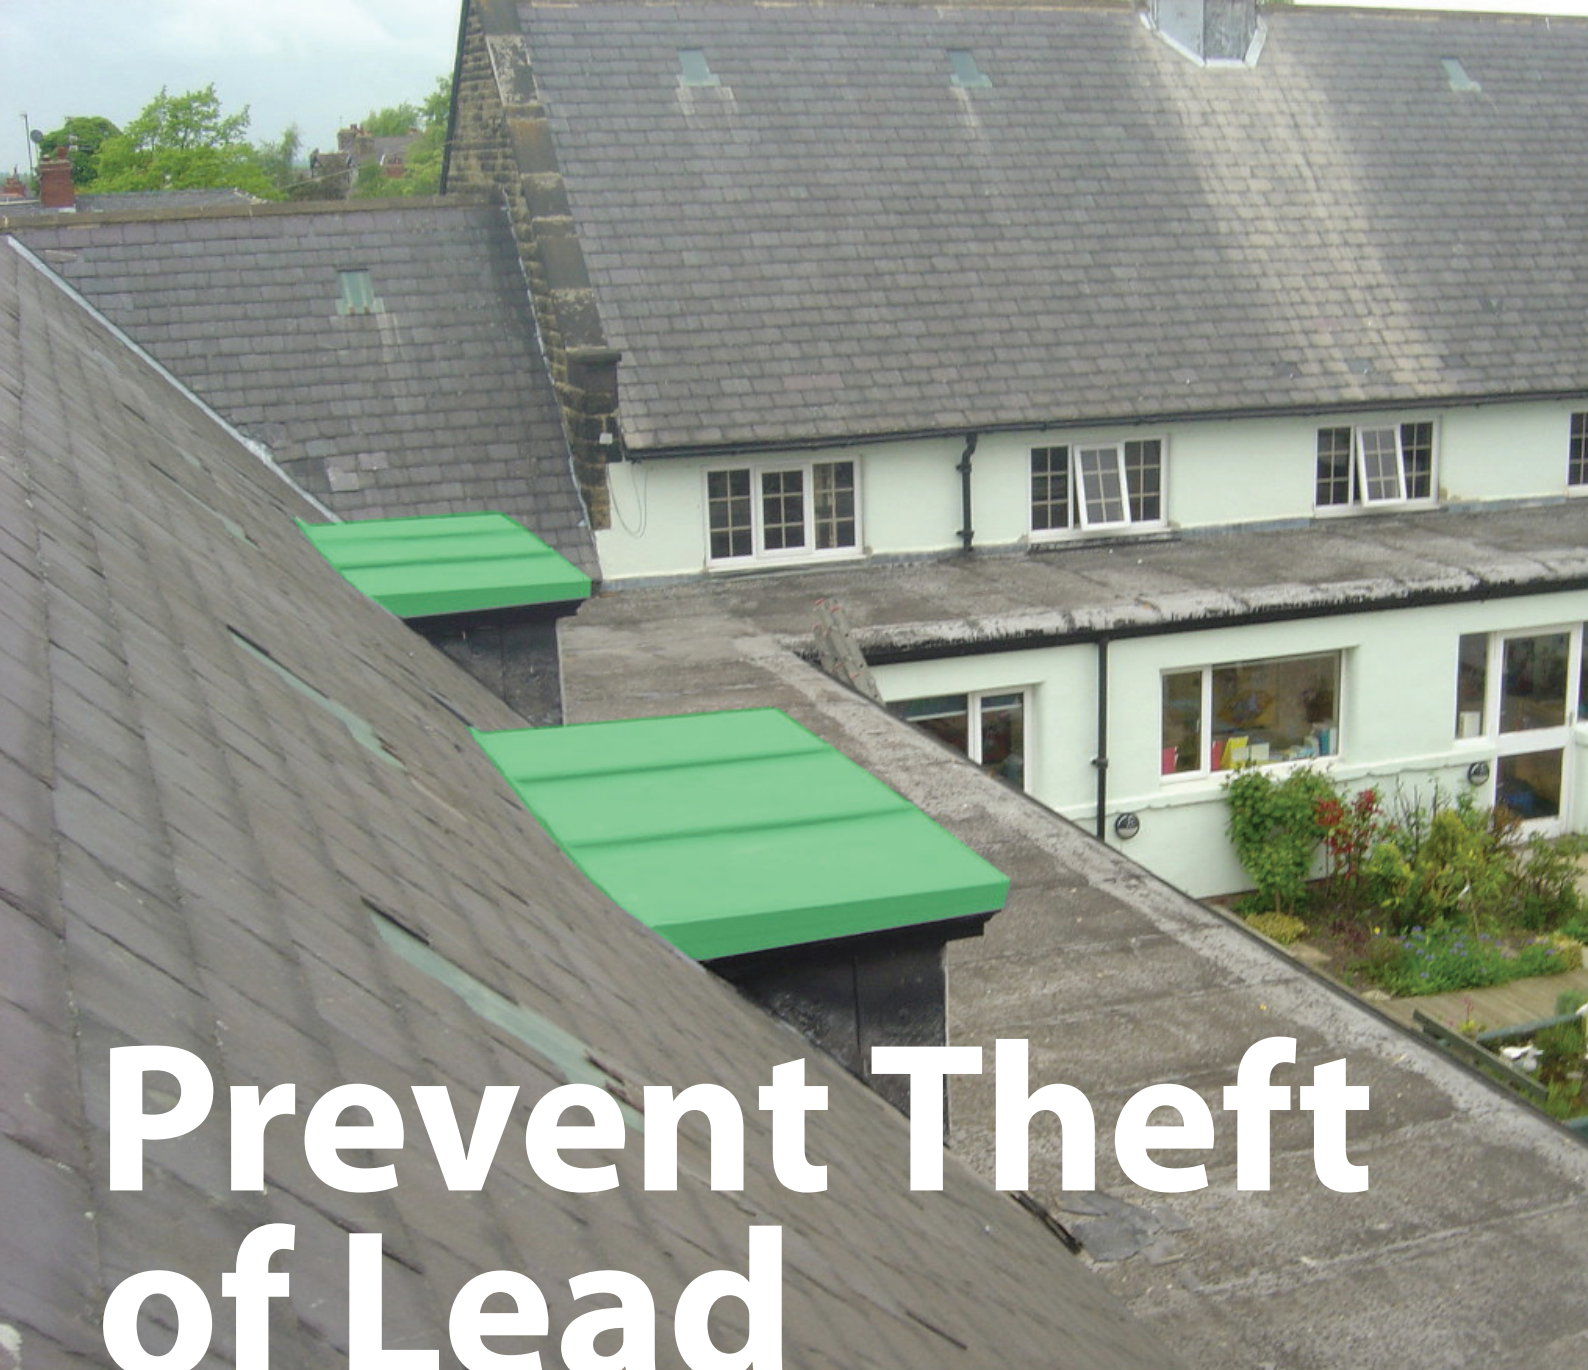
By way of example, in 2008, this local school had recently suffered from theft of the lead from their roof. The damage was so extensive that if not addressed, it would lead to structural defects resulting in a potentially disruptive high cost maintenance repair.

A Belzona local representative was contacted to provide a cost effective solution to repair the damage and to protect against future deterioration the lead work. The repair was completed in just less than one week. Revisiting the application in 2010, the school has not experienced any further problems, and the repair is still in service and in excellent condition.

In response to this problem, Belzona are offering a liquid applied polymeric membrane system for the long term repair and protection of lead work. In addition to the major issue of theft, lead is also susceptible to damage and deterioration through attack from extreme weather conditions due to being a commonly exposed area of any building.

protection system, lead work can be fully encapsulated resulting in a highly effective theft prevention system. This Belzona membrane also provides weatherproofing capabilities, subsequently preventing moisture ingress and reducing deterioration which results in long term roof protection and preservation of lead.
