Facilitate

BELZONA'S FACILITIES MAINTENANCE NEWSLETTER

ISSUE 2 JULY 2011

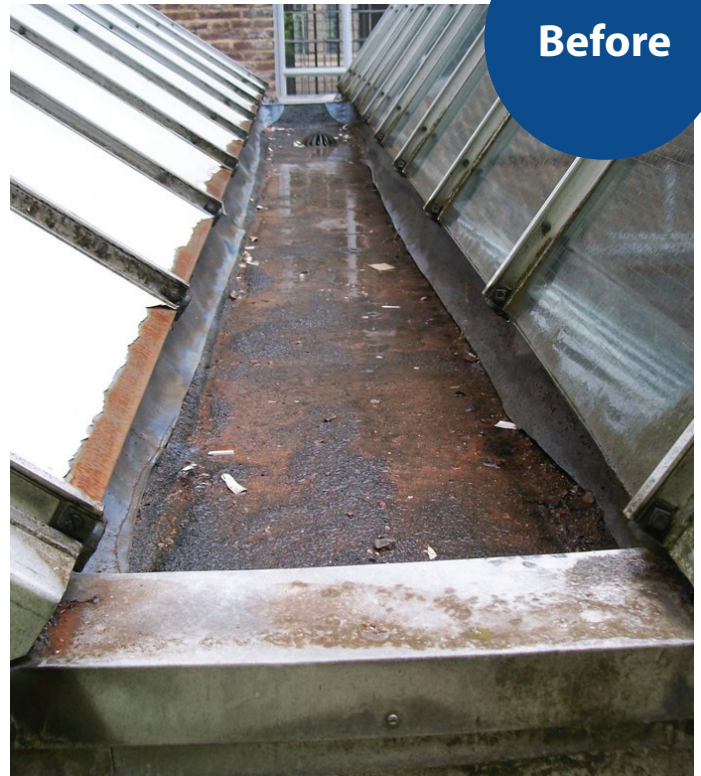
Before

The poor condition of the roof and gutters meant various areas were leaking directly into the reading room below where many valuable books are stored and read daily by students.

Belzona rose to the challenge and specified the fully reinforced Belzona 3111 (Flexible Membrane) System which is a single component, solvent free, microporous

coating for the long term repair and protection of all types of roofs. This versatile material provides outstanding weather proofing and waterproofing properties with excellent protection against infrared and ultra violet radiation and lends itself to application onto complex contours.

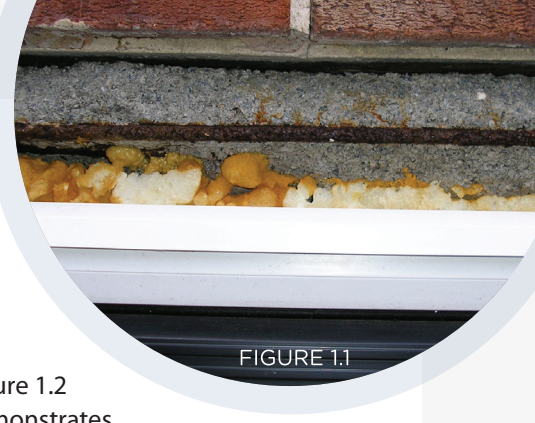
FIGURE 1.1

By way of a case study, Figure 1.1 shows the concrete lintels of a Housing Authority that had spalled badly due to environmental damage, revealing the reinforcement bars underneath. The Housing Authority was fitting new windows and their requirement was that the repairs were carried out quickly and effectively as the appearance was becoming unacceptable.

Before beginning the application, the damaged area had to be cleaned and prepared. All loose material from the lintel was removed either by hand or using a wire brush. Belzona 4911 (Magma TX Conditioner) was then applied to all areas that could be repaired. The Belzona 4141 (Magma-Build) product requires no specialist tools so was hand applied and moulded to the shape required.

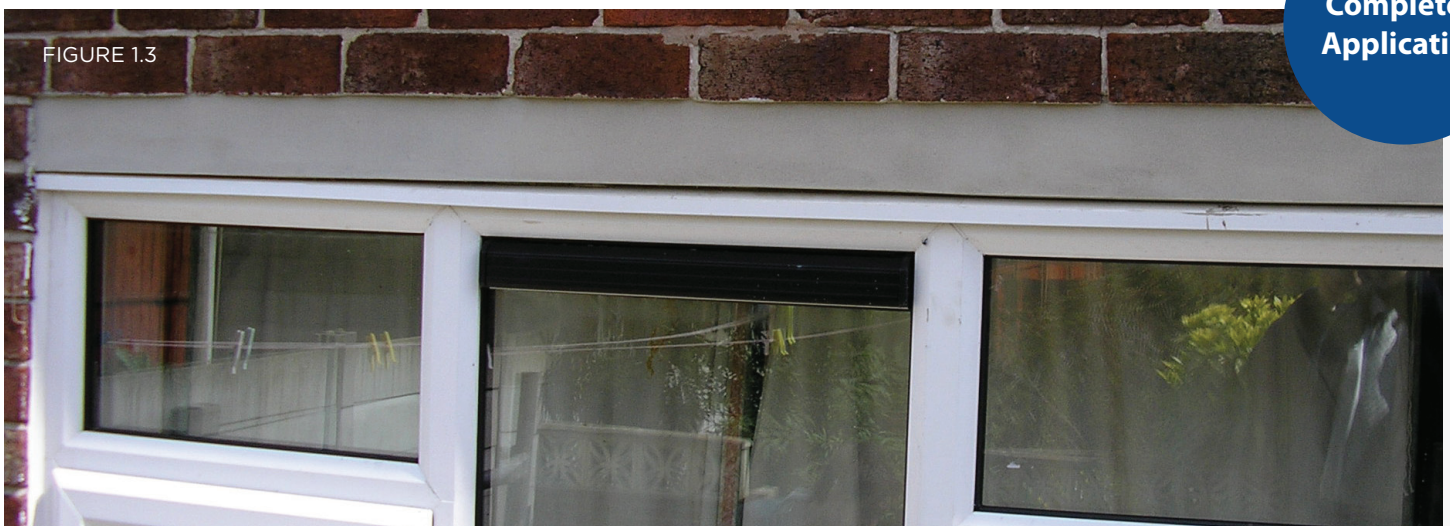
FIGURE 1.3

Completed Application

The Belzona solution was chosen as the best way to affect a very quick and simple repair that could be done all at once without the need for formers to be left in place. The ability of Belzona to protect and resist further spalling was also a prime consideration of the client. Alternative was the use of traditional sand/ cement mortars that would have lacked future protective performance and would have required a much wider time frame to complete. This scheme saw 20 lintels of around 2 metres each complete in just less than three days. Figure 1.3 shows the end result.

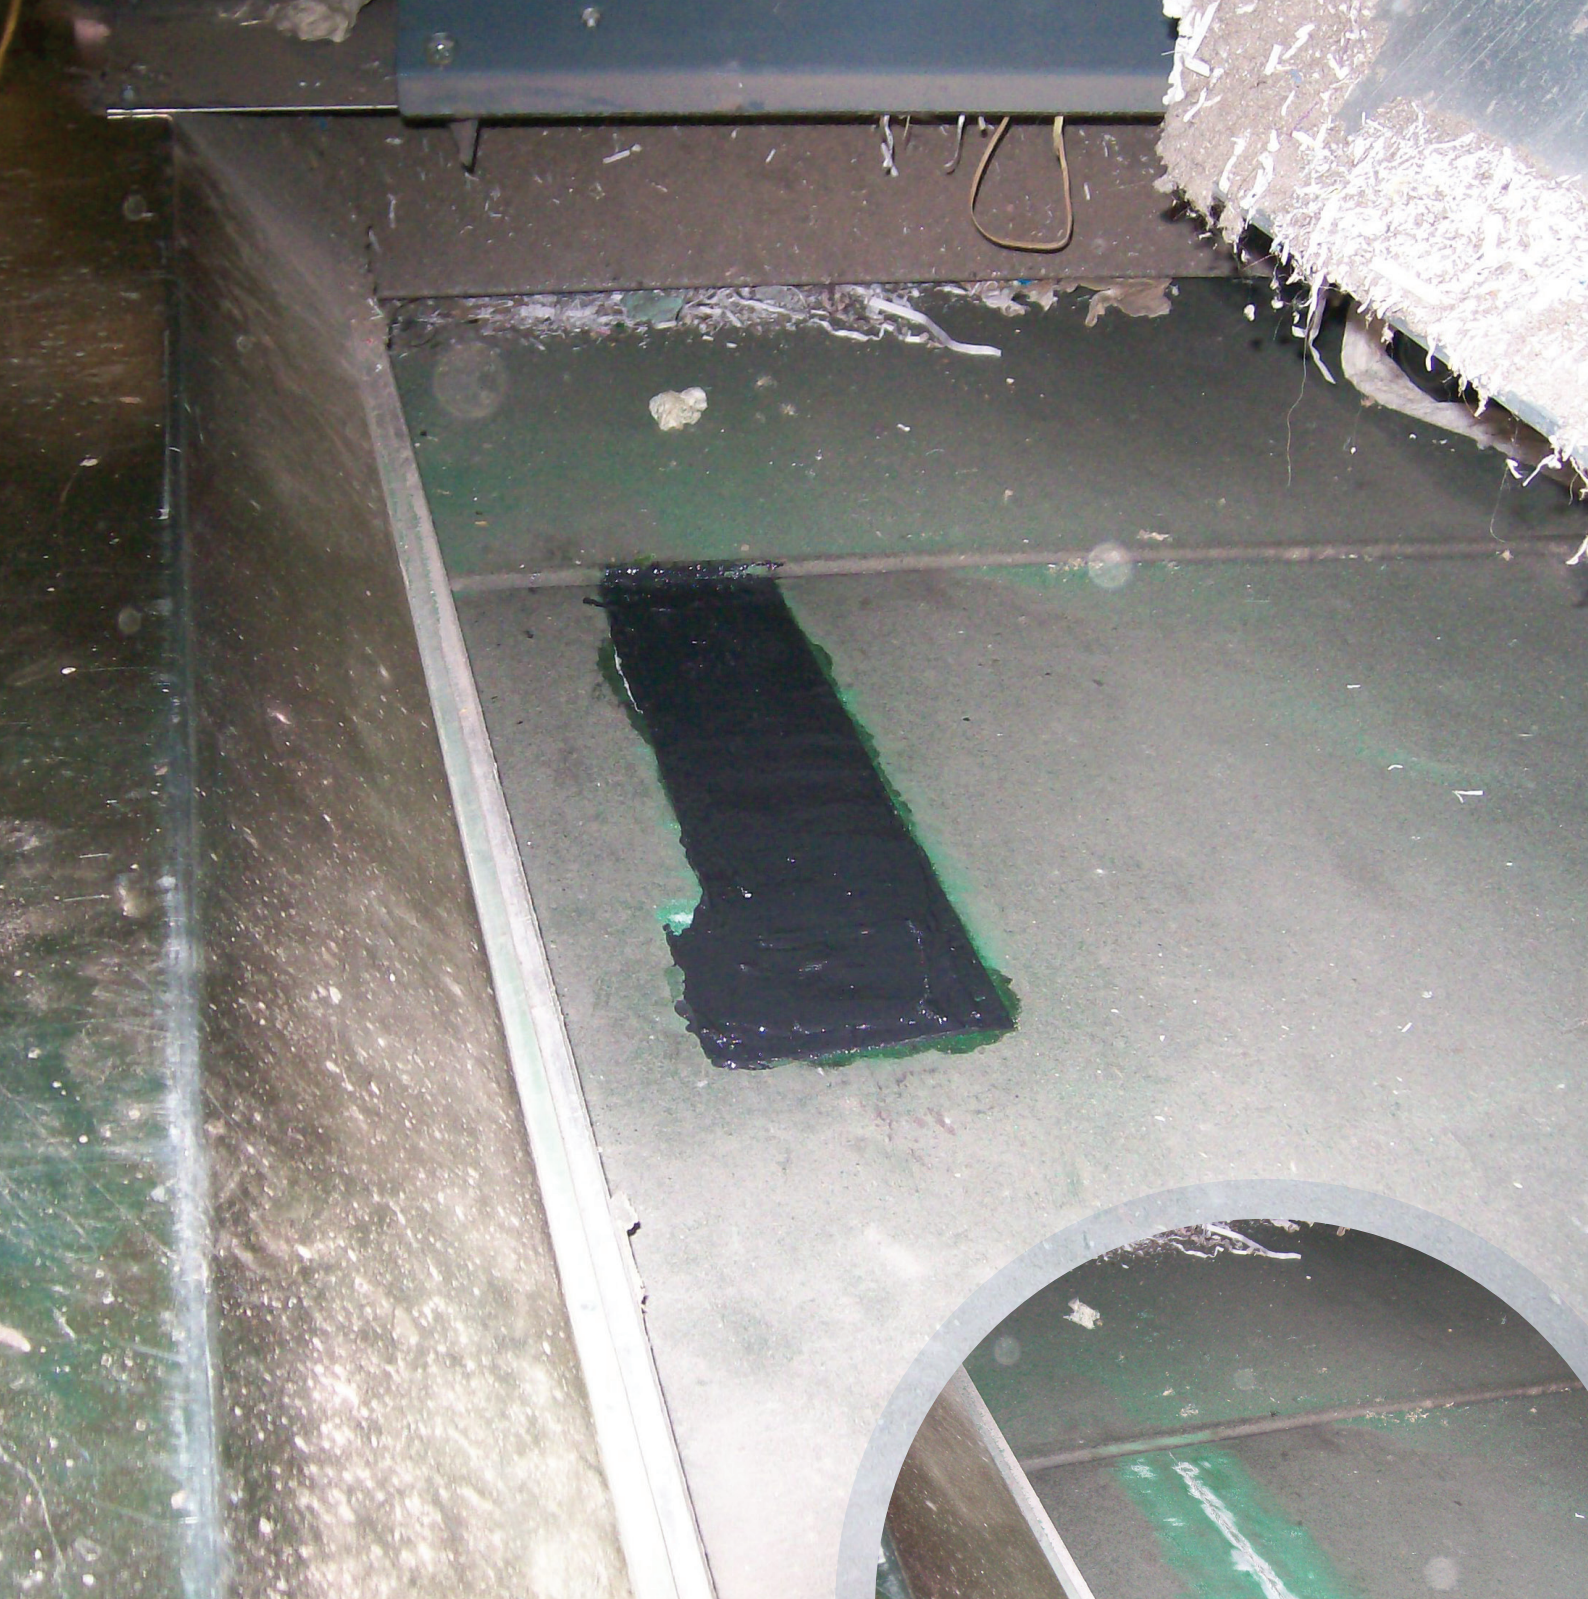
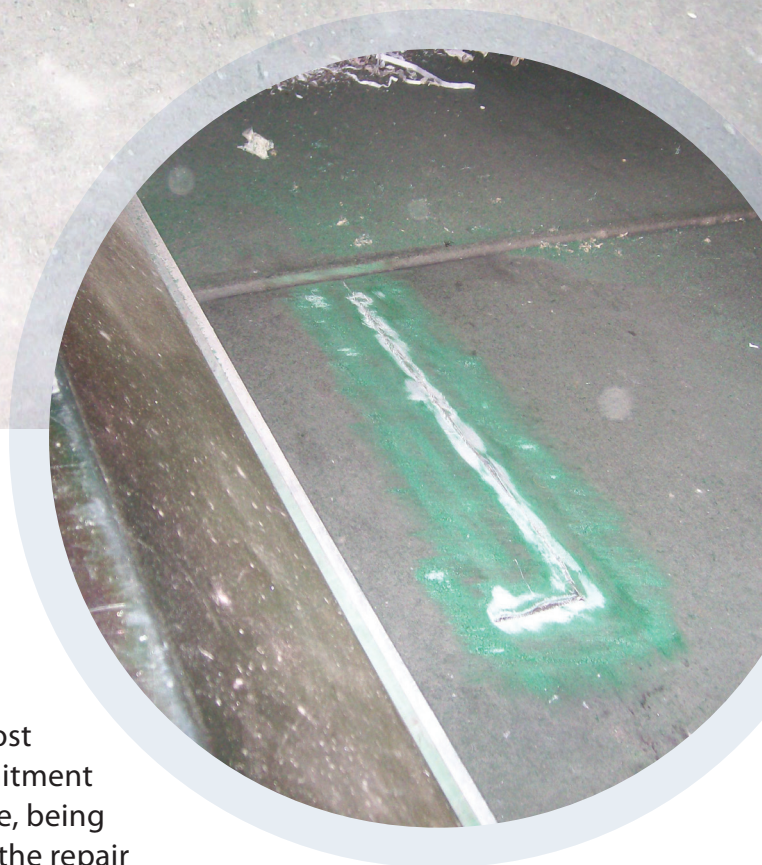
The procedure included removing the outer skin of the belt to expose the webbing and applying Belzona 2911 (Quick Drying Conditioner). When touch dry after 30 minutes the first coat of Belzona 2311 (SR Elastomer) was applied incorporating Belzona 9341 (Reinforcing Tape). The process was completed by a further coat of Belzona 2311 (SR Elastomer) to fully encapsulate the Belzona 9341 (Reinforcing Sheet) and the complete repair area.

The whole process including preparation and repair took around 1 hour 15 minutes plus a further 1 hour at 20°C for the Belzona 2311 (SR Elastomer) to cure completely and cost

in materials £39.10. The cost of replacing with a new belt is estimated at £600.00 plus labour. The client has informed Belzona the repair has worked perfectly and they have since carried out a further two repairs - a saving of in the region of £1,400.00. The success of these repairs has generated interest from other sites, eager to learn more about the Belzona solution.

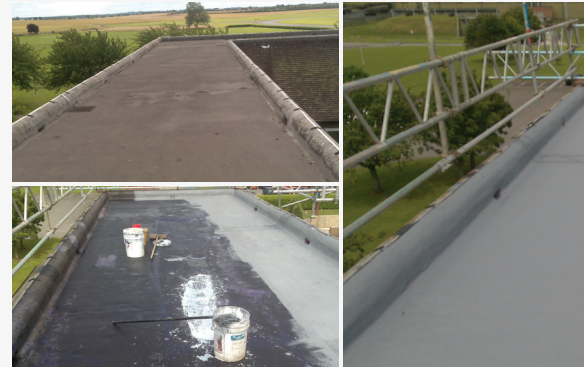
1. Officers Mess Roof at an MoD site in North Yorkshire

Problem – Several cracks and holes in the base of an asphalt round ridge tiles running round the edge of the roof, res officers' quarters. Belzona 3111 (Flexible Membrane) was flexible and durable coating which could be applied with resistant to varied and harsh weather conditions.

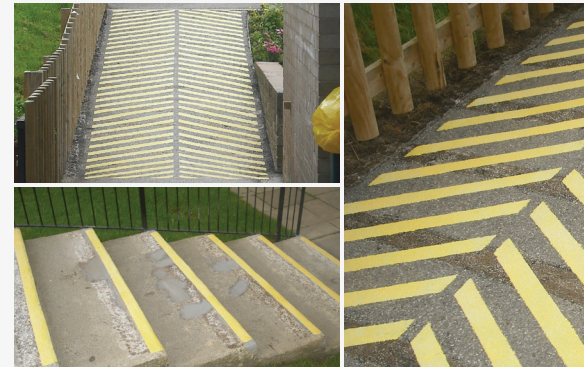
3. Primary School in North Yorkshire - Playground Steps

Problem – The large, tarmac playground slopes downwards. So during wet conditions a lot of water runs over them and children. Belzona 4411 (Granogrip) provides a high friction in all weather conditions.

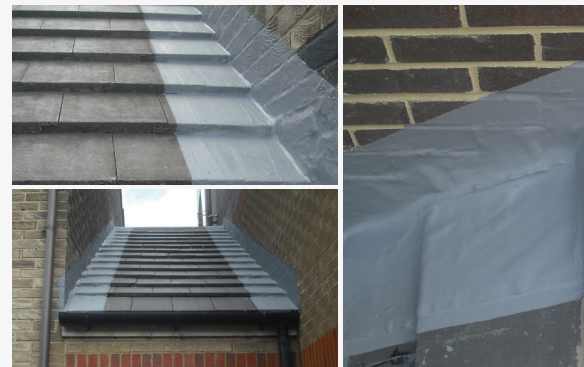
5. Library Roof in Colburn - 2010

Problem – Lead flashings were stolen leaving large areas. Belzona 3111 (Flexible Membrane) was selected to encase the stolen again which looks great and has no value for thieves.

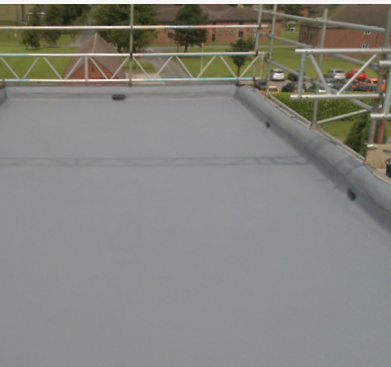
halt roof and poor detail on half-
ulting in severe water ingress into the
used as it provides a long lasting,
h minimal preparation. It is also

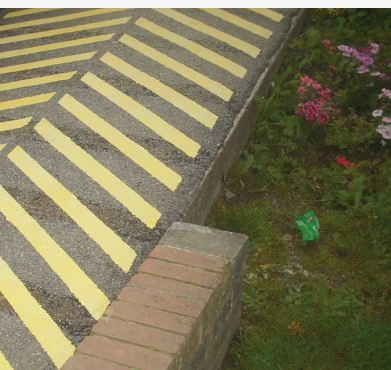
s and Ramp - 2010

ards towards the steps and ramp.
and makes them very slippery for the
on, high visibility, durable grip system

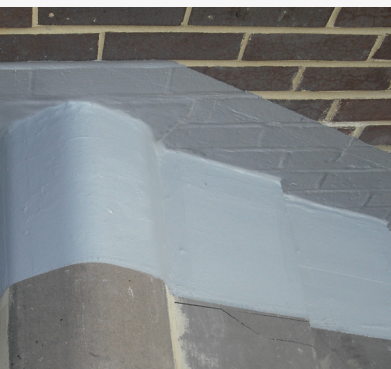
of the roof exposed to water ingress.
psulate the lead so it could not be
ves to steal and sell.

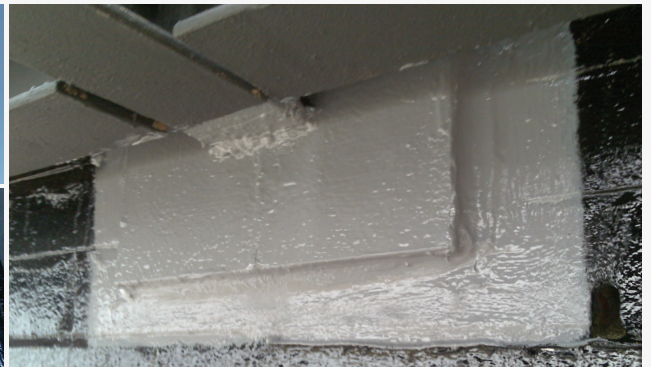
2. Air Traffic Control Tower in North Wales - 2009

Problem – Old, flaking paint on Air Traffic Control Tower. Water ingress through hair line cracks in brick mortar joints Belzona 5111 (Ceramic Cladding) was used to provide a seamless and aesthetically pleasing finish while offering protection against erosion/corrosion.

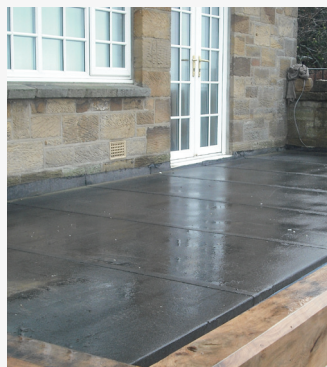
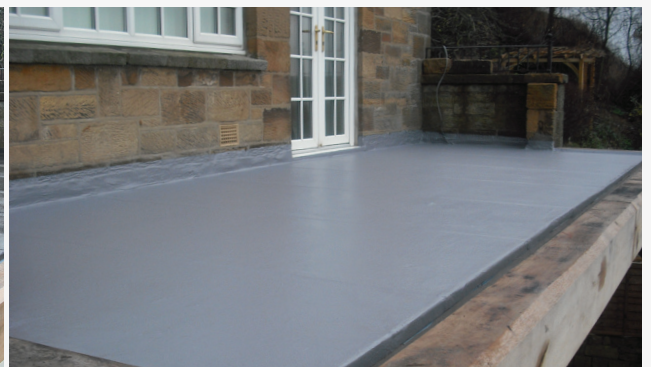
4. Domestic Residence, Whitby - Sun terrace/balcony - 2010

Problem – New build terrace. Belzona 3131 (WG Membrane) provides an aesthetically pleasing, durable, waterproof and flexible coating for the terrace. It would easily be able to handle the foot traffic from the residents and harsh weather from the sea front Our reputation for quality workmanship and Belzona's quality products are well known in our local area and the building contractor in question decided to use our system on the newly built sun terrace/balcony.

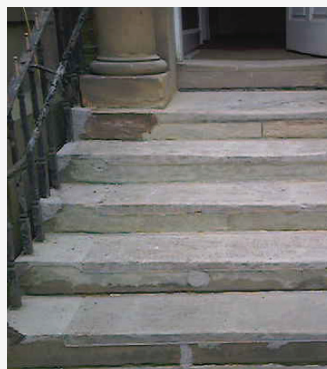
6. Masonic Hall, Scarborough - Front steps - 2008

Problem – Old, worn, and cracked stone steps looked off putting and were becoming dangerous to walk on. A lightweight repair system which is stronger/harder to damage than stone was requested to complete this repair. Belzona 4141 (Magma Build) was selected as it can be quickly applied, distressed and worked to make the new repair system look old and in keeping with the original stonework on the building.

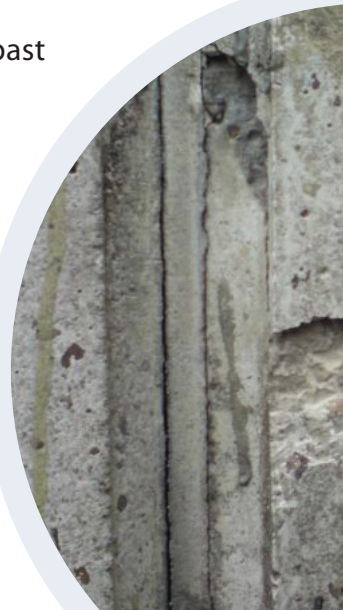
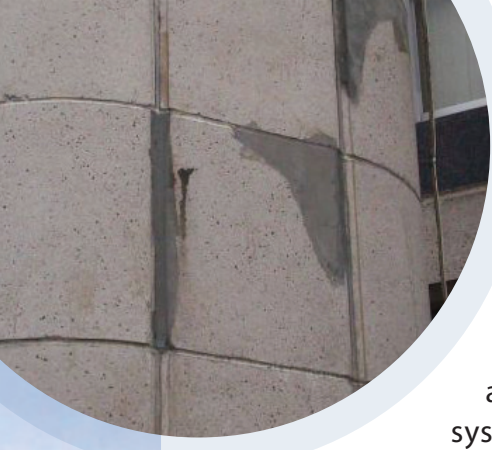
The chimney stack had several areas of damaged and eroded concrete due to moisture seeping through and causing the cracking and flaking of the concrete.

The areas were cleaned down and all loose concrete was removed before Belzona 4911 (Magma TX Conditioner) was applied.

Belzona 4141 (Magma-Build), a lightweight concrete repair system was then applied. The product has been designed specifically to rebuild damaged vertical/overhead concrete surfaces and can be applied by hand requiring no specialist tools.
