Facilitate

BELZONA'S FACILITIES MAINTENANCE NEWSLETTER

ISSUE 3

MAY 2012

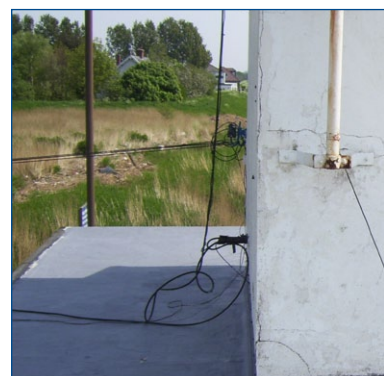
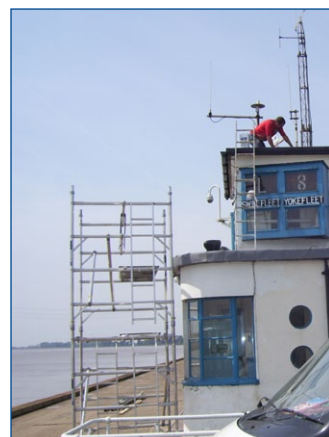
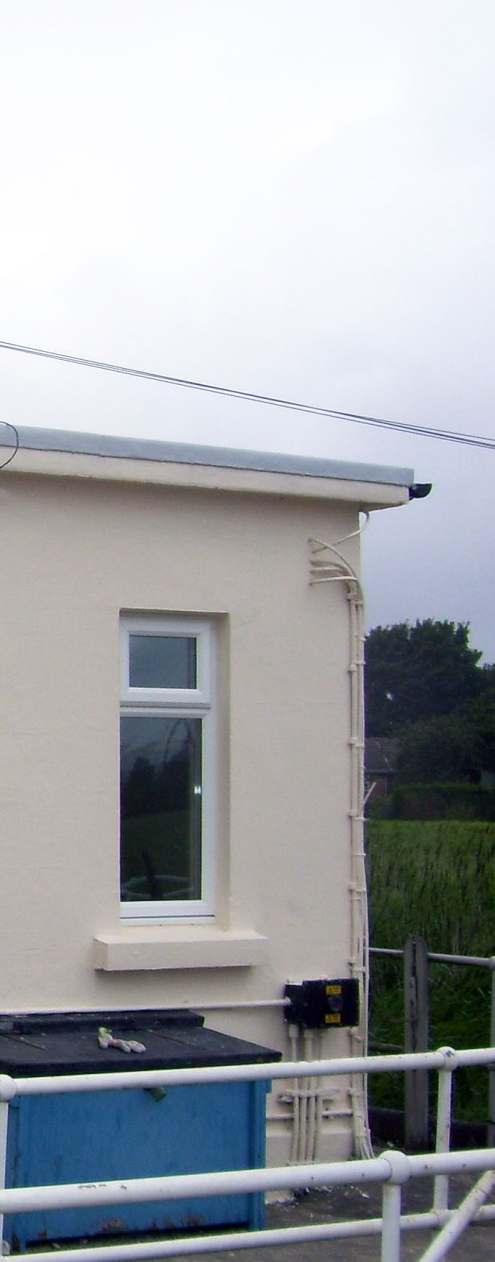
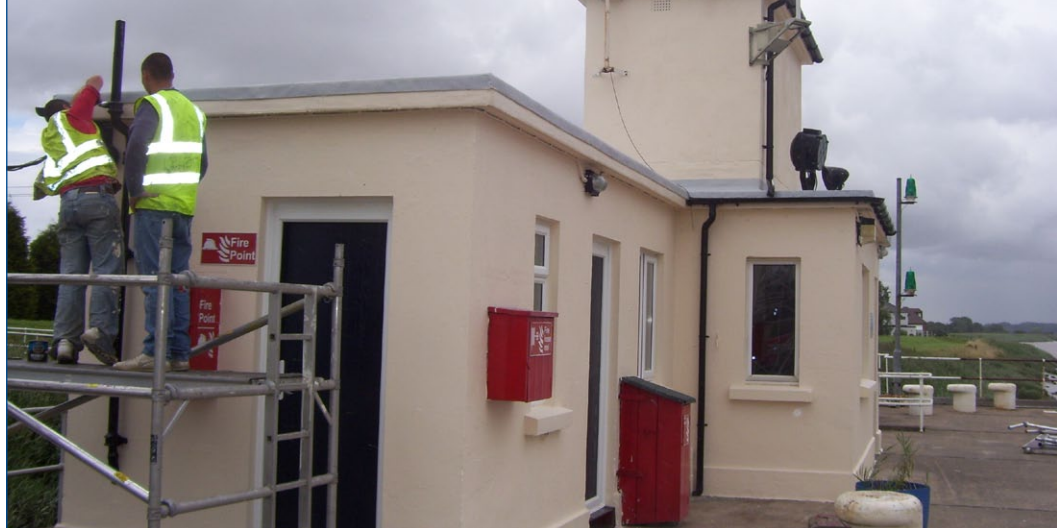
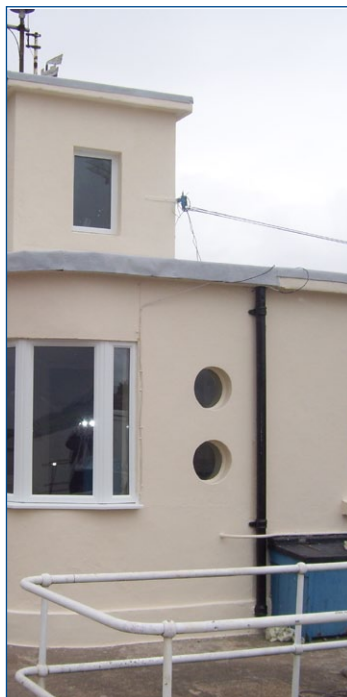
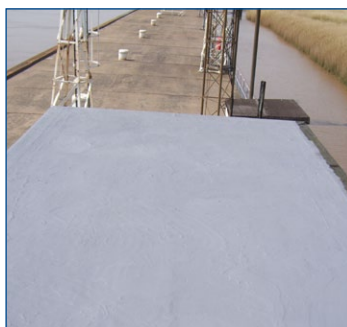
Due to its exposed location, the harbour office building in Goole was deteriorating. Heavy rain, high winds and varying degrees of salt deterioration to the walls and roof had resulted in both repairs and protective coatings being applied every six to twelve months.

The failing coating on the building was thoroughly cleaned and prepared using a high pressure water jet. Then, the damaged areas of the building were rebuilt and repaired using Belzona 4141 (Magma-Build) a lightweight repair composite for the rebuilding of damaged vertical and overhead concrete surfaces. Once the Belzona

product had fully cured, a three coat system of Belzona 5151 (Hi-Build Cladding) was roller applied to the building. This product offers long term waterproofing and weatherproofing of exterior and interior walls.

The final application Belzona provided was a total encapsulation of the building's roof using Belzona 3111 (Flexible Membrane). This solvent free, microporous coating was applied to provide the building with long term protection from extreme weather conditions including ultra violet and heavy rain.

This application was carried out in 2008 and to date there have been no further issues. The building is showing no signs of weather damage and the client is extremely pleased with the outcome.

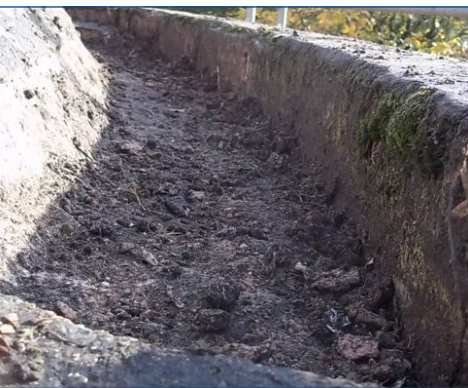
DAMAGED CONCRETE

The domed roof, gutter, parapet and decorative copings on the Bandstand showed signs of spalling and deterioration.

It was discovered that the cause of the problem was the lack of an effective roof coating on the dome rendering it porous. This was compounded by vegetation growth in and around the gutters resulting in blockages to the gutter drains. If the bandstand had been left untreated it would have ultimately become structurally unsafe.

After initial preparatory works, installation of the scaffolding and edge protection, the domed roof was cleaned and the vegetation removed. During the removal of the vegetation roots, some of which were a considerable size, it became apparent that they had undermined sections of the concrete gutter: deeming the extent of the concrete damage very serious.

Belzona Authorised Contractor, Specialised Access Solutions (SAS) excavated the affected areas of concrete and replaced them with Belzona 4131 (Magma-Screed), a concrete rebuilding and re-surfacing system. A waterproof coating was then applied to the domed roof, gutter detail and parapet walls to prevent further ingress and reduce the likelihood of future spalling. Belzona 3111 (Flexible Membrane) in a sand colour, matching the original colour of the band stand, was the product selected as it provides a high performance, long life waterproofing and weatherproofing system.

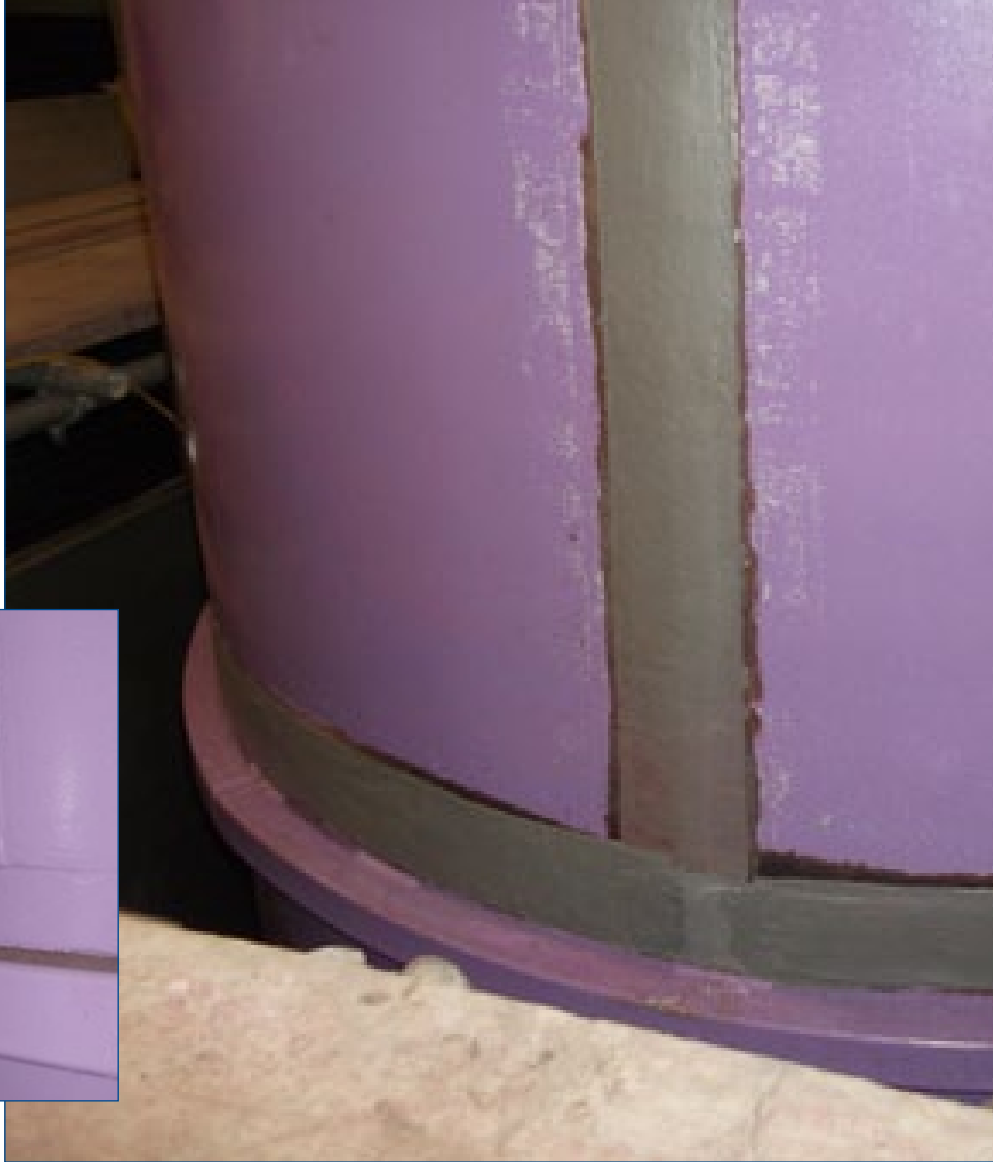
The engineers at the plant were looking for a long term repair solution for a caustic tank suffering leaks on the welded seams where the caustic acid was leaking from the painted mild steel tank. The tank was situated within a stainless steel secondary containment area and was made up of four half round sections which were welded together. The tank contained around 8000 litres of 28% caustic soda.

Application service provider Belzona Technosol Ltd won the contract to refurbish the tank. The entire area was pressure washed to ensure full adhesion of the Belzona products. An 80mm wide repair area was then masked off along the length of the welded seam and prepared using a Monti® MBX Bristle Blaster, a hand-held surface preparation tool suitable for use on a variety of substrates including metals, rubbers and plastics.

The first layer of Belzona 1111 (Super Metal) was applied incorporating Belzona 9341 (Reinforcing Tape) to the repair area. Once cured, a second coat of the reinforced product was applied. After removing the masking tape the product was left to cure. This application will provide a long term, corrosion protection solution.

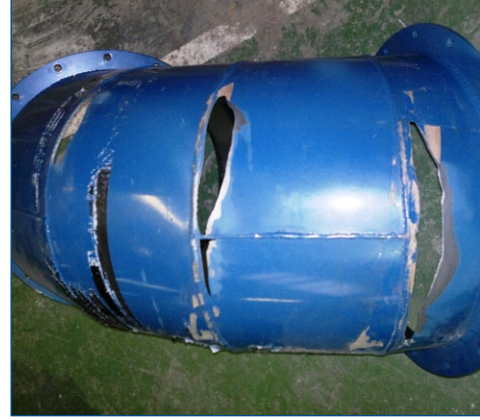
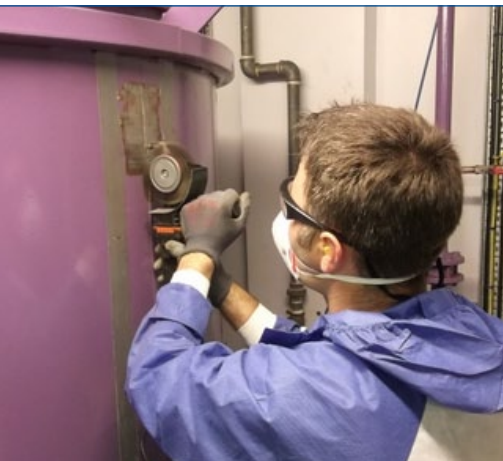
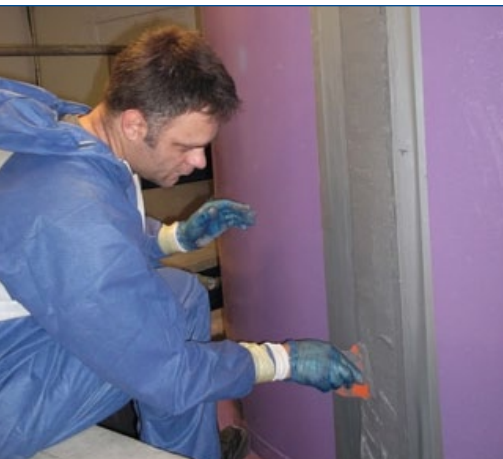
BELZONA'S COLD CURING PIPE REPAIR SOLUTION

The Client advised Belzona Independent Consultant Sid Crow that they had ducting installed in early 2011. Due to the nature of their process and the products running through the pipe, wear damage had been found at the pipe elbows within a very short time since installation.

Belzona recommended a simple plate bonding solution which ensured a quick and safe repair.

The application involved repairing a holed duct pipe elbow using Belzona 1111 (Super Metal) a high performance adhesive. The outer surface of the pipe elbow and the fabricated steel plate were prepared using blast cleaning to allow maximum adhesion of the Belzona product. Belzona 1111 (Super Metal) was then applied to both the steel plate and the surface of the duct pipe and bonded over the damaged areas of pipe.

The second stage of the application involved coating the internal bend with Belzona 1812 (Ceramic Carbide FP) a protective lining for the protection of surfaces subject to corrosion and abrasive attack.

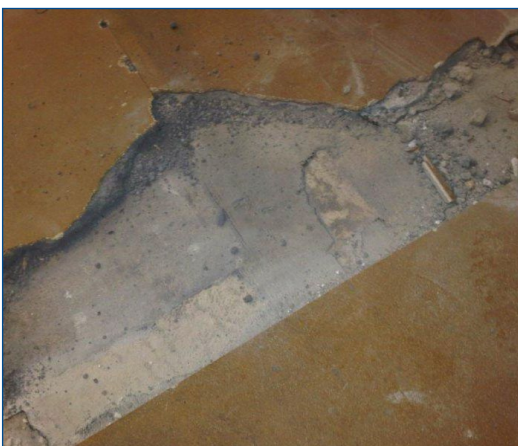
DAMAGED FLOOR AREA REMOVED

By way of example, in November 2011, Belzona Technosol Limited repaired a resin based floor at a premium whisky distillery in Scotland. Alternative repair solutions had previously been used to attempt to repair the floor in the bottling room but had failed. The areas of degraded floor were causing a health and safety hazard so the client contacted Belzona looking for a repair solution.

Belzona recommended that the existing resin flooring and underlying screed be removed to a depth of 80mm as this was the extent of the damage. Belzona 4131 (Magma-Screed) a high performance, non-porous resurfacing material for concrete was then applied incorporating concrete slabs. This method of application

The repair areas were dug out using power tools and hand tools including high performance dust extraction units. The floor surface and the underside of the concrete slabs were then prepared and conditioned using Belzona 4911 (TX Conditioner). Belzona 4131 (Magma-Screed) was then mixed and applied at a depth of approximately 6mm and the conditioned concrete slabs were placed on top and the floor area made level ready for the final 6mm coat of Belzona 4131 (Magma-Screed)

Once cured, the top surface of the concrete slabs were conditioned using Belzona 4911 (TX Conditioner) and a final layer of Belzona 4131 (Magma-Screed) was applied. This ensured the surface was level with the surrounding area leaving a non-porous 70 newton strength finish.

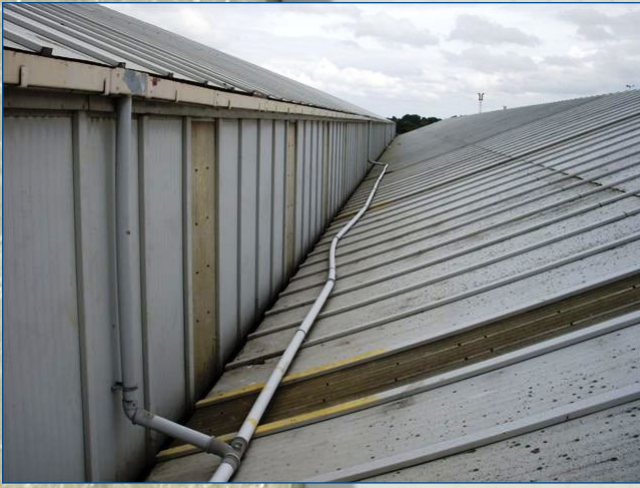
BEFORE

Weather can often cause serious damage to buildings and structures, which as a result, require a quick repair before any danger or permanent damage occurs. The train operator was experiencing severe flooding into the workshop where the trains are maintained. The uncontrollable flooding was caused by heavy

downpours. This water created a hazard due to the presence of electric rails throughout the workshop. Belzona suggested that redirecting the rain water from the drain pipes into the valley gutter would be the best option as the drain pipes were totally blocked and could not handle the heavy downpours. Due to the proximity of the adjoining building, access to the gutters and downpipes was extremely difficult, making redirecting the rain water the only solution.

The customer was extremely satisfied with the application as it required minimum downtime and left the workshop safe from any future damage. The customer was extremely impressed with Belzona's entire solution and work conducted.

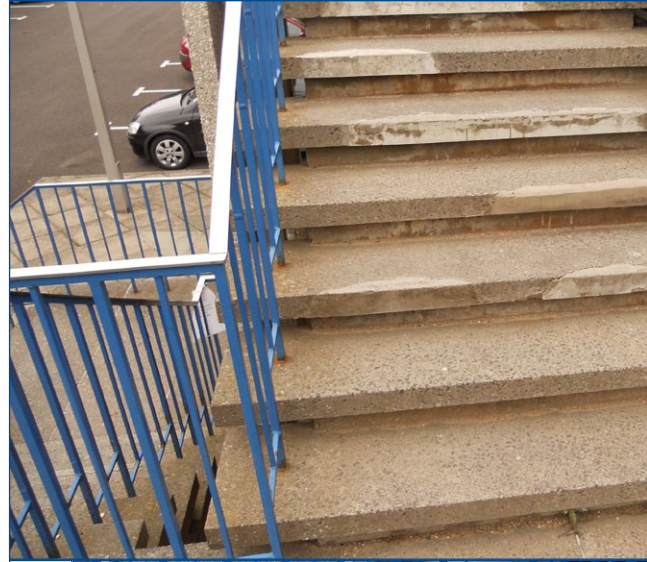
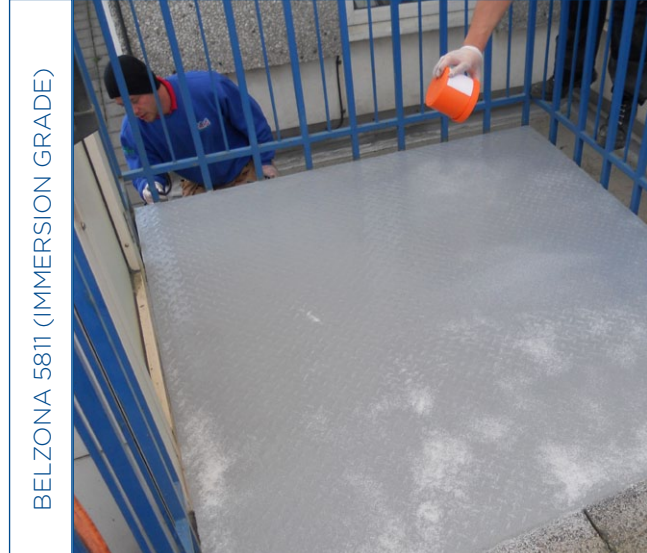
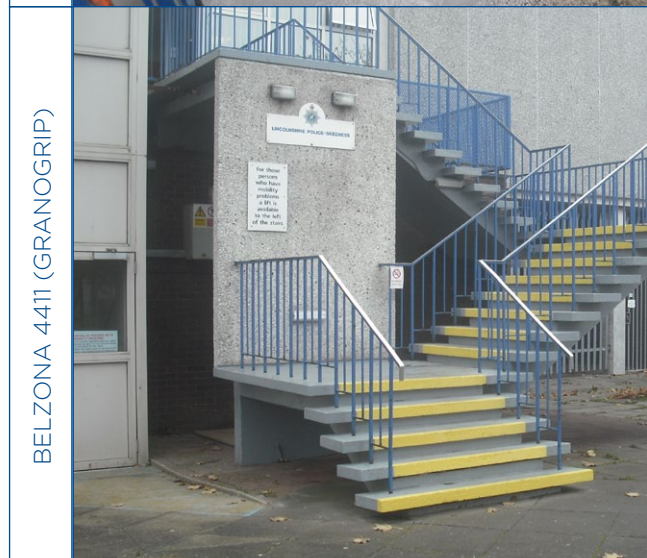
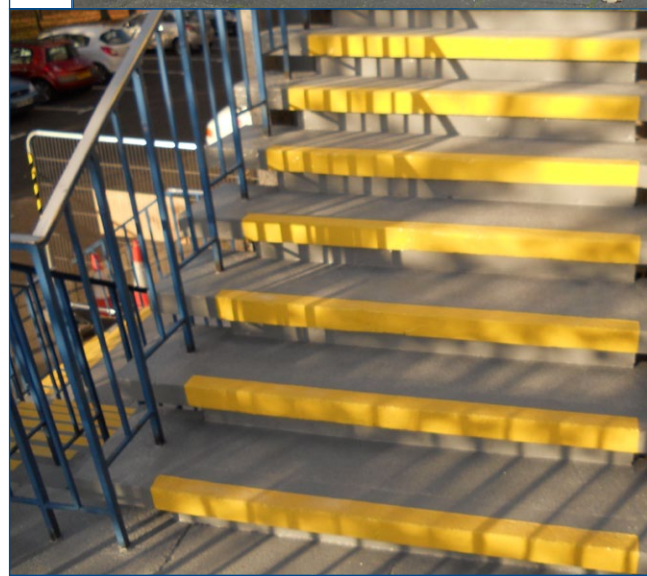
By way of example, in November 2011 a police station in Lincolnshire contacted Belzona looking for a repair solution for their damaged concrete steps. The stairs leading into the station had become damaged and worn resulting in a dangerous slip hazard to pedestrians. In addition, signs of carbonation had appeared underneath the concrete stairway.

Belzona 4131 (Magma-Screed) was used to repair the damaged areas of concrete on the staircase. This product provides excellent protection against the effects of harsh weather, abrasion and chemical attack. Once the concrete was repaired three coats of Belzona 5811 (Immersion Grade) were applied to the total staircase area including the steps and the underside. This product was combined with a coarse aggregate to provide a complete anti-slip system on the staircase.

The final element to this application was the creation of a safety grip system. Belzona 4411 (Granogrip) a three component system with aggregate encapsulated in safety yellow was applied to the step nosing's providing a safe and durable surface for pedestrians.

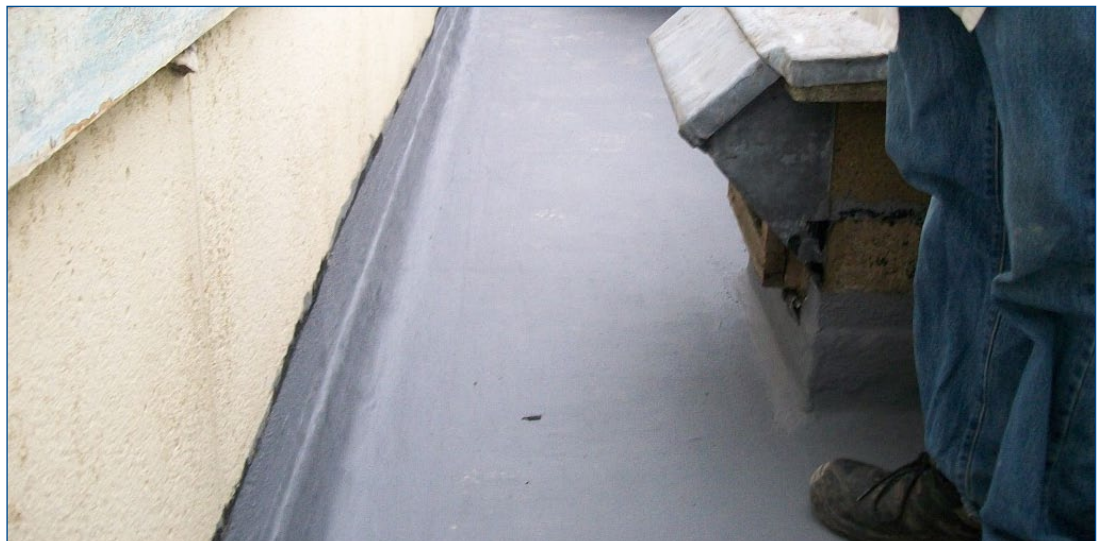
In December 2010, Belzona Authorised Contractor Sam Grain Contracts completed an application on a silo at an Oat Mill in Bedford. The roof of the silo containing ground corn was leaking causing water to penetrate into its contents. The client requested a water-based solution as solvents would taint the flavour of the corn.

The application commenced with the removal of the previous roof coating. Once the coating was removed it was found that the original asphalt substrate had cracked in several areas allowing water to penetrate through to the contents of the silo. Belzona 3921 (GSC Conditioner) was applied to the roof area prior to a two coat reinforced system of Belzona 3111 (Flexible Membrane) being applied.

Belzona rose to the challenge and offered Belzona 3111 (Flexible Membrane) as an ideal solution. To aid the application a tented area was created to ensure the Belzona 3111 (Flexible Membrane) could be applied whilst being protected from the external freezing conditions. It was also clear that a lot of heat was rising from the silo areas underneath so this helped with the application.

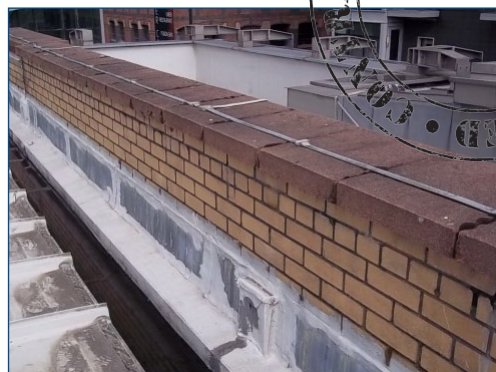
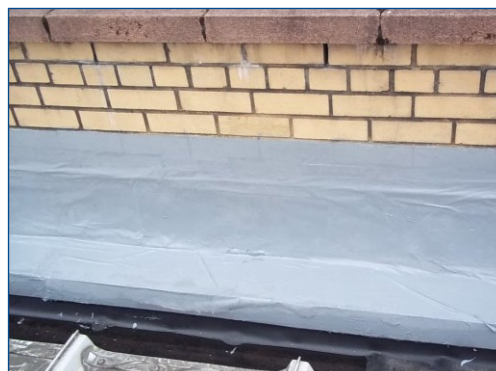
Leaking metal box gutter

The client was experiencing water ingress issues around a single ply lined metal box gutter and they believed the main cause to be poor flashing detail.

SAS recommended the use of Belzona 3131 (WG Membrane) to fully encapsulate the flashing detail and one brick course above to ensure this aspect of the gutter detail was weather proof.

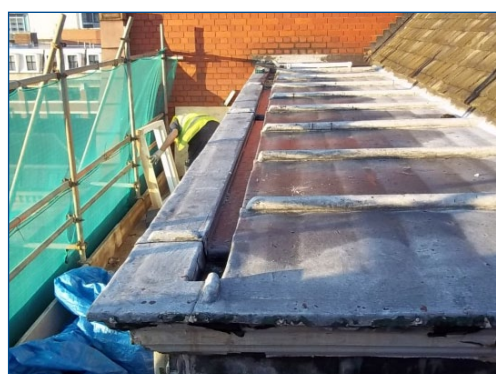
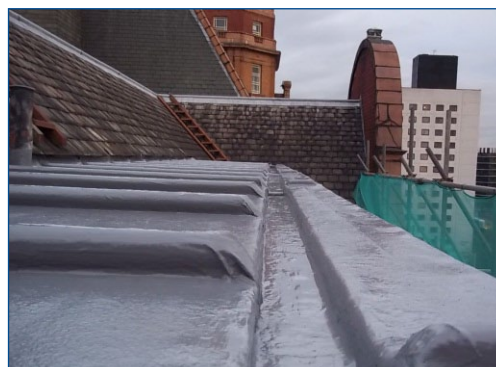
Damaged lead covered dormer roofs

Whilst having window repairs to three dormers the client identified some damp areas appearing in a wooden lined internal roof. On further investigation it was found that this damp was caused by damaged areas of guttering on the lead covered dormer roof. Belzona 3131 (WG Membrane) was selected to completely encapsulate the three roofs including all up-stands and gutter details.

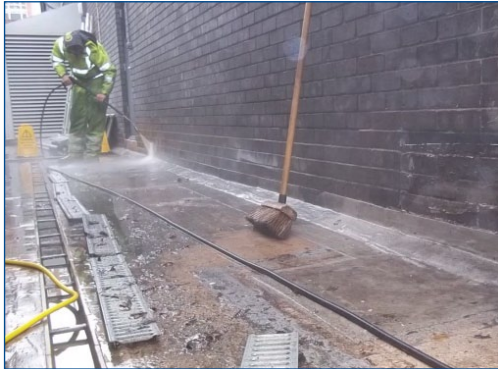
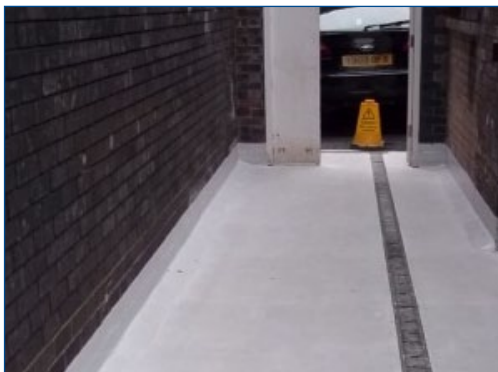
Water ingress on concrete walkway

A concrete walkway had been experiencing water ingress. Drainage had been unsuccessfully installed resulting in further deterioration. A two coat system of Belzona 3131 (WG Membrane) provided a seamless coating of the entire walkway incorporating the internal gutter detail. A third coat of Belzona 3131 (WG Membrane) was then applied incorporating Belzona 9221 (Surefoot Aggregate) to improve resistance to wear from foot traffic.

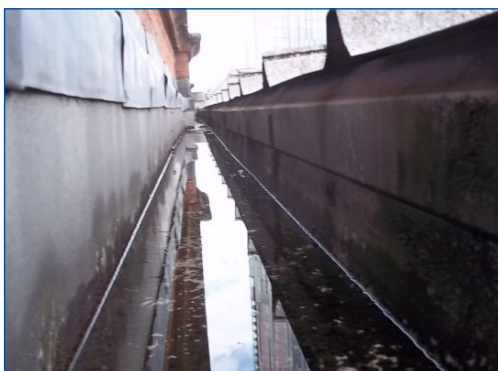
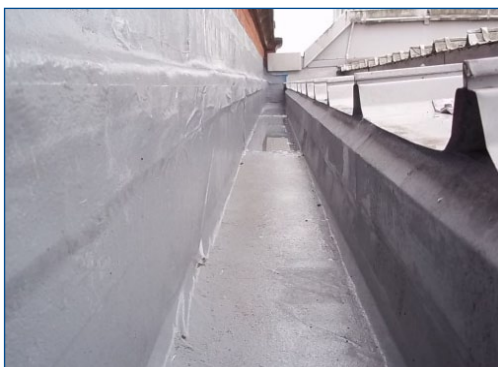
Galvanised box gutter

SAS were contacted by a client experiencing water ingress issues. On inspection, it was identified that the problem emanated from the box gutter areas. Belzona 3131 (WG Membrane) was selected to fully line the gutter detail including the up-stands and flashing areas where it was extended one brick course above the flashing detail to provide a complete water and weatherproof coating.
