Facilitate

BELZONA'S FACILITIES MAINTENANCE MAGAZINE

ISSUE 4

SUMMER 2013

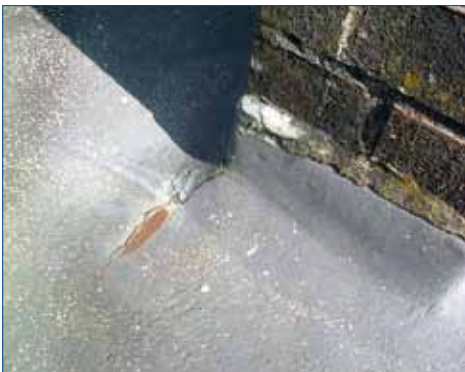
Belzona was contacted by a local authority managing a block of flats above a row of shops. Three of the flats' balconies required a new waterproofing system as the shops were suffering leaks caused by damaged/porous asphalt from the balconies above. Upon inspection of the asphalt balconies, it was discovered that there were a number cracks across the asphalt balcony floors. There were also a number of areas around the perimeters of the balconies where pointing was missing or coming away.

DAMAGED ASPHALT

The area was cleaned and any loose pointing was removed prior to the application. On bituminous substrates, no conditioner is required making this one product solution from Belzona extremely time and cost-effective. Two coats of Belzona 3131 (WG Membrane) were then brush applied combined with Belzona 9331 (Reinforcing Sheeting). A third coat of membrane was then applied incorporating Belzona (Surefoot Aggregate) in white to give the coating an anti-slip finish and provide a safe balcony area for residents

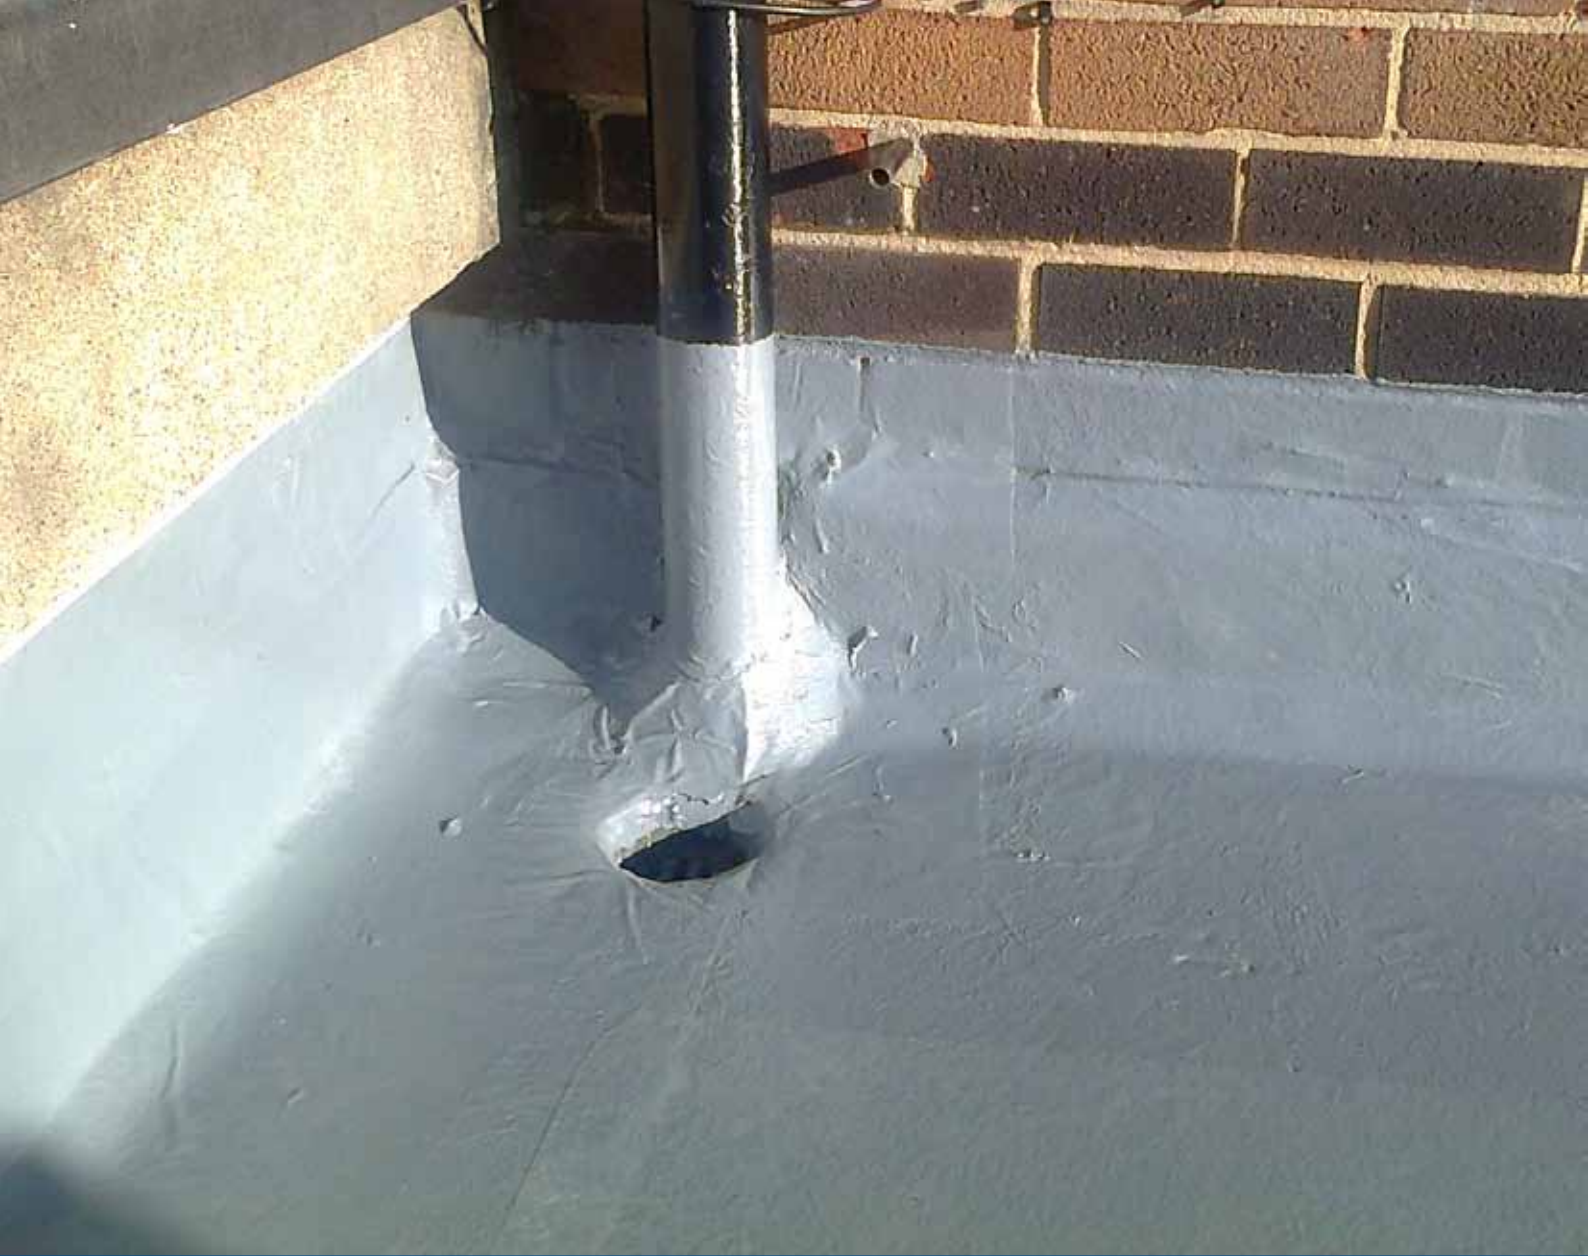
APPLICATION OF BELZONA 3131 (WG MEMBRANE)

conditions and will not be damaged by rain immediately after application. Its liquid base binds to the reinforcing sheet to form a tough, flexible and elastic polymeric film which can tightly follow contours. It is impermeable to liquid water, but permeable to water vapour, thus allowing a moist roof to breathe.

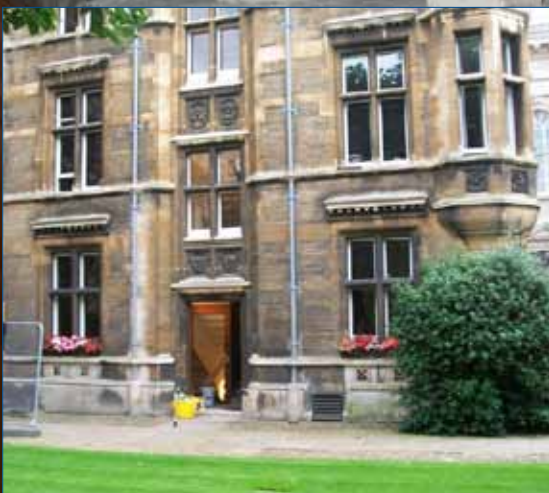
In September 2012, Belzona products were used to restore some badly worn steps at a college in Cambridge. Several years of foot traffic had resulted in the deterioration of the stone steps causing around 75mm of tread wear in the centre of the steps. This had left the staircase slippery and dangerous to pedestrians.

DETERIORATED STONE
STEPS

Wooden formers were assembled around each step to ensure the accuracy of the repair.

Belzona 4131 (Magma Screed) was selected for the application as its unique formulation provides exceptional compressive strength and excellent protection against the effects of abrasion, chemical attack and impact.

To achieve maximum adhesion to the stone steps the use of Belzona 4911 (TX Conditioner) was required prior to the application of Belzona 4131 (Magma Screed). The repair composite was trowel applied to rebuild each of the

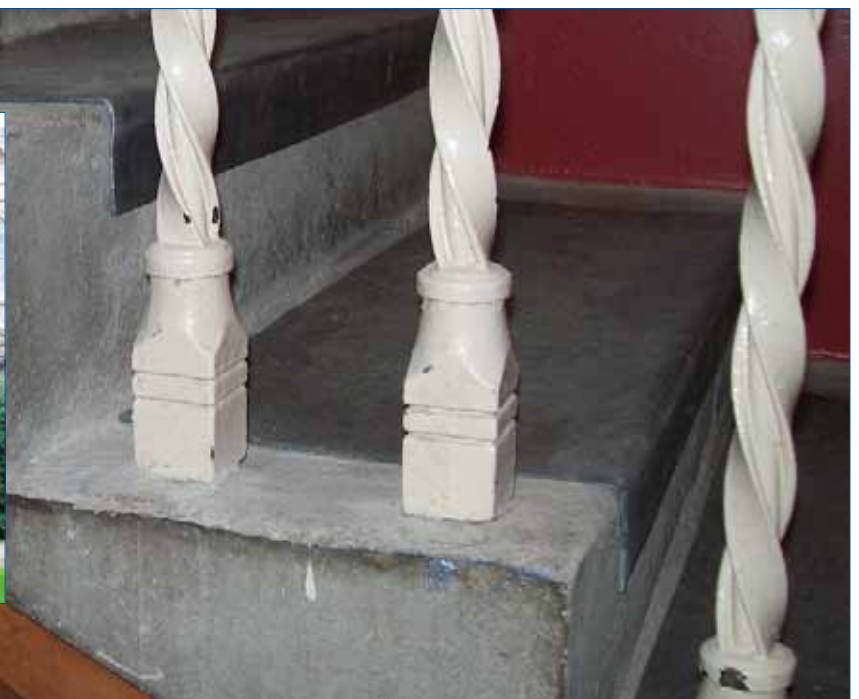
COMPLETED REPAIR

The completed application was then covered with sand-cast lead to ensure the repaired steps fitted in with the aesthetics of the traditional 16th century building. Belzona can provide solutions to any size establishment ranging from small primary schools through to a large colleges or

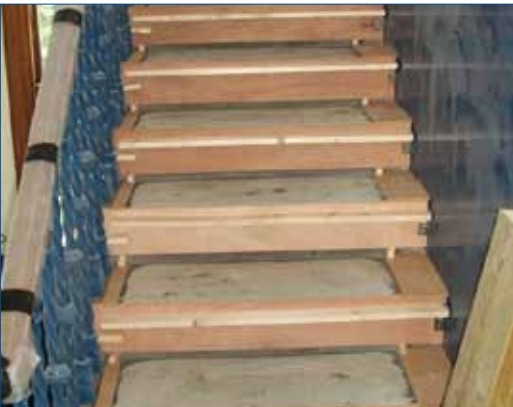
WOODEN FORMERS
INSTALLED

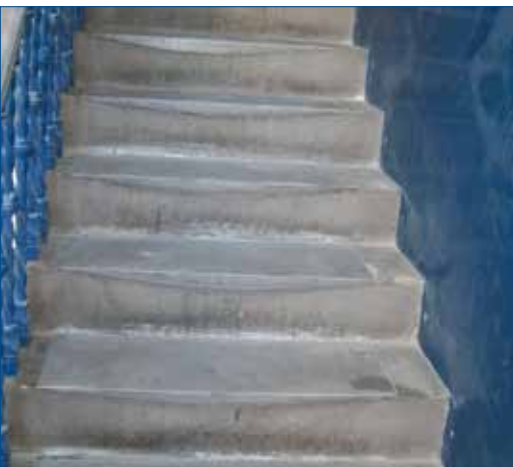
BELZONA APPLICATION

steps to their original dimensions.

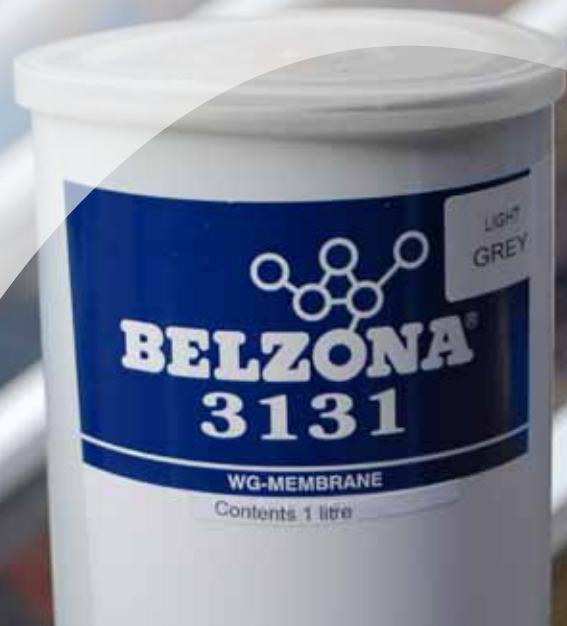
or debris collecting on the roof. In September 2012, a chilled food supplier in Worcester required a repair solution to a seriously damaged roof. Months of inclement weather had resulted in several cracks in the felt roof. In addition, holes in the parapet wall were discovered which were leaking through into the packing area below. Belzona recommended an easy to apply liquid membrane system which has the ability to follow complex roof contours.

BELZONA 3131 (WG MEMBRANE) SEALING LEAKS

a Belzona 9331 (Reinforcing sheet) was specified for the application. All loose substrate matter was removed and a fungicidal wash was used to remove all of the vegetation. To ensure maximum adhesion it was necessary to apply Belzona 3931 (WG Membrane Conditioner) to the application area. Two coats of Belzona 3131 (WG Membrane) were then brush applied to the entire roof area.

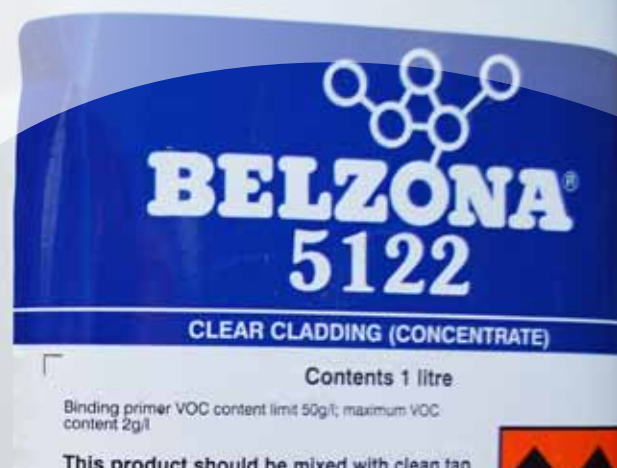
BELZONA 5122 (CLEAR CLADDING CONCENTRATE) SPRAY APPLIED

The entire front elevation was high pressure washed to remove all of the surface grime and plant life. The damaged areas were repaired using Belzona 4141 (Magma Build) and then the entire front elevation was sealed using Belzona 5122 (Clear Cladding Concentrate).

To ensure excellent adhesion to the substrate, Belzona 4911 (Magma TX Conditioner) was applied to the repair areas prior to the application of the Belzona 4141 (Magma Build). A cement tone additive was combined with the product to colour match the Belzona product with the bath stone. This product is a non-porous concrete repair compound and was used to rebuild the severely damaged vertical stone

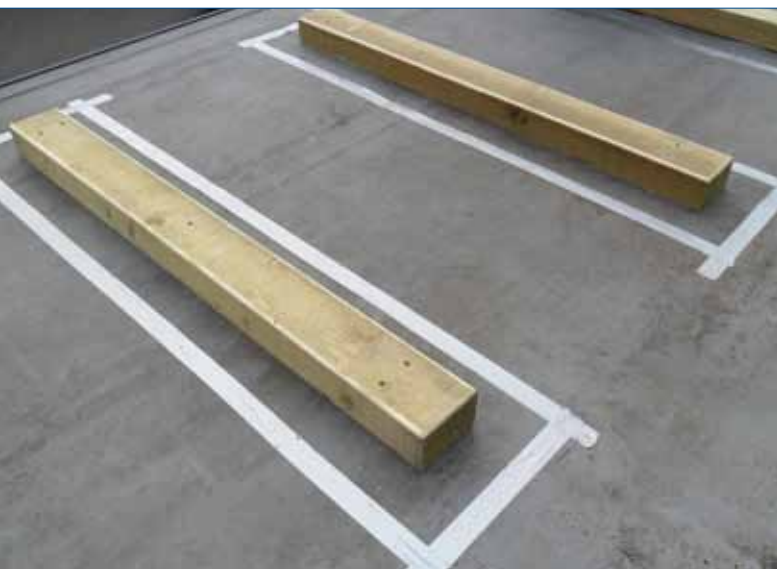
PREPARATION OF BASE PLACES

The chosen product for the application onto the solar panel brackets was Belzona 3111 (Flexible Membrane) which offers unrivalled water and weatherproofing solutions for all types of roofing substrates, complex architectural design and insulation. The simple solution provided by Belzona involved the surface area being prepared with Belzona 3911 (PSC Surface Conditioner) a brush applied porous surface conditioner, followed by

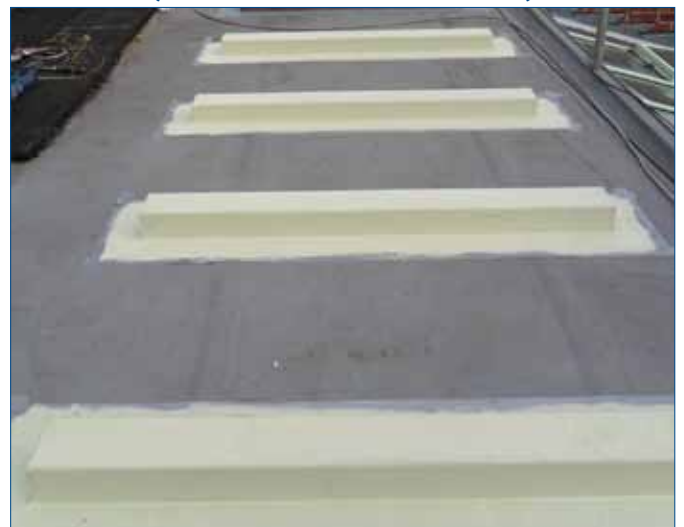
1ST COAT OF BELZONA 3131 (FLEXIBLE MEMBRANE)

two coats of Belzona 3111 (Flexible Membrane) incorporating Belzona 9311 (Reinforcing Sheet). In this case, the Belzona 3111 (Flexible Membrane) was selected for its waterproofing capabilities, ensuring the solar panel brackets remain protected from the effects of the environment for years to come. Furthermore, the product has been specially formulated to offer solar reflective properties, helping to keep facilities cool and reduce air conditioning costs over the summer months. The fire service has since expressed their satisfaction with the solution and Belzona is delighted to assist the fire service become more energy efficient and self-sufficient.

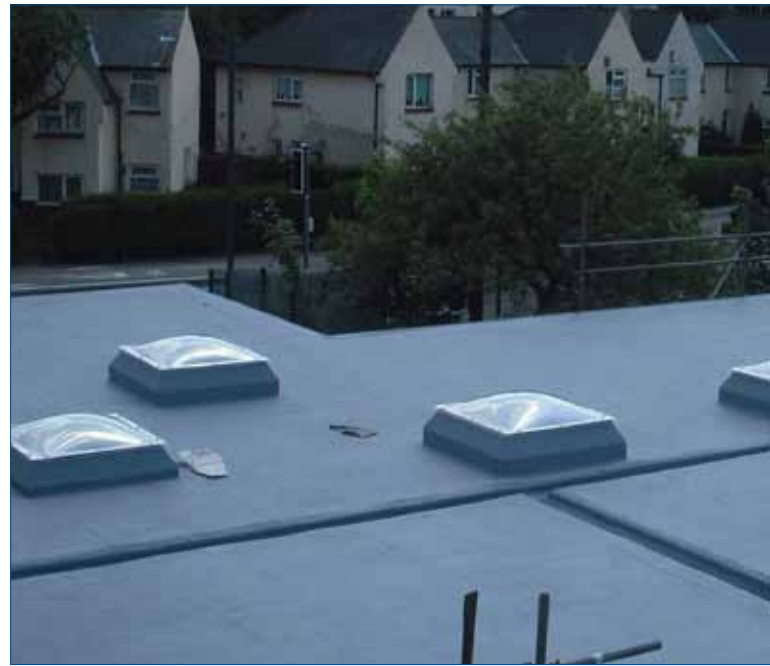
COMPLETED APPLICATION

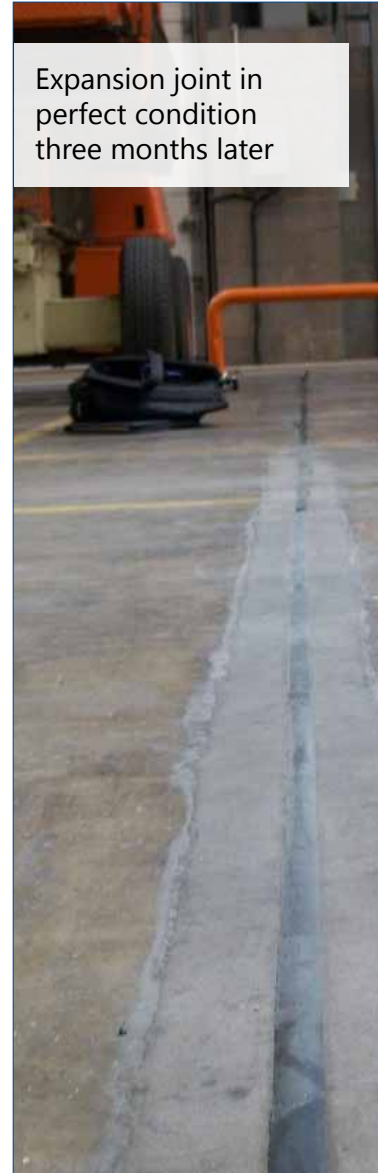
Expansion joint in perfect condition three months later

Field Sales Engineer, Philip Miles returned to the site 3 months after the installation and the application was in perfect condition. The client was very pleased with the repair and plans to repair several other expansion joints in the future.

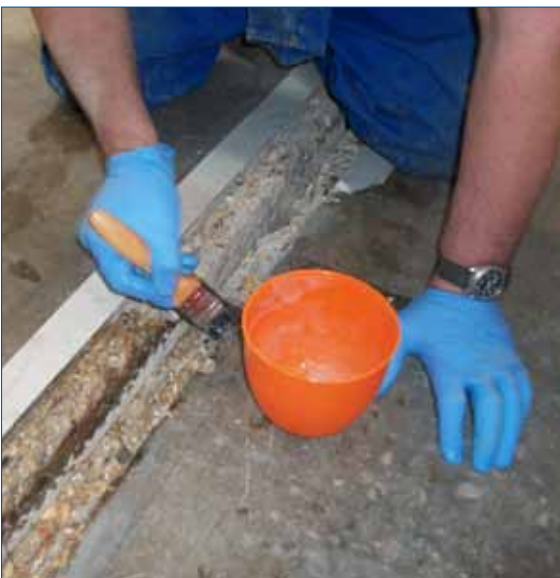
CONDITIONER APPLIED

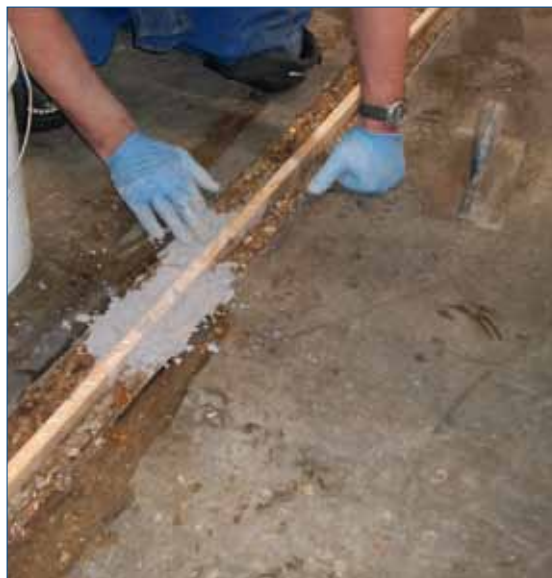
REINSTATING EDGES OF JOINT

Due to its excellent impact resistance and bond strength, Belzona 4111 (Magma Quartz) was used to effectively and quickly reinstate the edges of the joint and thus provide protection against further impact damage. The joint was then sealed using of the Belzona 2211 (MP High-Build Elastomer) which, due to its outstanding elasticity, high bond strength and no shrinkage cure, will provide the ultimate long term seal.

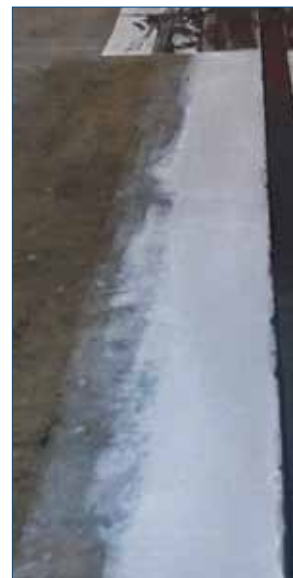
INSTALLING

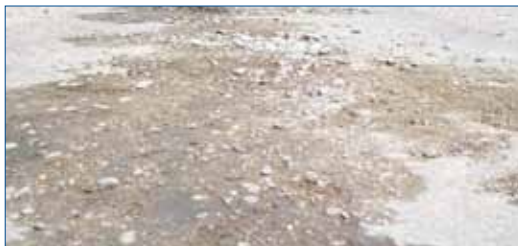
Areas of a concrete ramp had become damaged due to impact from the gas cylinders when being loaded and unloaded and also from frost damage. The badly degraded surface was making unloading increasingly difficult as the tall narrow cylinders could not stand up safely. This is a common problem at many distribution sites across the UK.

DAMAGED AREA

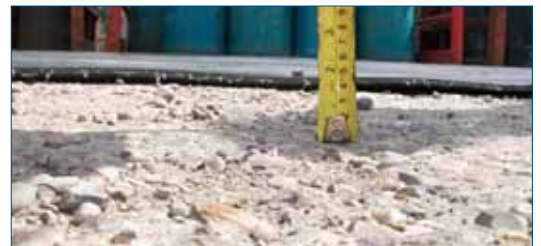
DAMAGED AREA

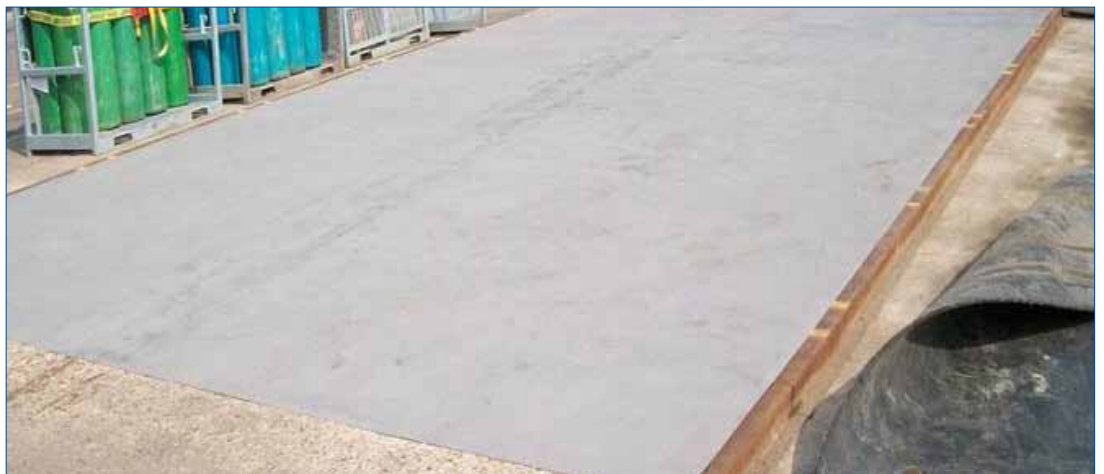
COMPLETED REPAIR

The concrete ramp was pressure washed to remove any surface contamination. Belzona 4911 (Magma TX Conditioner) was then applied to the prepared areas to provide maximum adhesion before the Belzona 4131 (Magma-Screed) a two component system for the repair and resurfacing of concrete and stonework was applied to the ramp and troweled smooth. The product was selected firstly for its high performing properties which offer protection against impact and abrasion. Secondly for being impermeable and resistant to frost damage.

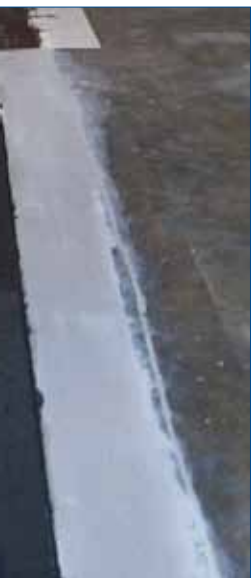
ELASTOMER

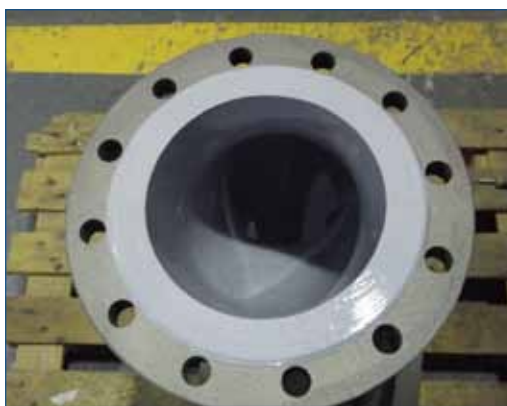
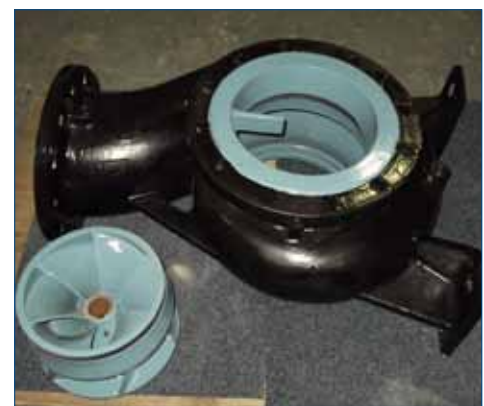
Once the pump unit was high pressure washed and blasted to a substrate cleanliness of at least SA 2 1/2 and a surface profile of no less than 75µm it was found that the main areas of damage were the impeller and the volute casing.

The first stage of the application was to coat the internals of the pump casing and the impeller with two coats of Belzona 1341 (Supermetalgilde) a high performance coating for improving the efficiency of fluid handling systems and protection of all metals from the effects of erosion-corrosion.

protective coating to the externals of the pump casing. The Belzona 5811 (Immersion Grade) system was ideally suited to this application as it demonstrates outstanding protection from the effects of salt water and the environment and was designed for substrates operating under immersion conditions in contact with aqueous solutions.

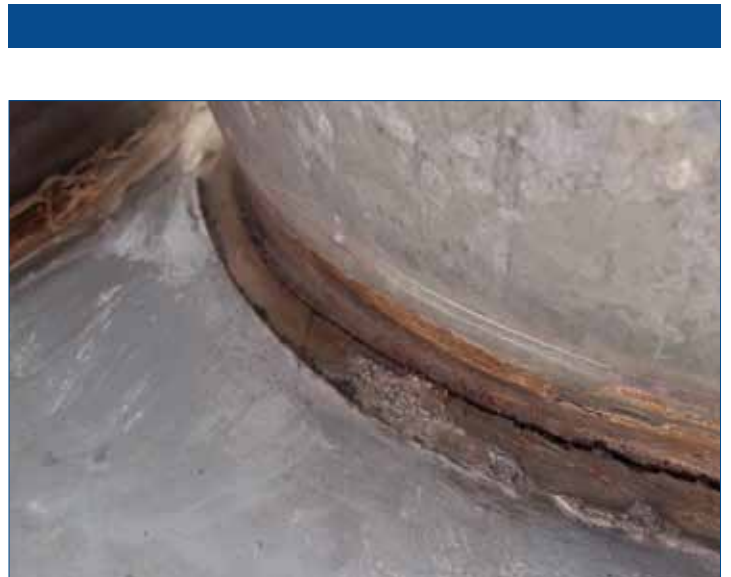
In September 2012, the bad weather experienced in the UK had caused rubber seal degradation on some ducting joints allowing rainwater to leak directly into the production area at a manufacturing factory in North Yorkshire. This was causing major disruption and health and safety issues to staff manufacturing products on the floor below.

CORRODED DUCTING JOINTS

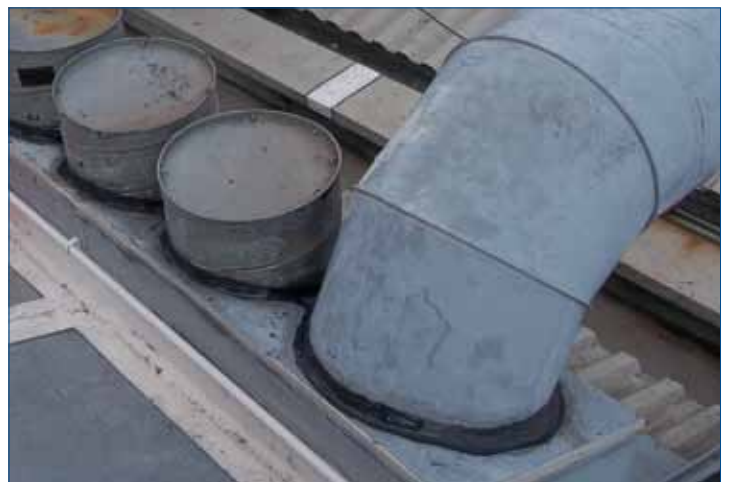
JOINTS SEALED WITH BELZONA 2211
(MP HI-BUILD ELASTOMER)

Surface preparation was carried out by using a wire brush prior to the application of Belzona 2911 (Elastomer QD Conditioner).

Once the conditioner was touch dry, Belzona 2211 (MP Hi-Build Elastomer) was applied with a plastic applicator to ensure the joints were fully sealed.

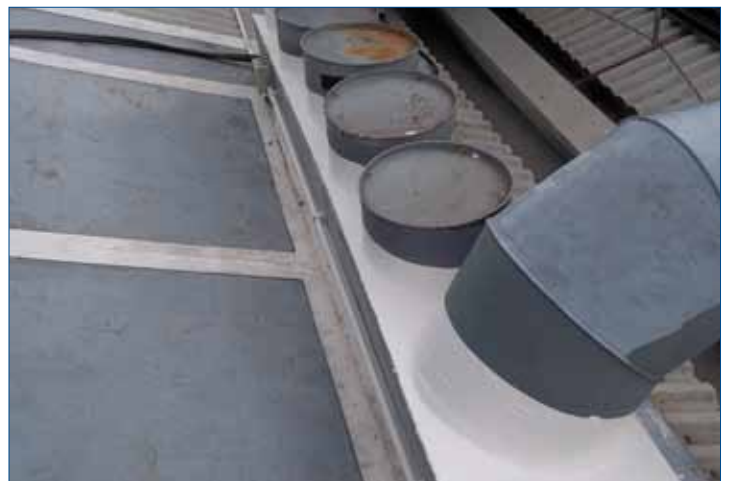
FULLY ENCAPSULATED WITH BELZONA
3111 (FLEXIBLE MEMBRANE) IN WHITE

Once cured, a fully reinforced Belzona 3111 (Flexible Membrane) system was applied to the duct areas to fully encapsulate the HVAC equipment. This product offers unrivalled water and weatherproofing solutions for all types of roofing substrates, complex architectural design and insulation. The simple solution involved the surface area being prepared with Belzona 3921 (GSC Surface Conditioner), a brush applied general surface conditioner, followed by two coats of Belzona 3111 (Flexible Membrane) incorporating Belzona 9311 (Flexible Membrane Reinforcing Sheet).
