Facilitate

FOCUS ON: The Water and Wastewater Industry

Refurbishment of Dilapidated 99-Year-Old Reservoir Tower

Issue 6 - Spring 2015

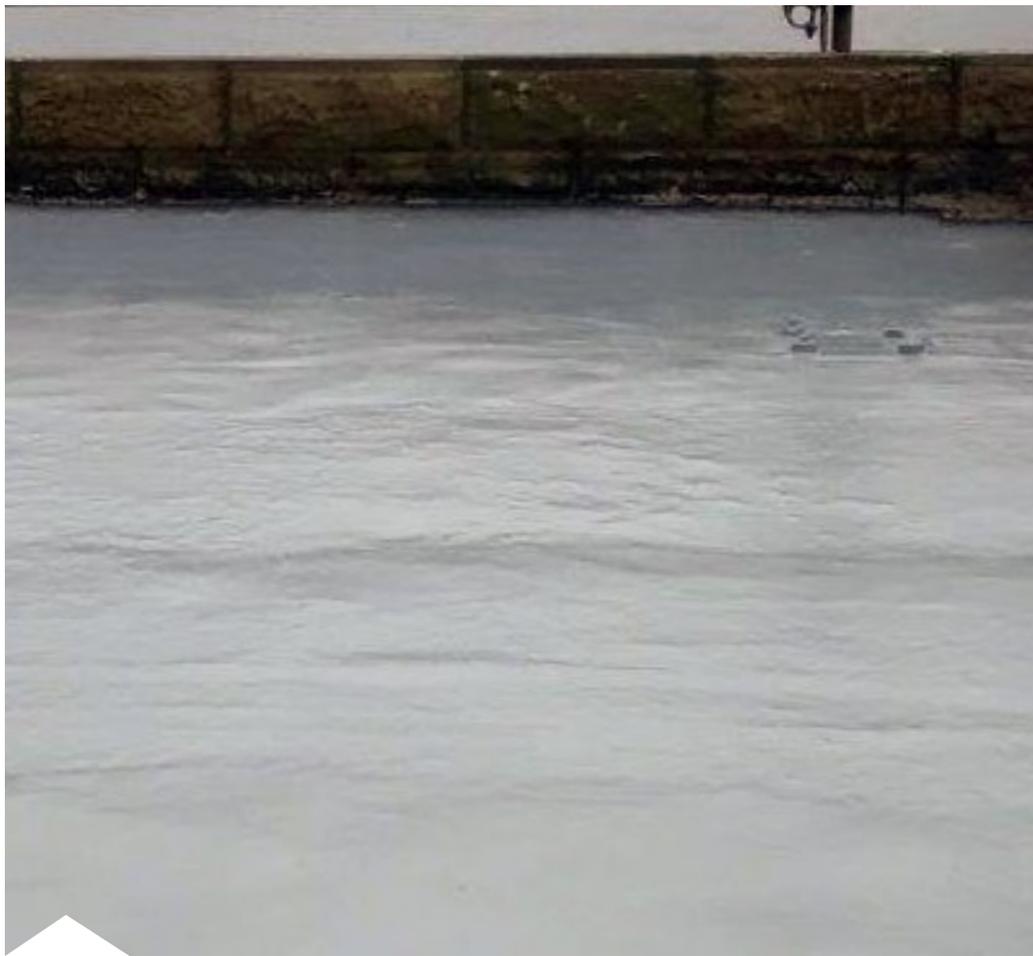
Roof repaired and protected with hard-wearing material and waterproof coating

Once this was all cleared away, the damaged concrete was then rebuilt using Belzona 4131. This is a non-porous system consisting of high molecular weight polymers and oligomers incorporated with an aggregate mix; a durable combination that will provide a hard-wearing repair to the roof.

The Belzona 3131 membrane system was subsequently applied to the entire area to prevent further water ingress. This moisture activated urethane coating bonds strongly to all types of roofing materials and will not be damaged by rain, even immediately after application. The system incorporates a reinforcement sheet to add strength to the repair and allow the easy control of the coating thickness during application. Its excellent elasticity will also ensure the repair will adapt to the movement of the roof.

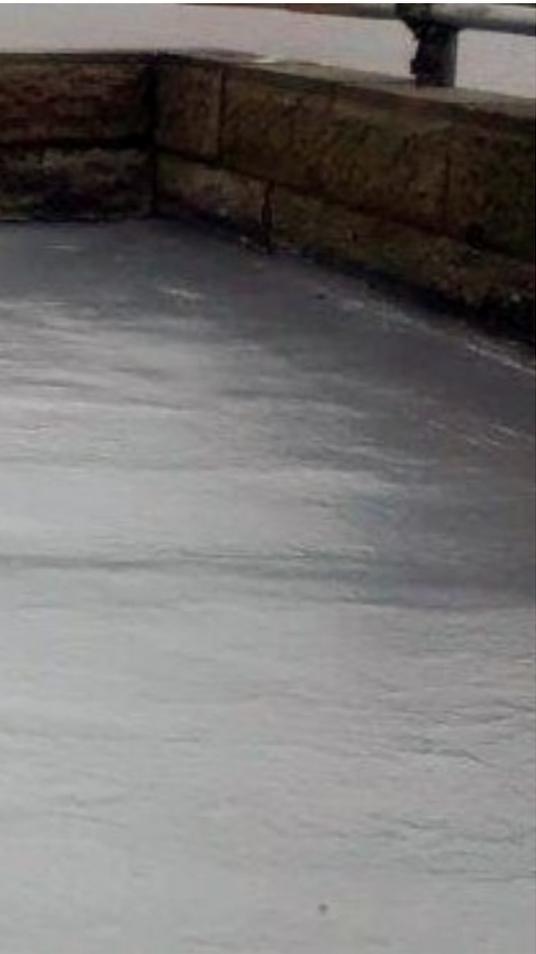
Ceiling successfully repaired and protected

For the ceiling, the damaged materials were removed and the rebars were appropriately cleaned and prepared before rebuilding with Belzona 4141. The entire ceiling was then coated with Belzona 5151 to provide further protection and an aesthetically pleasing finish.

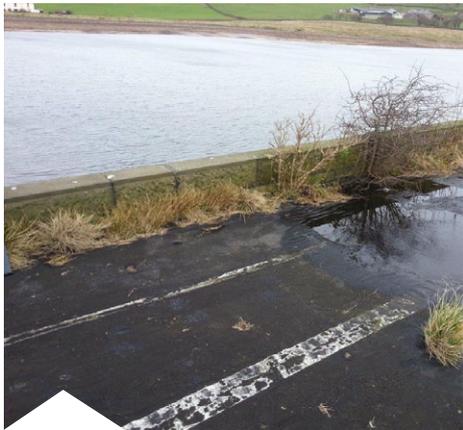
Environmental damage to the asphalt coated concrete roof was causing water ingress resulting in spalled concrete on the ceiling underneath. Alongside this, severe plant growth was also visible across the roof area, further contributing to the damage of the substrate. The reservoir required a maintenance solution that would not only fix the damaged areas but would also provide long-term protection against future environmental challenges.

Standing water leading to water ingress

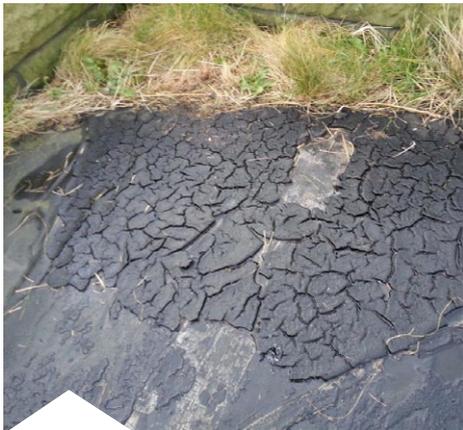
Firstly, the application team got green fingered and began to eradicate all the roots and vegetation from the application area along with the damaged asphalt. On removal of the asphalt, it became clear that some of the concrete substrate had also been badly affected by the vegetation and water damage, thus requiring all the friable concrete to also be removed.

Deteriorated asphalt substrate

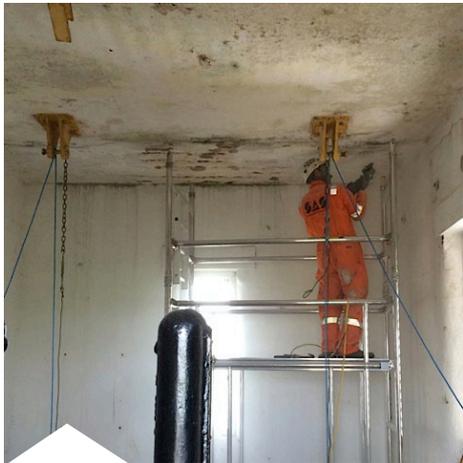
Preparation of the ceiling

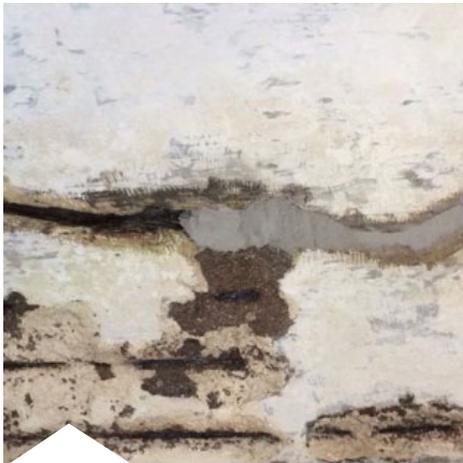
Lightweight material used to rebuild ceiling

Belzona 4141 (Magma-Build) was specified to repair the ceiling as its lightweight properties enable application onto the overhead masonry surface without the need for shuttering. To complete the application, Belzona 5151 (Hi-Build Cladding) with its water repellent and self-cleaning properties was chosen to coat the ceiling.

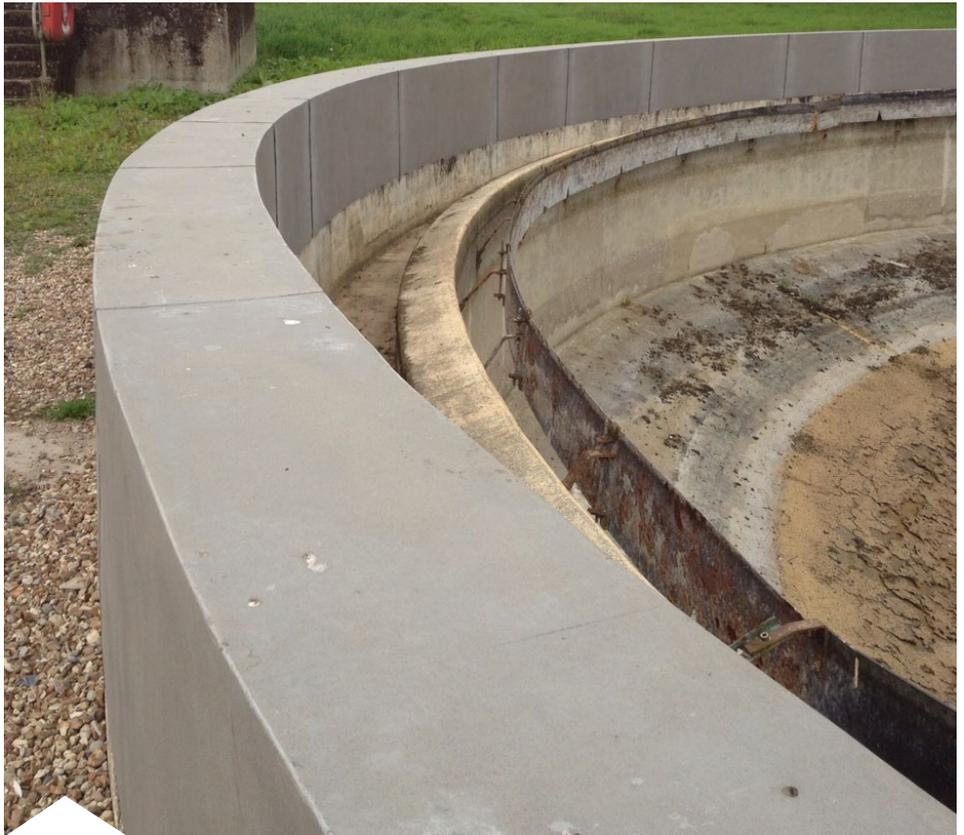
Substrate rebuilt and protected with rapid curing epoxy system

For the repair and resurfacing of the substrate, the company chose the non-porous, hard wearing epoxy repair composite, Belzona 4131 (Magma Screed). This material has been proven to exhibit excellent abrasion resistance. When tested in accordance with ASTM D4060 with a 1kg load the typical loss per 1,000 cycles is just 685mm³. This means once the Belzona system has cured, the tank walls will be able to withstand continuous impact caused by the weight of the agitator arm.

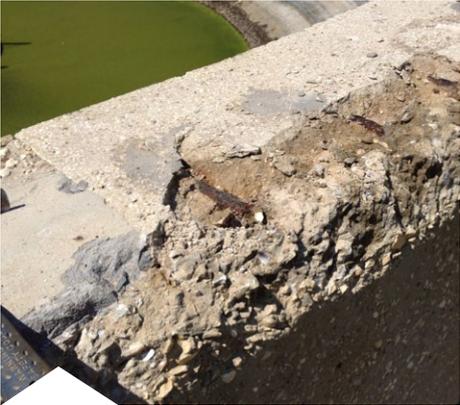
During inspection by a Belzona Engineer, it was found that erosion damage had occurred to the top of the reinforced concrete tank walls, resulting in the loss of the smooth wall cap. The damage had been caused progressively by the weight of the agitator arm, which is supported by a wheel travelling on a track on the top of the wall. In addition to this, freeze-thaw damage had also occurred as a result of recent harsh winters. The culmination of damage had resulted in the formation of potholes which caused the wheel to become trapped. If left unrepaired, this eventually would have led to severe damage to the agitator motor, which would be extremely expensive to replace.

Badly eroded substrate

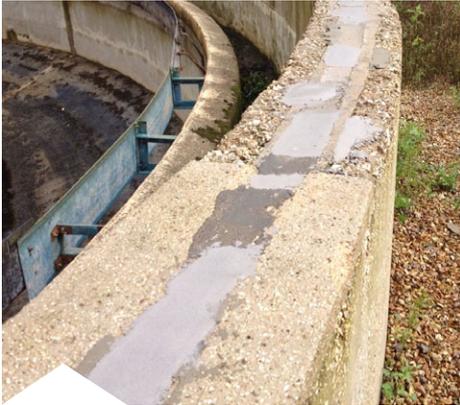
Area rebuilt with durable material

Once the substrate was thoroughly cleaned and prepared, Belzona 4911 was then applied to condition the surface ready for the repair application. Belzona 4131 was subsequently applied to repair and resurface general areas of the settlement tank. The movement joints were then repaired using Belzona 2131. As this was applied simply by pouring, this further facilitated a quick application procedure.

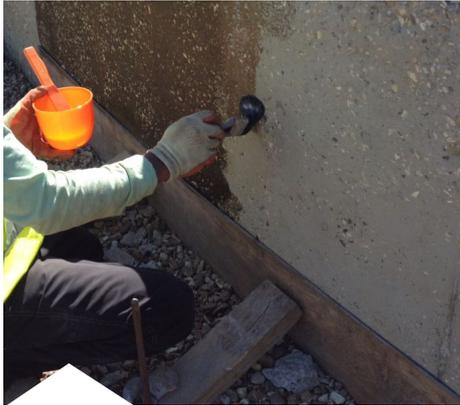
Substrate prepared with conditioner

The application would also incorporate Belzona Fungicidal Wash and Belzona 4911 (Magma TX Conditioner) to prepare and reconstitute the friable substrate prior to application. The thixotropic resin conditioner is specially designed to provide strong adhesion of the Belzona material to masonry surfaces.

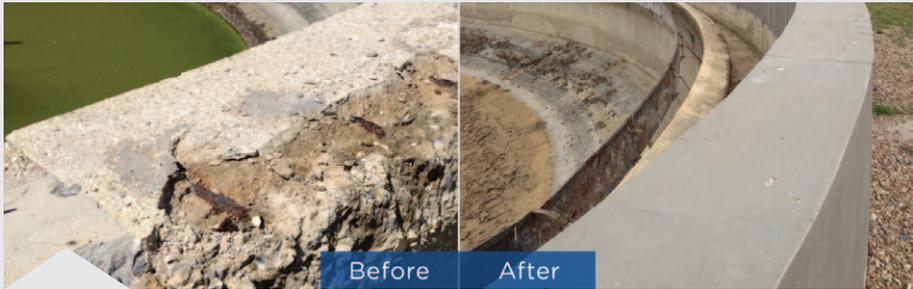
Tank wall repaired and protected with epoxy materials

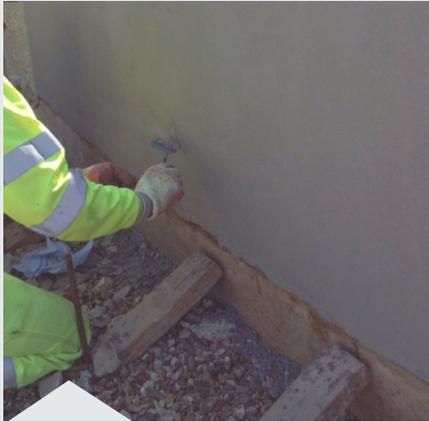
Repair and resurfacing

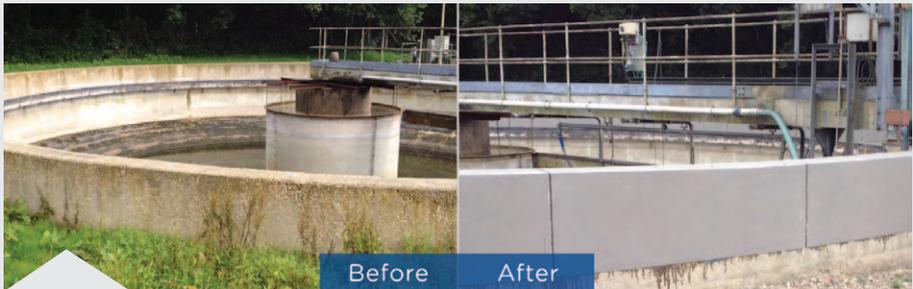
Long-term protection of eroded settlement tank

By choosing to repair and rebuild the settlement tank walls with a durable, rapid curing epoxy material, the utility company was able to bypass the time-consuming and expensive procedure of installing a new settlement tank wall. In addition to these savings, as the Belzona system exhibits a strength that is five times stronger than concrete, the substrate will remain robustly protected for many years to come with minimal need for maintenance work.

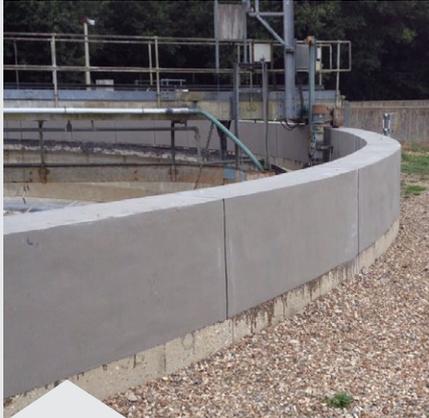
Substrate protected against abrasion

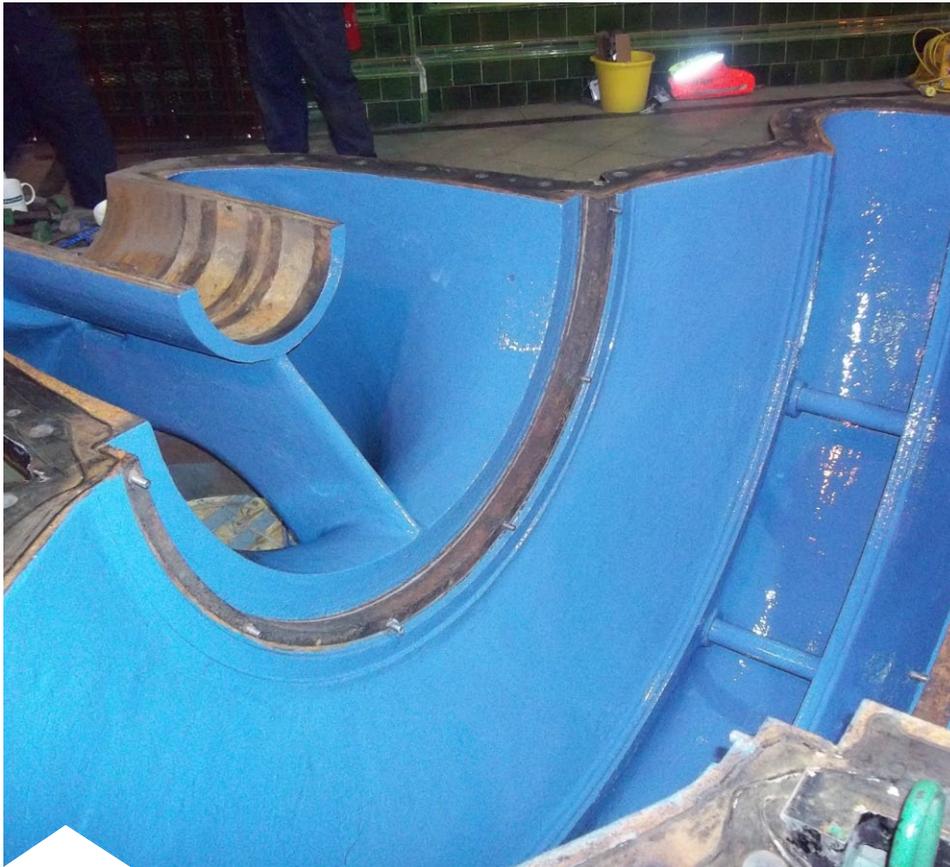
Efficiency restored to pump

This would be followed by a protective coating of Belzona 1341 (Supermetalgilde). This coating was specified as it will provide long-term erosion and corrosion protection to the equipment and improve the efficiency of the pump. In fact, Belzona 1341 has been proven to increase efficiency by up to 7% on new equipment and up to 20% on refurbished equipment, leading to significant energy savings.

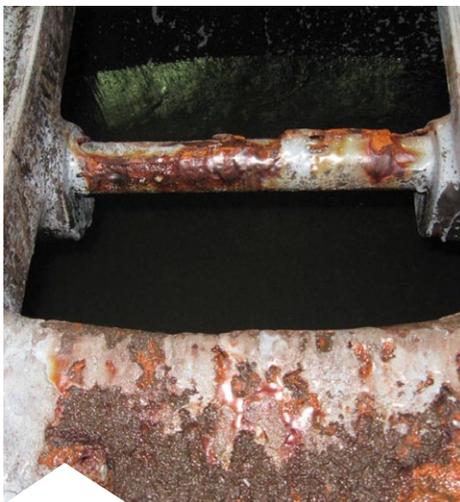
Pump casing severely corroded

Due to the physical size and weight of the top half of the pump casing, it was not practical to turn the casing over, therefore, the casing was mounted on blocks (supported by the crane for safety) and scanned from underneath. During this inspection, each casing was identified as having Substrate Corrosion To Rust Grade D. This is the highest level of corrosion grade on the scale, indicating severe rusting of the cast iron and pitting (ISO-8501-1).

Once the hydraulic profile was completed and all the equipment had been scanned, it was decided that several refurbishment applications should be carried out on three of the pump volutes, totalling a surface area of 282m². Due to the extent of the damage (some areas of each volute exhibited up to 50% corrosion) complete metal repairs using Belzona 1111 (Super Metal) were prescribed. This repair composite provides robust corrosion resistance and has excellent adhesion characteristics.

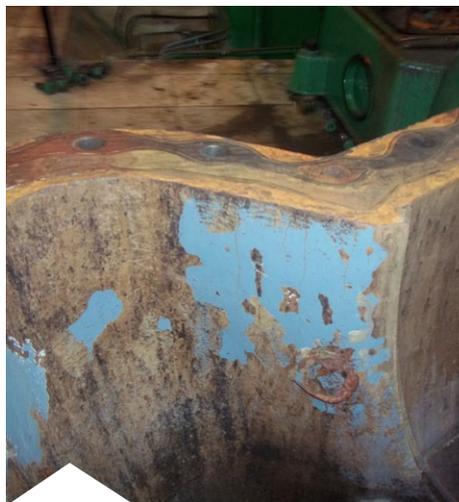
Pump casing prior to removal of existing coating

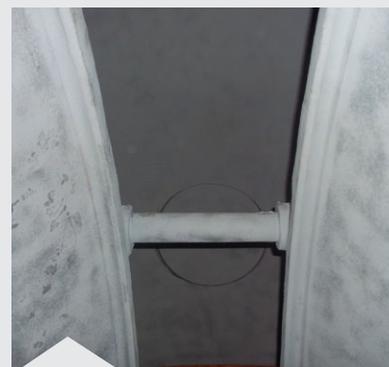
Pump casing after sponge blast

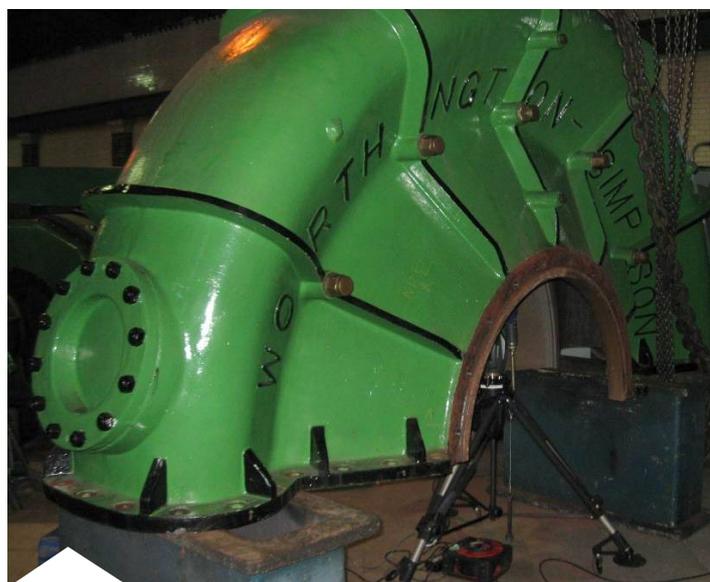
Pump casing mounted on blocks for screening

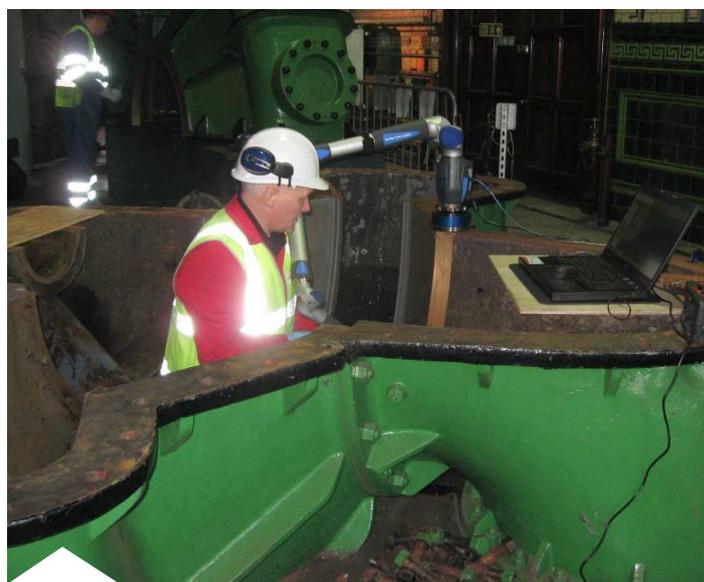
Lower casing being scanned to capture hydraulic details

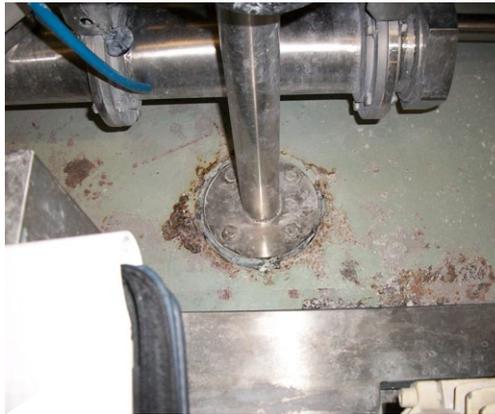
A leading pharmaceutical company in Maidenhead was experiencing severe chemical attack on a pressure pot room floor. The originally applied polyurethane protective coating on the steel/aluminum checker plate floor had failed due to the spillage of flavour oils and the use of caustic soda to clean the room two to three times a day.

Corrosion caused by flavour oils and caustic soda

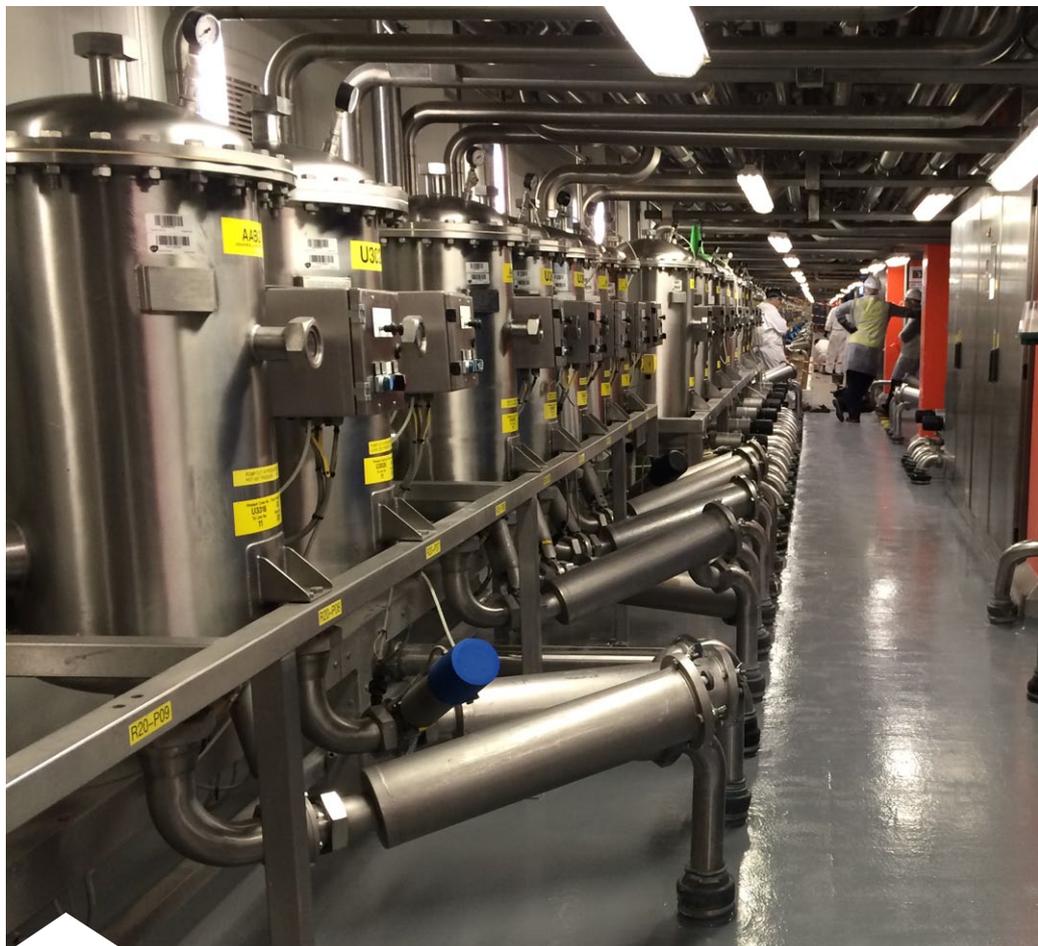
Floor protected against chemical attack

The Belzona system successfully restored the protection on damaged areas of the floor, fortifying the substrate with excellent chemical resistance for many years to come. The cold curing properties of Belzona 5811 allowed for a rapid and safe application method with reduced health and safety risks.

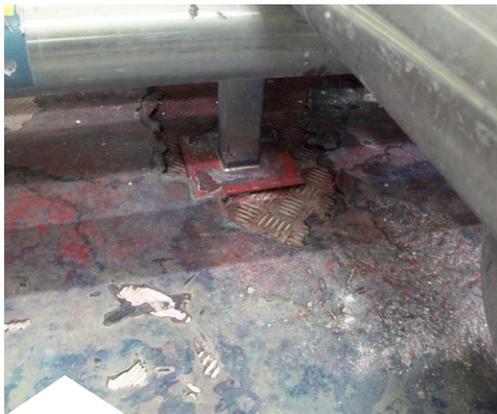
Damage caused by aggressive chemicals

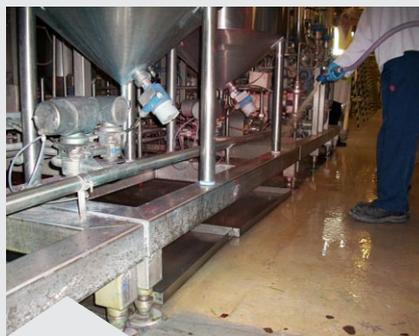
Substrate cleaned prior to application

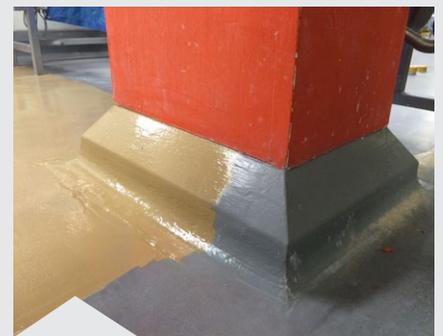
Application in process

Firstly, all contamination and debris was cleared away. Once mixed, the first coat of Belzona 5811 was then applied in beige colour onto the prepared surface using a roller.

After the first coat had been applied, the second coat was then brushed onto the substrate in grey colour to create a minimum thickness of 400µm. This technique avoided the need for hot work as the system cures quickly at room temperature 20°C, reducing health and safety risks. After just five days, the substrate achieved a full mechanical cure and after one week the floor was ready to be subjected to chemical contact, saving the company valuable downtime.

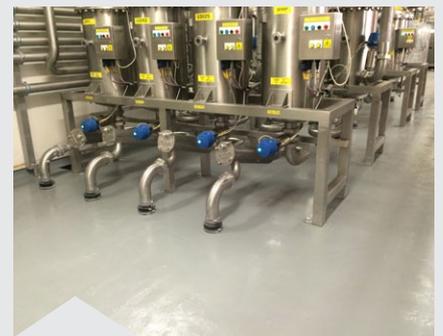
Full chemical protection after just one week

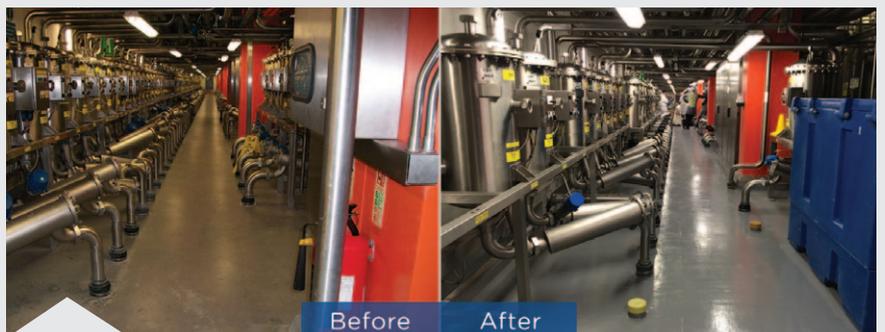
Long-term protection from aggressive chemicals

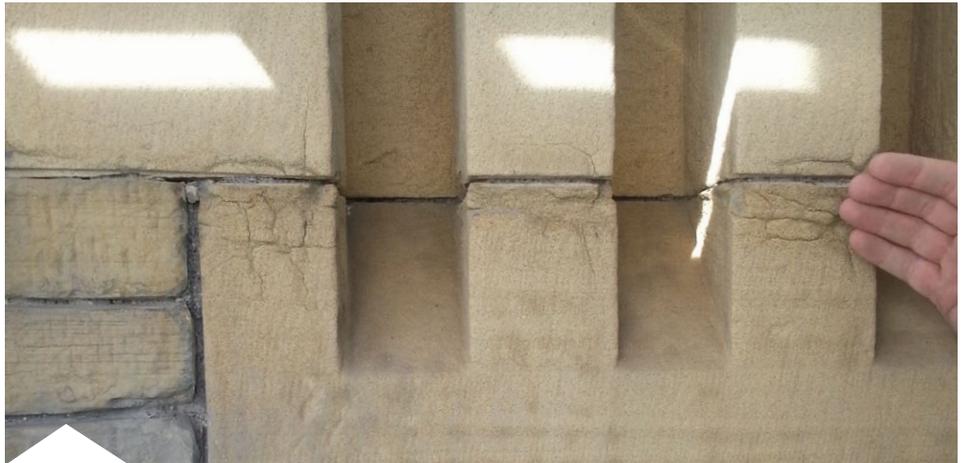
Eroded stonework identified on a school building presented a potential hazard to staff and pupils. Over the years, the stonework had been continuously subjected to multiple erosive effects such as salt crystallisation and freeze-thaw cycles, leaving the substrate badly damaged. The erosion had led to a risk of falling debris, which if left unchecked could have caused serious injuries to staff and pupils.

Weathered stonework on school building

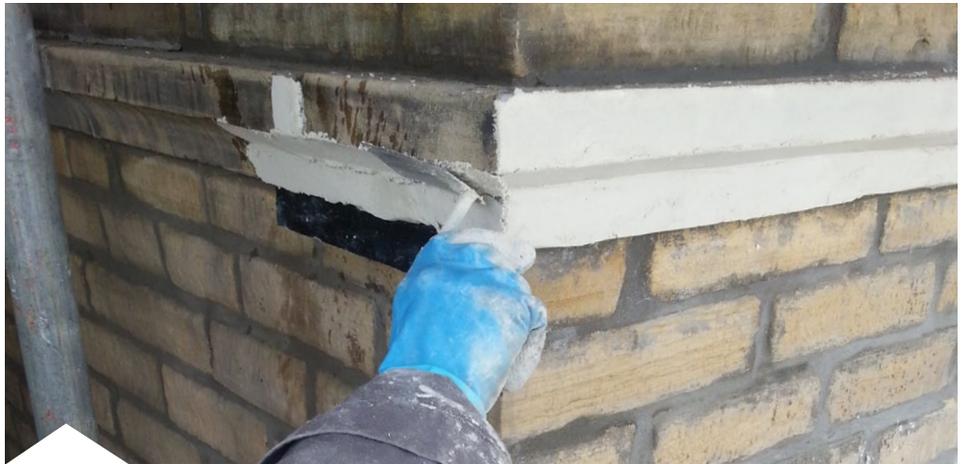
Application of lightweight repair material

Next, Belzona 4141 was applied to repair and rebuild the damaged areas of the substrate where the stonework had eroded away. The lightweight properties of this material enabled its application up to 5 inches (127mm) thick on the vertical surface with minimal support during application and curing. The material was shaped by hand to match in with the existing stonework, thus ensuring the repair was in keeping with the aesthetic of the building. Its odourless properties further ensured the application could be carried out causing minimal disturbance to staff and pupils.

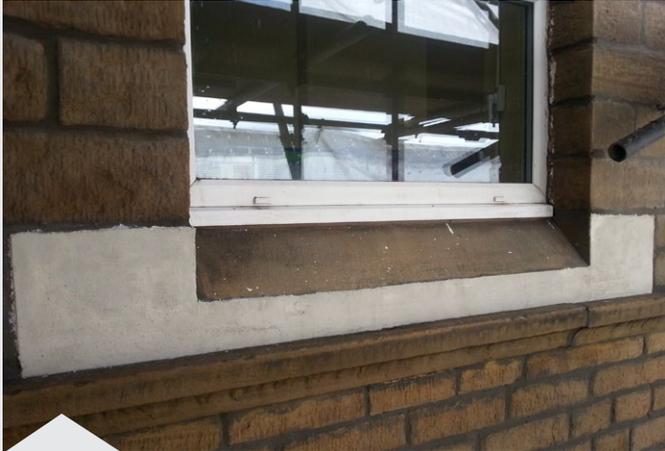
Stonework sucessfully rebuilt with hard-wearing system

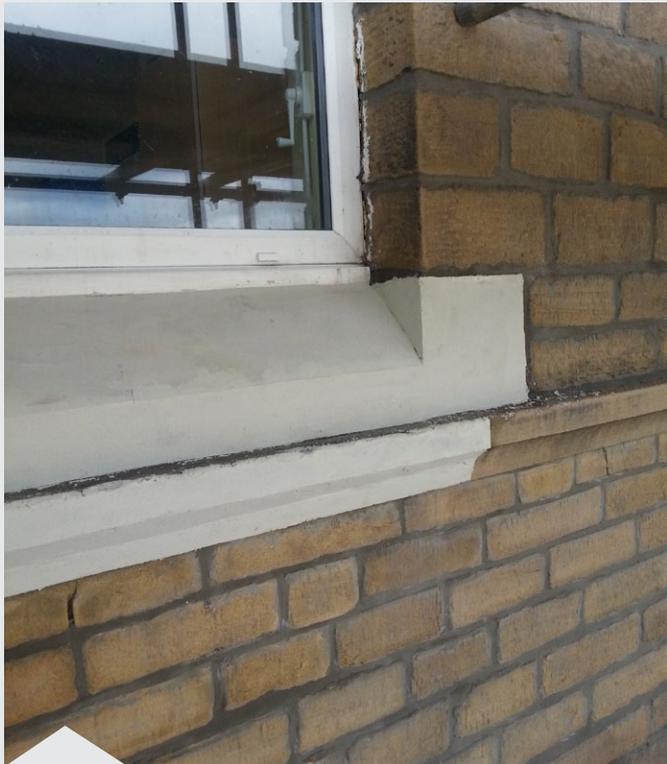
Seamless application on overhead stonework

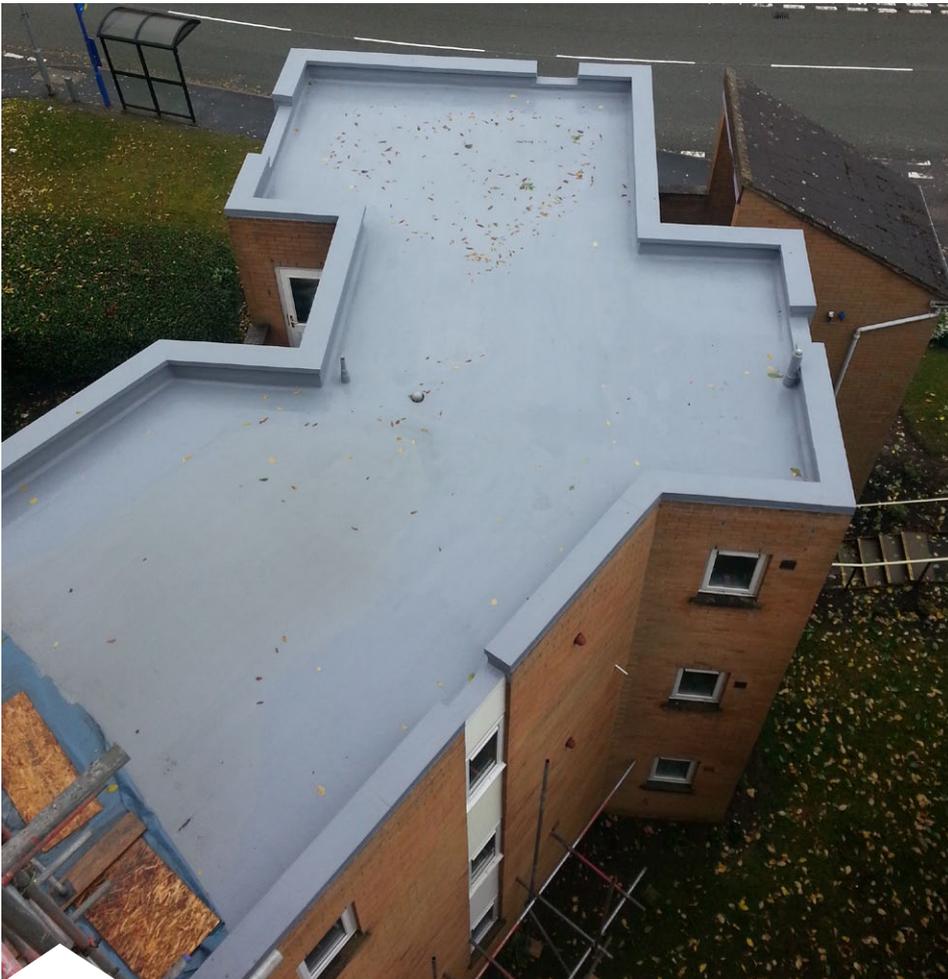
Microporous structure allows surface to breathe

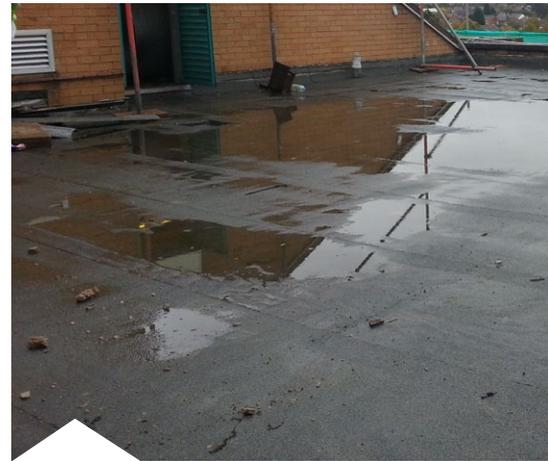
At a large housing association in Loughborough, a number of weathering problems were identified on a series of 28 flat roofs. Each of the roofs was deteriorated to varying degrees. In some areas, failing mineral felt and cracked asphalt substrate had led to water ingress. In other areas, the mortar between the parapet coping stone joints was failing, allowing water to penetrate through the brickwork below. On some of the parapets, strips of flashing tape had been installed over the coping stones joints to seal them but these had started to fail and required replacement using a more durable system.

Standing water leading to water ingress

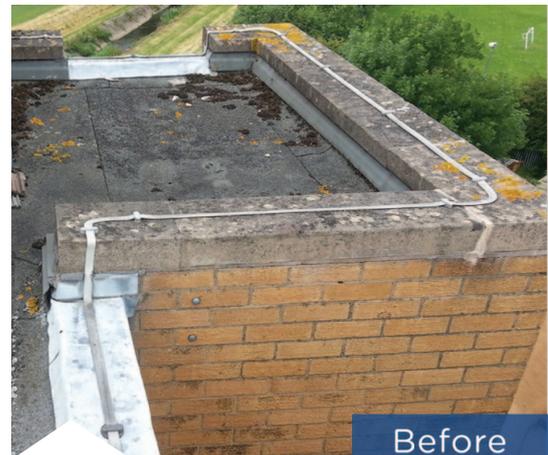
Long-term roof protection

Following an inspection by a Belzona representative, a cold applied liquid coating for long-term roof protection, Belzona 3111 (Flexible Membrane), was specified to repair the damaged roof areas. This coating was prescribed in conjunction with Belzona 9311 (Reinforcing Sheet), a specially woven, open mesh fabric designed to give the repair added durability and strength.

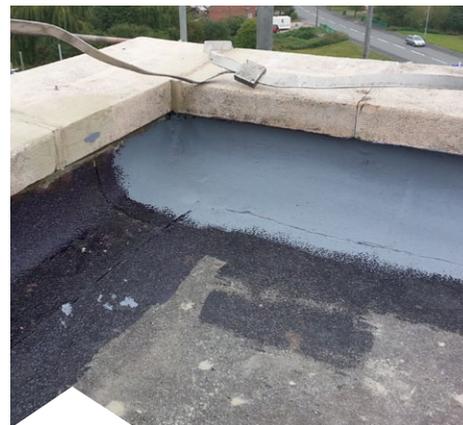
Application onto conditioned surface

After all the debris was cleared away, the Belzona conditioners were applied using a roller to provide a quick coverage. Once the conditioner had dried, the reinforcement sheet was laid out and

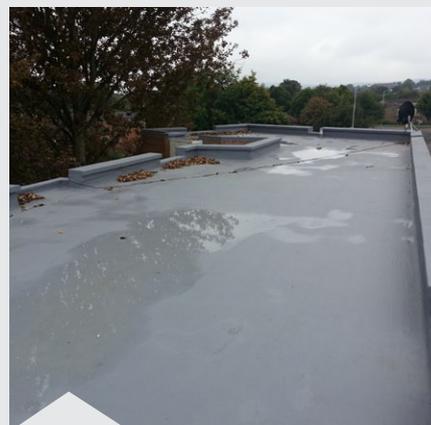
Outstanding waterproofing properties

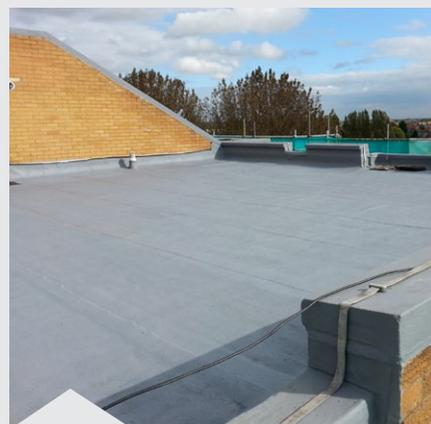
Tough material follows all roof contours

Due to the versatility of the Belzona roofing system, the application team were able to facilitate a series of bespoke repairs specially designed for each different application situation. The tough, flexible and elastic polymeric film tightly follows all roof contours, encapsulating and providing long-lasting protection to every area of the roof.

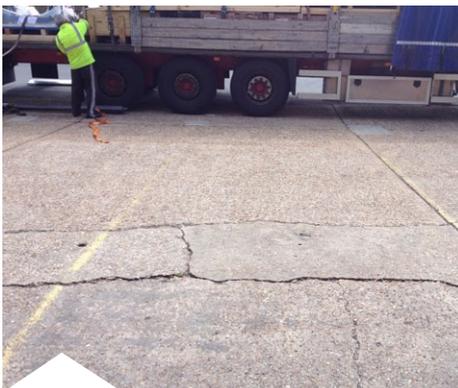
The loading bay had a gradient levelling off down to road level. When the lorries are loading and unloading, they have to reverse from the road up the gradient and into the loading area. At the start of the gradient, the lorries wheels lose traction causing abrasion and damage to the concrete substrate. To overcome this, the lorries take a run-up to the loading bay. However, this repeated action had led to damage on the loading bay and also presented a potential injury hazard to personnel. Over time, the damage to the concrete slab had significantly worsened, making the loading and unloading process much more hazardous and in need of an urgent solution.

Abrasion damage on concrete substrate

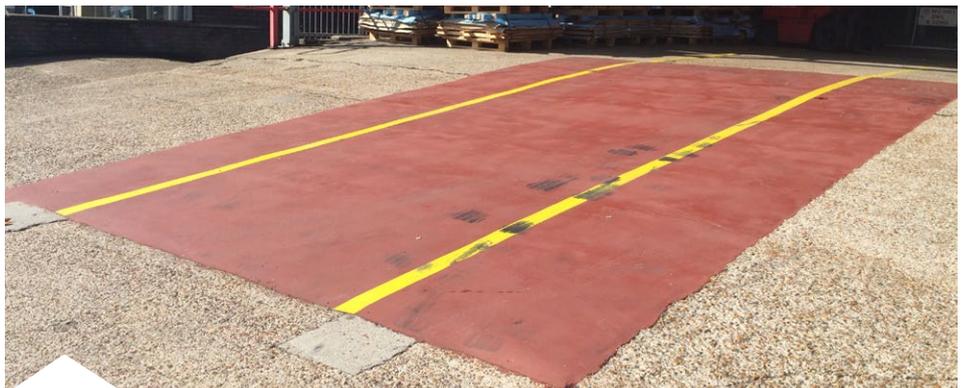
Loading bay fortified with abrasion resistant repair composite

Following an inspection by a Belzona Engineer, the company decided to repair the damaged substrate using Belzona 4131 (Magma-Screed), an extremely durable epoxy repair composite specifically designed for resurfacing and protecting large areas of concrete. As Belzona 4131 exhibits excellent grip properties in both wet and dry conditions, this will ensure the loading bay area will remain thoroughly protected no matter how harsh the environmental conditions are.

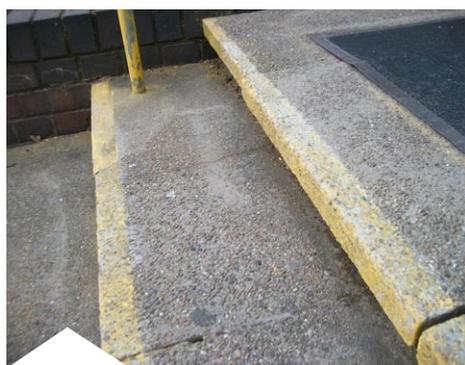
Badly damaged school steps

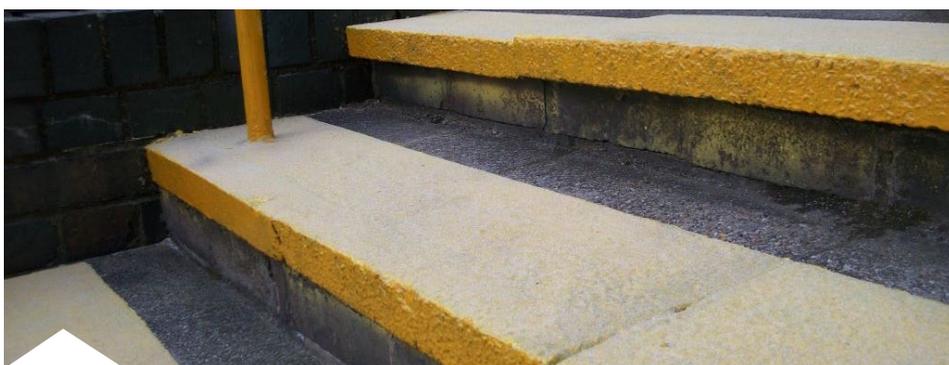
Long-lasting safety grip system

Years of wear and tear had left concrete steps at a school entrance badly damaged and in need of urgent protection. The eroded substrate presented a potential slip hazard to staff and pupils as the majority of the previous grip system had worn away. The school sought a long-lasting safety grip system that could be installed quickly and with minimum disruption to the school's operation, so as not to impede on the day-to-day usage of the steps.

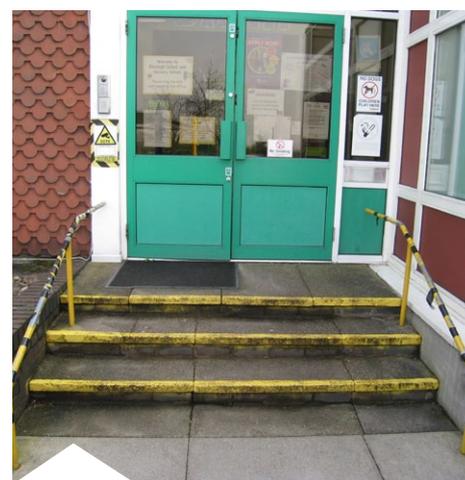
Safety grip system required for damaged steps

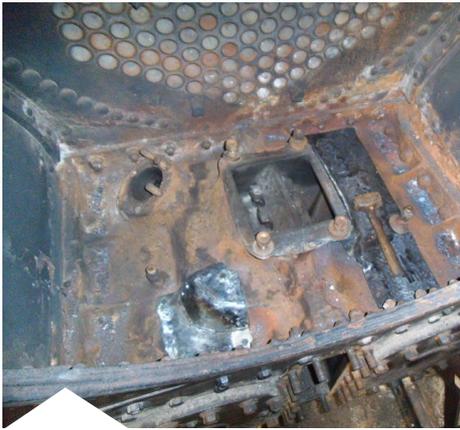
Badly corroded steam chest

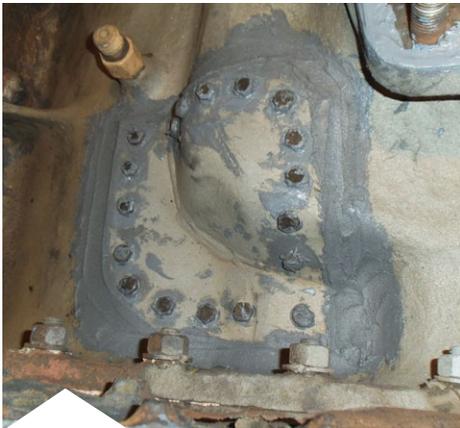
Plates bonded with epoxy repair composite

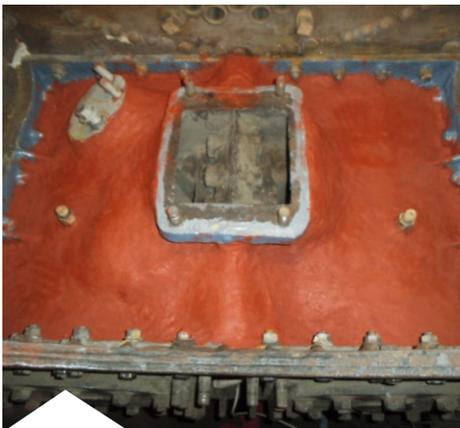
Acid and heat resistant epoxy system

As a part of the celebration of the London Underground's 150th anniversary, the steam locomotive Metropolitan No. 1, built in 1898, was scheduled to make a number of trips on the city's Metropolitan line. After a steam leak in the original cylinder block was detected, Belzona was contacted to see whether a high temperature resistant epoxy coating could solve the problem.
