IN FOCUS: Flange Protection

SOLUTIONS FOR FLANGE REPAIR AND PROTECTION

Issue 109

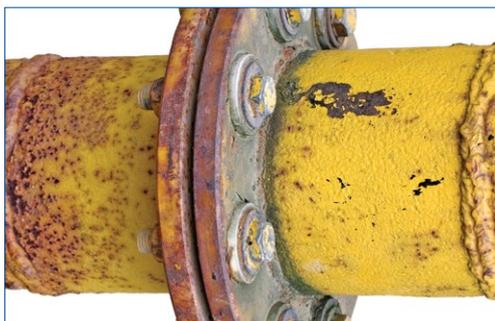
General corrosion on flange

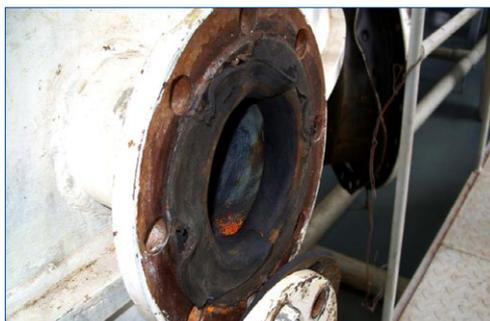
Highly corroded flange face

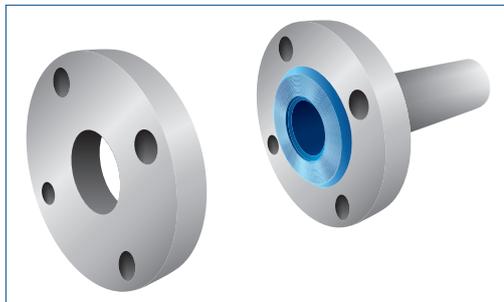
Flange face repaired with [Belzona Flange Face Forming Kit](#)

The Belzona Flange Face Forming Kit is a unique repair kit developed to aid the flange face forming technology in combating the common problems with mating surfaces of flanged joints such as heat distortion, corrosion and erosion. In conjunction with Belzona two-part epoxy repair composites (see product selector below), this flange repair kit provides a complete package solution which is simple and cost-effective to install.

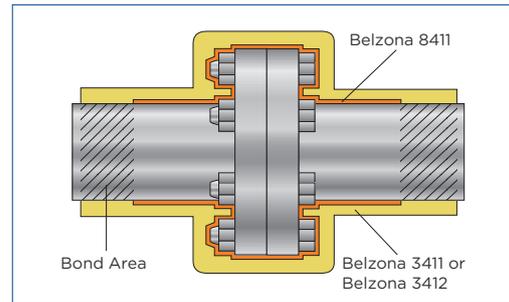
Belzona's flange encapsulation system

To answer external flange corrosion issues, Belzona has formulated two coatings (one peelable and one sprayable) specifically designed for the protection of flanges, fastenings and associated pipework to exclude moisture and prevent crevice, galvanic and atmospheric corrosion. Both systems begin with a layer of the corrosion inhibitor, Belzona 8411. Then either Belzona 3411 (Encapsulating Membrane) or Belzona 3412 can be used to provide a tough, flexible encapsulating topcoat.

These durable systems can be used to protect most flange shapes, sizes or configurations from corrosion and completely encapsulate the flange to exclude any moisture. Belzona 8411 also has release properties allowing the Belzona 3411 and Belzona 3412 topcoats to be peeled back from the joints to allow inspection.

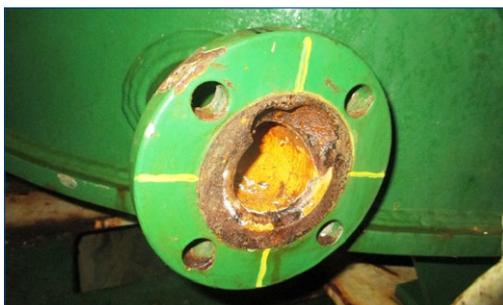
The existing lining had failed, leading to corrosion of the vessel internals and severe loss of metal on the adjacent flanges. The client was unable to use hot work and had a limited amount of time to carry out the application. Indeed, conventional cut and weld repair methods involve hot work and require replacement flanges which may not be available in emergency situations, especially in areas with limited access such as offshore platforms.

Flange face highly corroded

The Belzona flange face forming solution was chosen for this repair as it does not require hot work or replacement flanges and it can be rapidly performed minimising downtime. After the surface on the flange face was prepared, the selected Belzona material was mixed and applied to the damaged surface and to the former, pushing the material well into the prepared profile. Both surfaces were brought together and once the correct level was achieved the former was bolted to the flange. Once the product was sufficiently

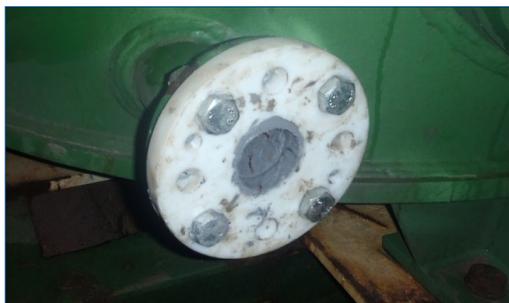
Former in place with Belzona material

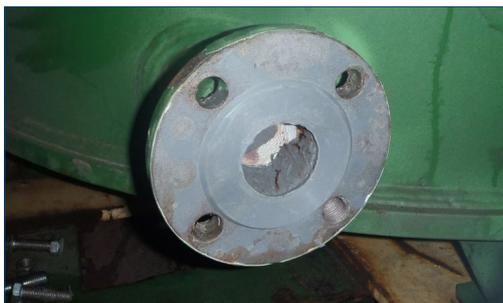
Flange face forming completed

cured the former was dismantled and bolts removed, leaving a perfectly formed sealing face on the original flange.

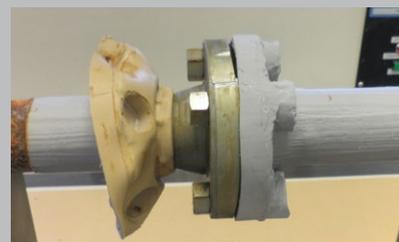
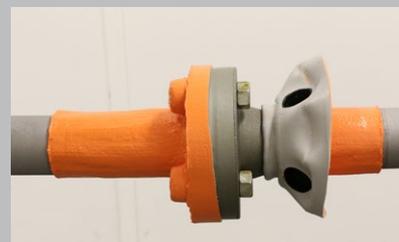
The corrosion resistance of the Belzona 3411 system has been proved by the salt spray test, used to assess a coating's ability to resist attack from a continuous salt fog. The salt chamber converts a 5% sodium chloride solution into a hot fog at 35°C (95°F).

After 1000 hours of exposure to the salt-fog atmosphere, no corrosion was reported under the encapsulating system. In comparison, the exposed steel part at the end of the flange showed a high level of corrosion.

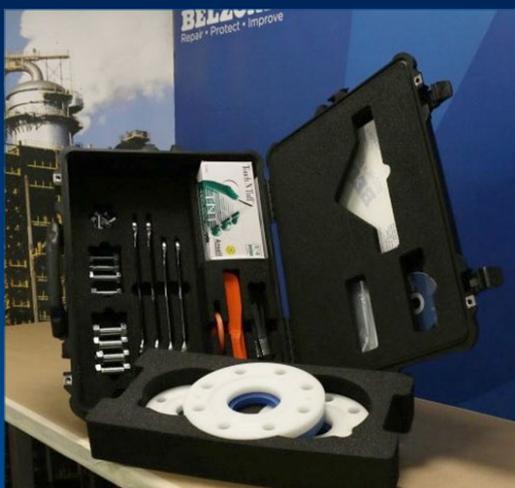
For restoring damaged flange faces and corrosion protection

- Simple to use as all the necessary accessories are in one kit
- Contains 6 reusable plastic formers
- Lightweight allowing easy transportation to emergency situations and areas with limited access
- Minimised downtime as the kit eliminates the need for spare flange

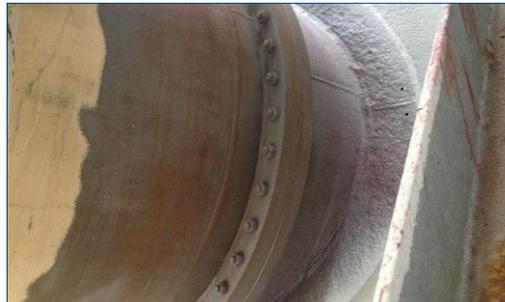
52" flange grit blasted

The application was carried out by the plant personnel in accordance with Belzona's application procedures. The customer saved several thousand dollars over the previous fiberglass system with easier installation. The unit was inspected 90 days after the installation and it looked as good as it did on day one. The client was very satisfied with the Belzona solution and is planning to use Belzona 3411 on other flanges. ■

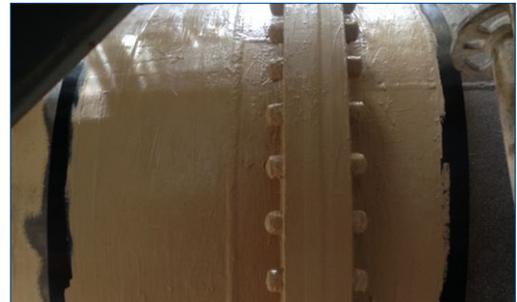
First layer of Belzona 3411 applied

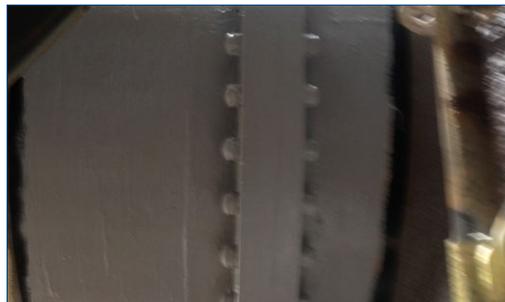
Completed application on the flange

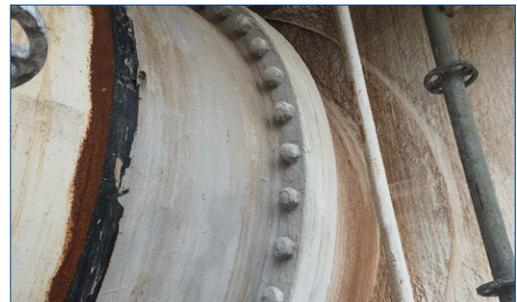
Flange in perfect condition after months in service
