# IN FOCUS: Process Vessels

## COLD APPLIED EPOXIES TAKE THE HEAT

# FPSO P57 PRESSURE VESSEL CORROSION PREVENTION SOLUTION

UPGRADE OF MULTIPHASE SEPARATORS  
Cold bonded fittings inspected eight years later – all in excellent condition

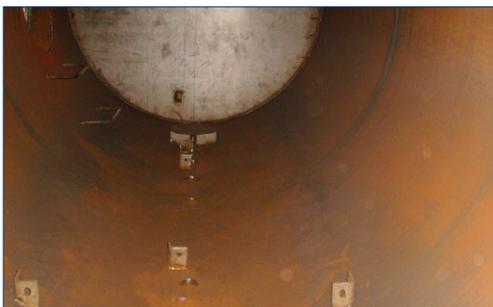
Corroded separator

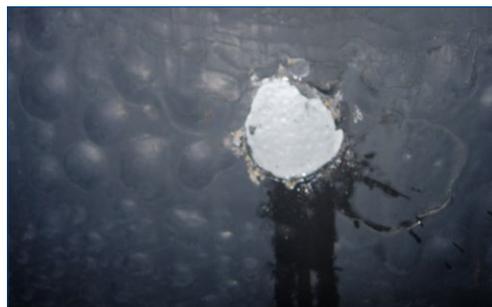
Blistering of coating with low cross-link density

Systems with low cross-link density are susceptible to a high degree of permeation of both water and gases leading to corrosion.

This phenomenon increases dramatically as the polymer system reaches its softening point, whereby distances between the polymer molecules' cross-link sites increase and permeation occurs more readily. Even conventional epoxy resins, which typically display good resistance to permeation at ambient temperatures, can only offer limited protection at elevated temperatures.

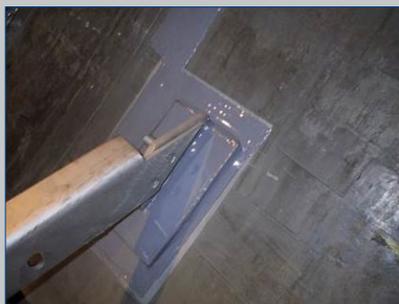
Belzona commissioned tests with Lloyd's register to measure tensile shear adhesion, tensile adhesion and cleavage adhesion of [Belzona 1511 \(Super HT-Metal\)](#) in March 2004. Tests were conducted using Schenk/Instron servo hydraulic test machine at 50% humidity and 23°C (73°F).

| Adhesion test | Max Load (kN) |
| Tensile shear adhesion | 51.31 |
| Tensile adhesion | 20.62 |
| Cleavage adhesion | 22.32 |

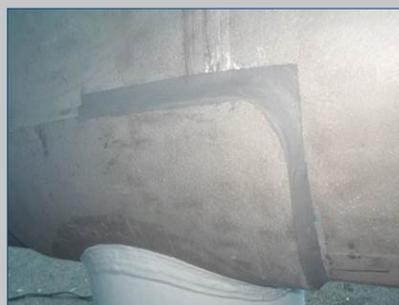
For external bonding [Belzona 1111 \(Super Metal\)](#) cold bonded patch repair was tested by Lehigh Testing Laboratories where repair withstood pressures up to 3,400psi (23 N/m<sup>2</sup>).

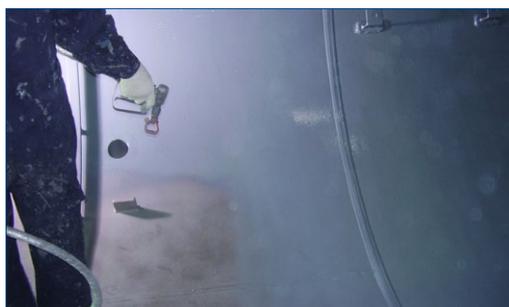
Spray applied Belzona lining

Surface preparation is carried out following set guidelines: typically after testing for internal contaminants the surface is cleaned, degreased and grit blasted achieving the cleanliness of "near white metal" ISO Sa 2.5 and minimum profile of

75um (3 mils). Application environment is also controlled. The substrate and environmental temperatures as well as humidity are measured and reduced to appropriate levels. To reduce the risk of inadequate application standards, applicators and coating inspectors are trained and validated by Belzona.

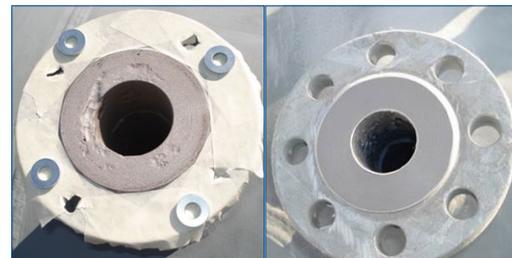
Flange face corrosion is a common problem affecting pressure vessels, where the face must be isolated to prevent oxidation. Belzona composite materials do not corrode and bond strongly to the flange face, where prefabricated formers are used to shape specified Belzona material on the flange face.

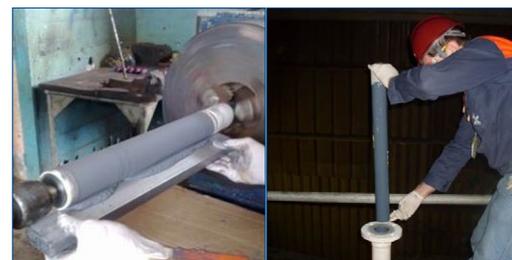
In order to protect small bore nozzles, a conventional coating would not be sufficient due to the risk of pinholes or holidays when coating a narrow nozzle. This issue is rectified by introducing prefabricated nozzles made from Belzona composites that do not corrode. The inserts and the nozzle are wetted out with a Belzona coating grade material, before being installed and bonded together to ensure corrosion protection.

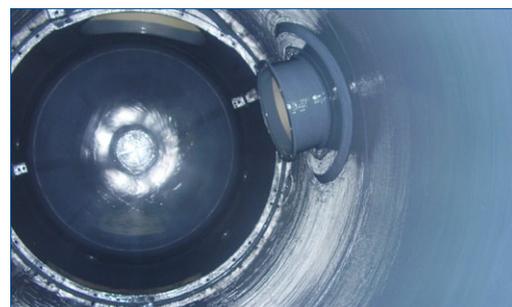
Process vessel lined for corrosion protection

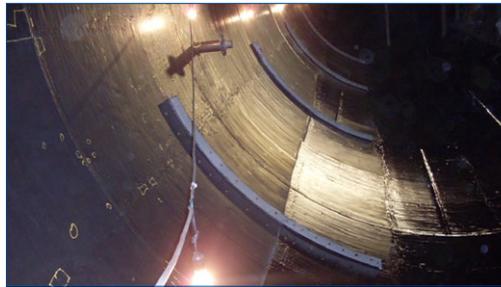
Application in 2009

Temperature, pressure and chemical resistance requirements were carefully evaluated before specifying [Belzona 1591 \(Ceramic XHT\)](#), capable of withstanding immersion temperatures of up to 180°C (356°F), to line the vessels. Other areas that commonly suffer from corrosion, such as small bore nozzles and flange faces, were also to be isolated from the environment with the use of Belzona materials.

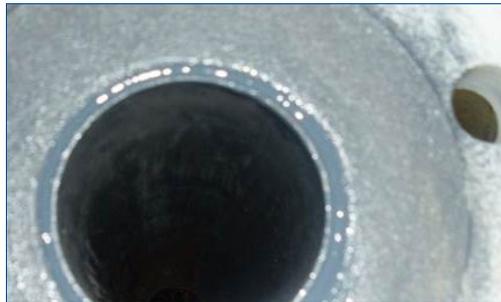
Flange and small bore nozzle protected

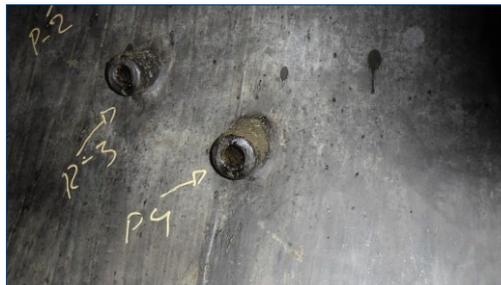
Inspection in 2013 - Flawless

The work was carried out in September 2009 and in February 2013 V-T6205A was opened for inspection. The condition was described as "flawless"; lining, flange faces and nozzles all showed no signs of deterioration. ■

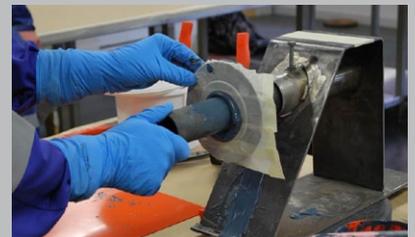
Belzona prefabricated composite nozzle inserts are "glued" into the small bore nozzle, thus eliminating the risks of pinholes and holidays. Composite insert can also act as a sacrificial erosion resistant layer in extreme abrasive conditions.

In conjunction with the flange face forming technology, vessels' weak points are effectively isolated from corrosive media.

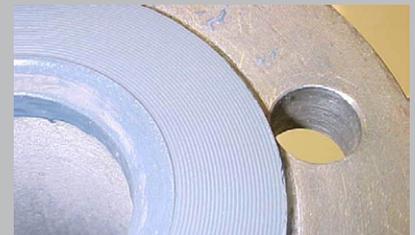
A flange face forming kit has now been made available and consists of necessary accessories to carry out flange forming applications. Currently available #300 psi, which includes six formers (2x2", 2x3", 2x4") covering all range of schedules.

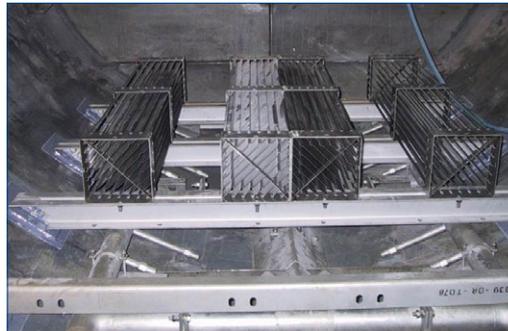
Cold bonded beams

The lower edges of the new baffles were supported on beams which were mounted within the vessel using new clips bonded to the vessel wall with Belzona and some intermediary brackets tied back to existing clips. This had the effect of creating a solid structure right through the centre section of the vessel. The plate packs were supported on new beams similarly supported with Belzona. The weir extensions were bolted in two pieces to the top of the existing weirs and the

The coalescing plate packs were designed and fabricated in a modular cell form and supported within the vessel on cross beams, mounted on new clips bonded to the vessel wall. The lower rows of cells were fixed to the beams at the time of bonding and remained there while curing to ensure the beams were fixed squarely and positioned correctly.

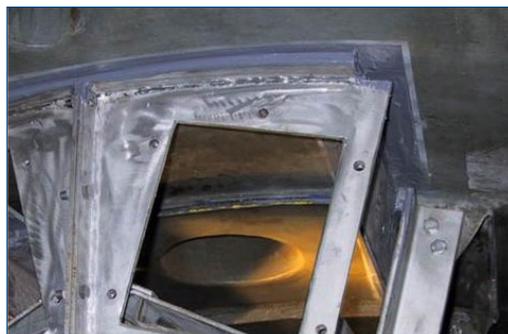
Overhead fittings bonded

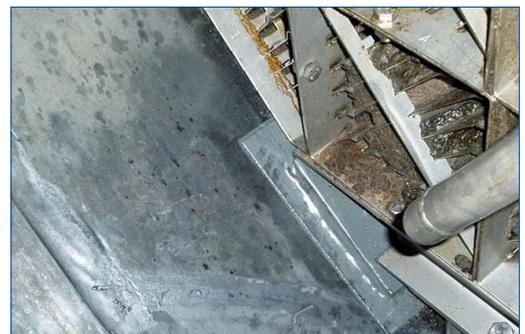
Inspection eight years later

Eight and 10 years after the application, the separator was inspected and Belzona bonded fittings were found to be in excellent condition.
