World's Most Valuable Company Cut Costs with Cutting-Edge Polymer Repair Systems

Damaged concrete floor and expansion joints at airport repaired with minimal disruption

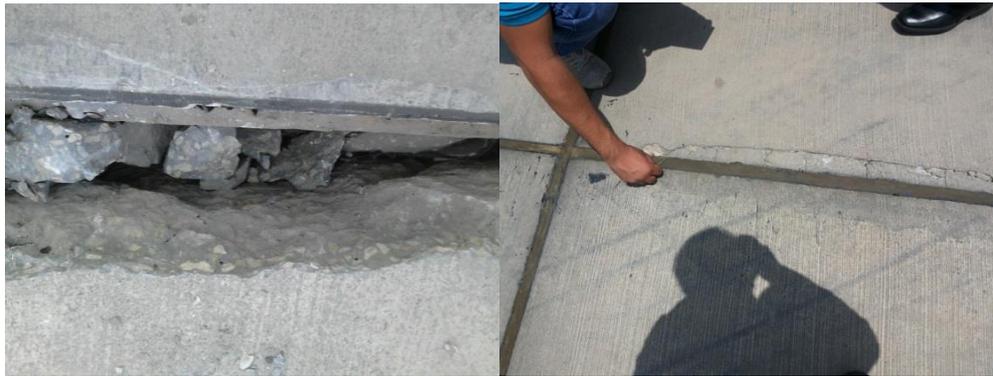
The deteriorated areas, situated in 40 different locations including aircraft taxiways and ramps, were exhibiting severe signs of wear and damage. The concrete had become cracked and spalled and the previous expansion joint sealant had peeled away from the edges of the joint. Due to the high turnover of aircraft, it was imperative that the repair solution incurred as minimal downtime and disruption as possible, ensuring it would not impact on the day-to-day running of the airport.

Cracked and spalled concrete

Deteriorated expansion joint

"A number of concrete areas were rebuilt with Belzona 4111 (Magma Quartz) and the expansion joints were repaired with Belzona 2221 (MP Fluid Elastomer). The two component epoxy resin system, Belzona 4111, contains selected quartz particles to create an extremely durable rebuilding material with a compressive strength (when tested in accordance with ASTM D695) of 92.7 MPa (13,450 psi). As the material is stronger than concrete, the substrate is able to withstand heavy loading without fear of degradation. Prior to the application of this material, surfaces were firstly coated with Belzona 4911 (Magma TX Conditioner) to ensure maximum adhesion was achieved.

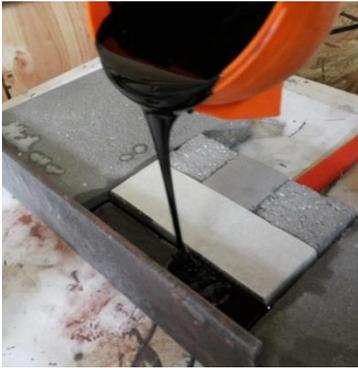
Pouring of flexible elastomer into sample piece

“For the expansion joints, Belzona 2221, a tough polyurethane resin with outstanding flexible properties was applied. This material will accommodate high levels of movement and enable the expansion joints to successfully absorb any shock or impact and return to their original shape undamaged. Belzona 2921 (Elastomer GP Conditioner) was applied prior to this system in order to ensure an effective molecular bond with the concrete substrate. The sample application took 18 labour hours to complete and was left to cure for three days. In order to assess its performance, fork-lift trucks were then driven over the repaired areas. As the combination of epoxy and polyurethane systems successfully withstood these loads, the airport decided to continue with the application to the complete 150 linear meters (492ft) of damaged area.”

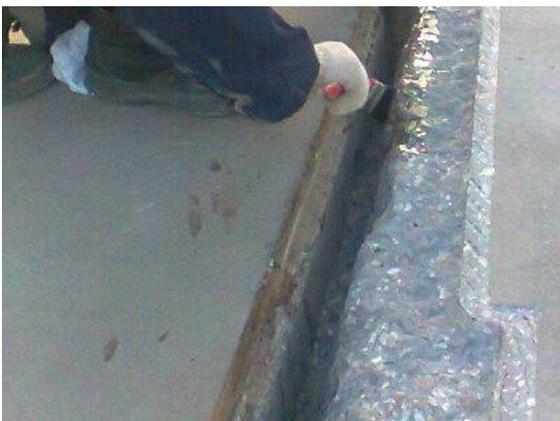
Conditioning of concrete surface

Firstly, the concrete was prepared to reveal a sound substrate. Any old coating or previous patch repairs were fully removed. Loose contamination was brushed away and the substrate was then cleaned using Belzona 9111 (Cleaner Degreaser). The surface was then conditioned using two coats of Belzona 4911. Where the concrete edges or nosings were damaged, timber battens wrapped in polyethylene sheets were installed before direct application of Belzona 4111 using a trowel. The material was then tamped down firmly so as to ensure maximum contact with the surface.

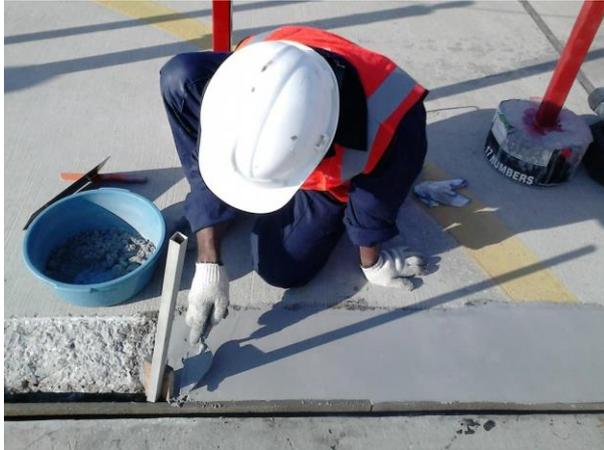
Application of rebuilding material

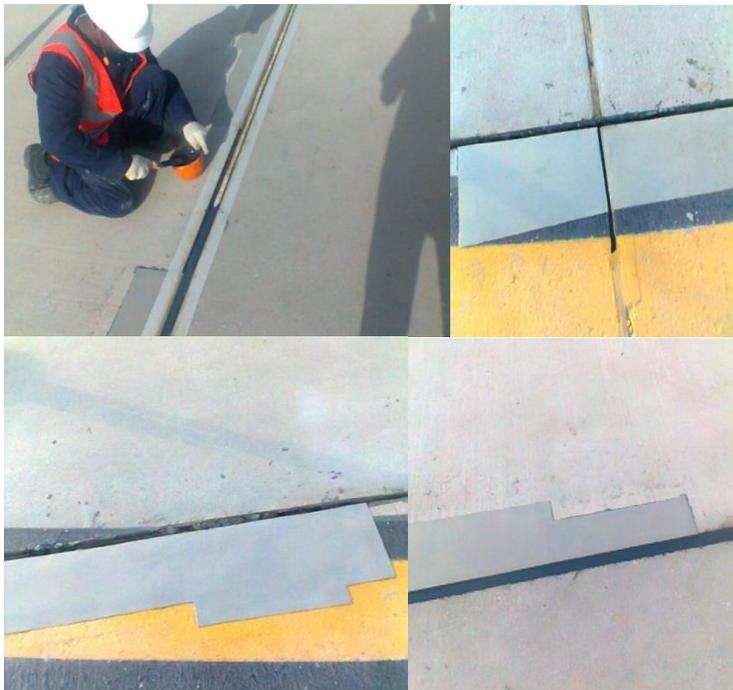
Concrete rebuilt and expansion joints installed

For the expansion joints, any loose contamination was brushed away and the substrate was cleaned using Belzona 9111 to remove any dirt, oil and grease. Where the elastomer was to be applied directly onto Belzona 4111, the Belzona 4111 was slightly abraded using emery paper. Belzona 2921 was then applied in two coats to condition the surface. A foam backer rod with a diameter of approximately 20% greater than the width of the joint was installed. Where the depth was greater than 4cm with no support below, filler boards were placed to control the application depth. The Belzona 2221 was applied using a simple pouring technique at a nominal thickness of 1cm (0.4 in), and the system was left to cure.
