## Over 500 Flanges Protected with New Encapsulating Technology

*Peelable and resealable system tackles severe weathering and galvanic corrosion at gas supplier site*

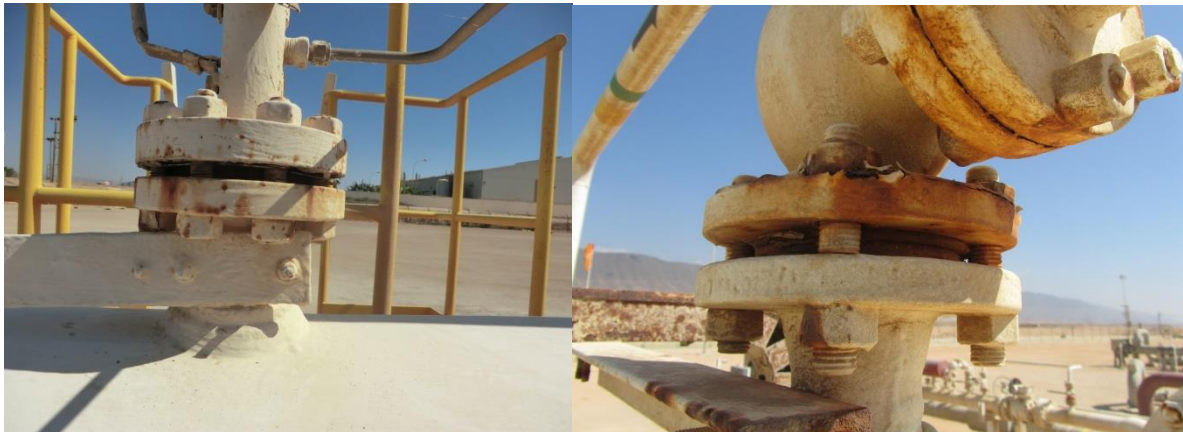
Flanges damaged by corrosion

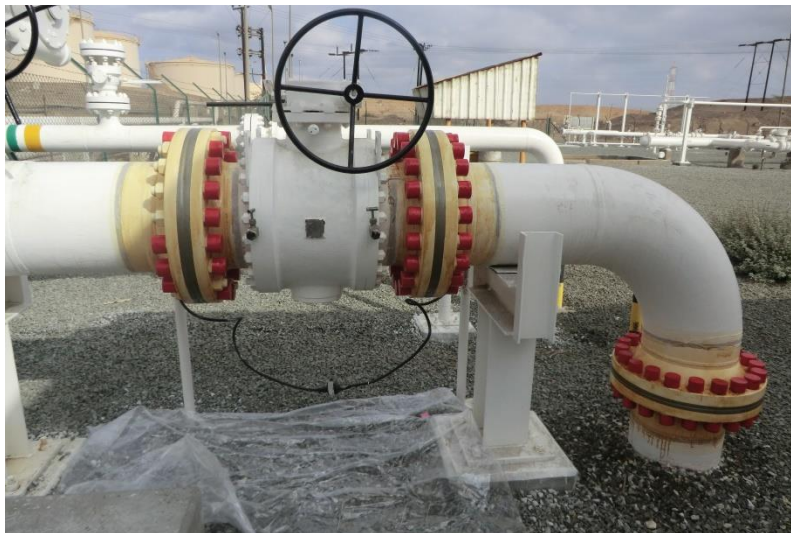
Surface prepared, Belzona 8411 applied and bolt caps installed

- 1) Firstly, the surfaces were cleaned with Belzona 9111 (Cleaner Degreaser) and the surfaces were thoroughly abraded with abrasive paper to remove any gloss. Once surface preparation was completed, the bond area was degreased again with Belzona 9111.
- 2) To seal the gap between the flange faces, a strip of Belzona 9431 (Instant Bridging Tape) was used. Masking tape was applied over the two bond areas to protect these sections of pipe from accidental overspray of Belzona 8411.
- 3) Belzona 8411 was then applied onto the flange, pipe and fastenings ensuring the film coverage was even and complete. Once the Belzona 8411 was touch dry after one hour, the masking tape was removed and plastic caps were fitted over the nuts and bolts.

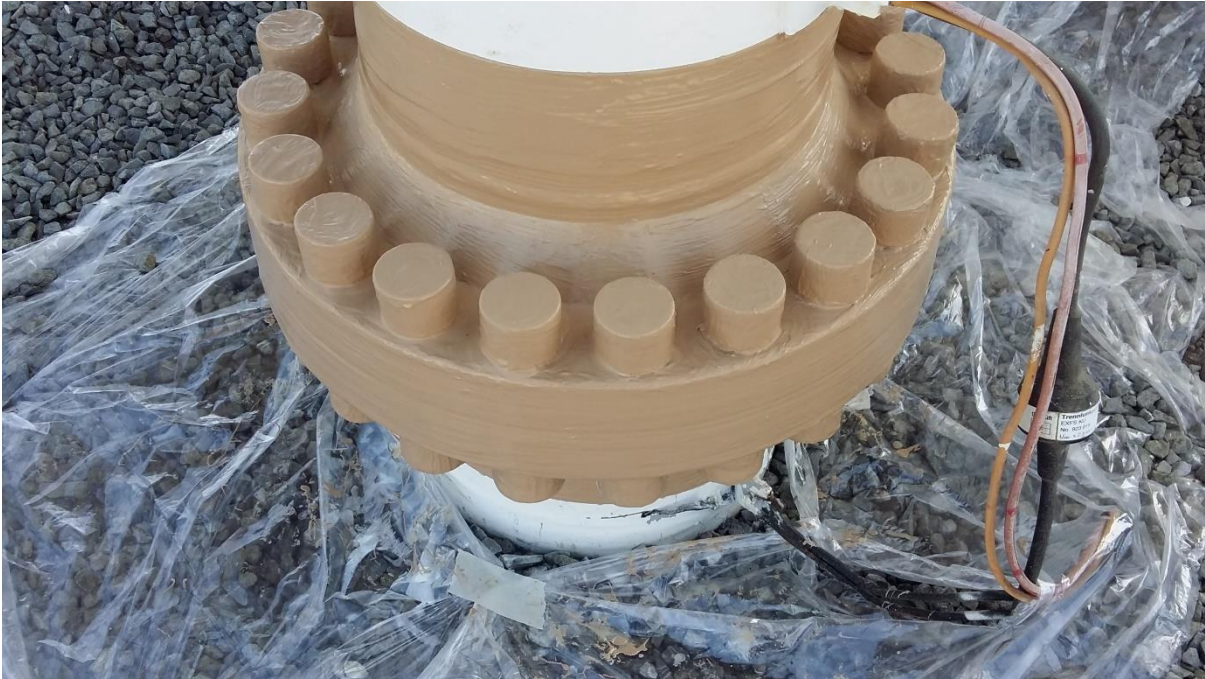
Application of first coat of Belzona 3411

- 4) A further strip of Belzona 9311 (Reinforcement Sheet) was applied to bridge the gap between the flange faces and two strips were applied to the bond area.
- 5) Belzona 3411 was mixed and using a short bristled brush, the material was applied over the area to be protected at a thickness between 30 and 40 mils (750-1000 $\mu$ ). While the first layer of Belzona 3411 was still wet, strips of Belzona 9311 (Reinforcement Sheet) were embedded into the Belzona 3411 around the flange circumference and at both ends of the repair where it bonds to the pipe to add strength to the system.

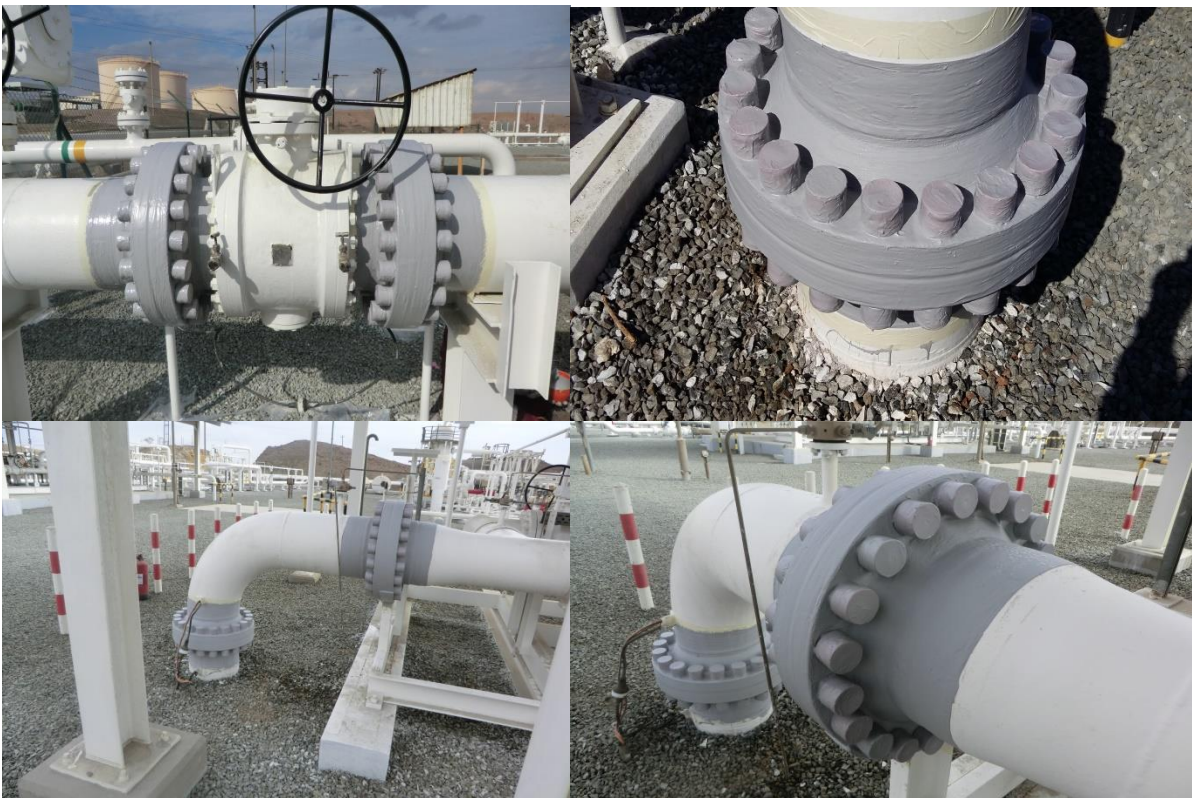
Belzona 3411 successfully installed on over 500 flanges with different shapes and configurations

- 6) Once the first coat had cured after one hour, the second coat of Belzona 3411 was mixed and applied to the same thickness as the first coat (in grey colour) and was left to cure.
