Overcoming time constraints and wet conditions on equipment maintenance

Leaking seawater tanks repaired with surface tolerant, fast curing polymeric material

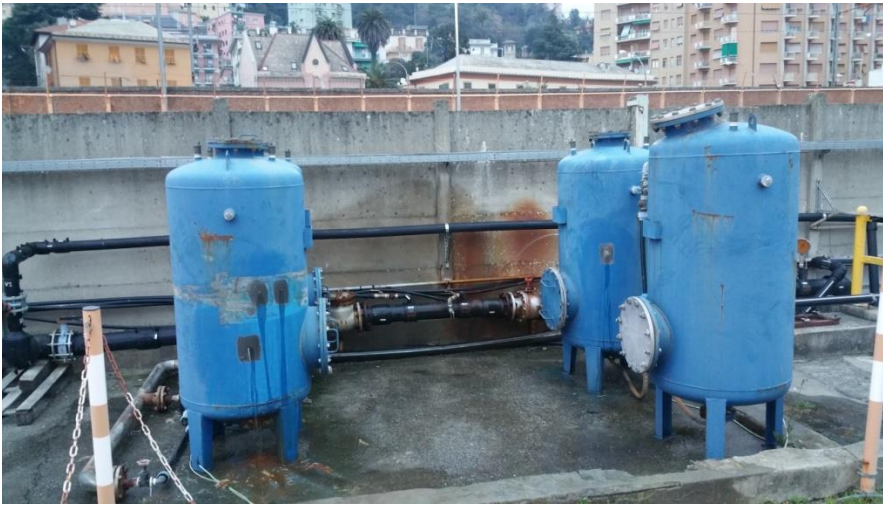
Image 1: Leaking seawater tanks at hydrocarbon storage tank farm

One of the vertical seawater tanks at the tank farm had sprung a leak, with severe corrosion having made a through-wall defect which was leaking seawater. Three further tanks had suffered similar corrosion damage to a lesser extent, thinning the tank walls in certain spots which threatened to develop into further leaks in eight places. This project posed a complex problem, as the damaged area could not be dried and the plant could not be shut down for longer than two hours. This tight time window meant that solutions with anything but the shortest of cure times were not an option for the client. The decision was made to use Belzona 1212 to cold-bond metal repair plates to the tanks, in order to reinforce the weakened spots and seal the through-wall defect.

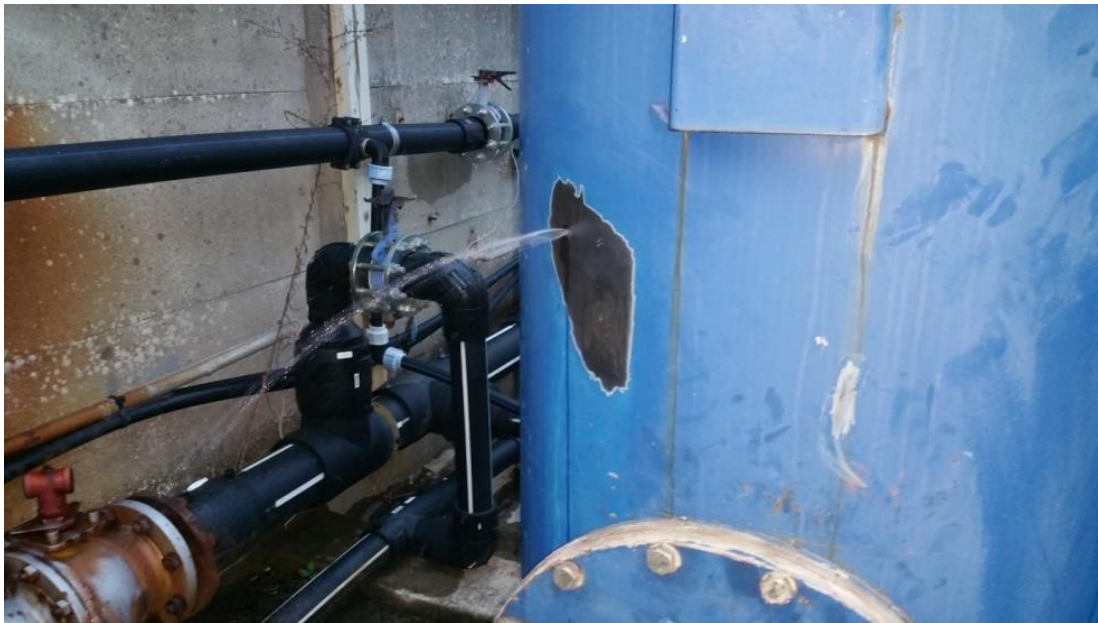
Image 2: Live seawater leak

The surface areas were rapidly prepared with a mechanical hand-held tool to remove the existing paint and achieve a more suitable working surface, and Belzona 1212 was then applied directly onto the leaking and damaged areas. Metal plates were then cold-bonded using the same material, sealing the leak and reinforcing the weakened areas of the tank walls. This application was carried out in-situ directly onto the tanks, meaning that downtime was reduced to a minimum. Within two hours, the repair material had cured to a satisfactory level, allowing the client to turn their attention back to business.

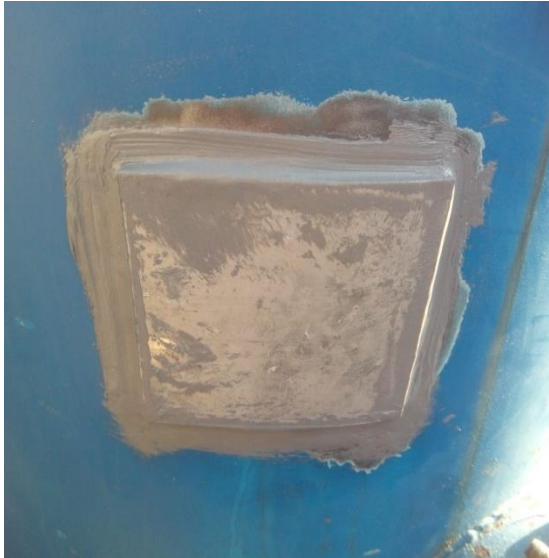
Image 3: Plate cold-bonded with Belzona 1212
