Novel polymer technology transforms disused warehouse at 75-year-old dairy

A disused warehouse was transformed into a cold store as part of a major refurbishment of a family run dairy in Gloucestershire.

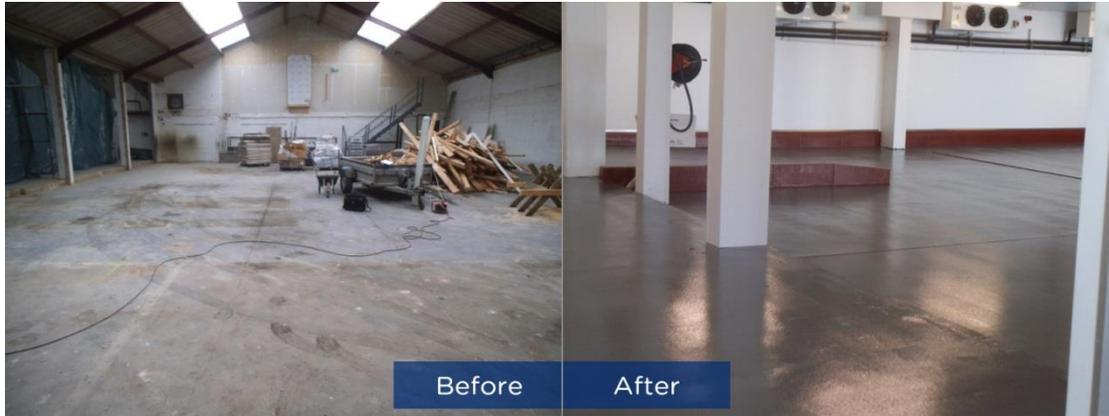
[Image 1&2 Before and after the completed application]

The Belzona systems chosen included a slurry mix of Belzona 4111 (Magma-Quartz), an epoxy based material designed to protect surfaces from impact and abrasion; this was used to bond down the kerbstones. Belzona 4131 (Magma-Screed), a non-porous resurfacing material, was used to repair several areas of concrete floor damage.

A lightweight material, Belzona 4141 (Magma-Build), was used to repair damage to the vertical concrete columns. This material can be applied to vertical surfaces without the use of fixed shuttering. By using this material, the columns will remain thoroughly protected within the busy working environment as it is designed specifically to combat numerous types of deterioration including abrasion, impact, erosion, chemical attack and carbonation of concrete.

For the application, a primer was firstly brush-applied to the concrete floors, walls and vertical columns before the application of Belzona 4141, Belzona 4131 and Belzona 4141. A trowel was used in the larger areas to apply the material and a filling knife and Belzona applicator tool were used in the smaller areas.

The floor and kerbstones were then coated with Belzona 5231 (SG Laminate). This is a high-build, solvent-free coating ideal for providing protection against the pressure jet washing, sanitising agents and chemicals used on the site. This was applied by brush to cut in around the edges, then again a roller was used for the larger areas. As it can be difficult to attain a seamless finish when coating large floor areas, a team of several people lined up and applied the coating simultaneously. This ensured a consistent layer of coating across the substrate was achieved. Extra aggregate was added to the coating before it cured in order to create a safety grip surface and prevent slippages in the cold store.

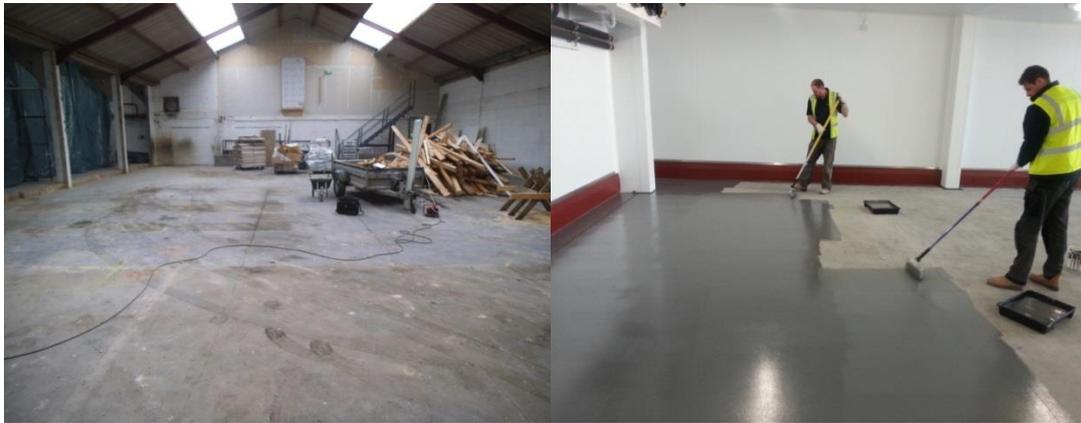
[Image 3- Disused warehouse before application] [Image 4- During application of the Belzona system]

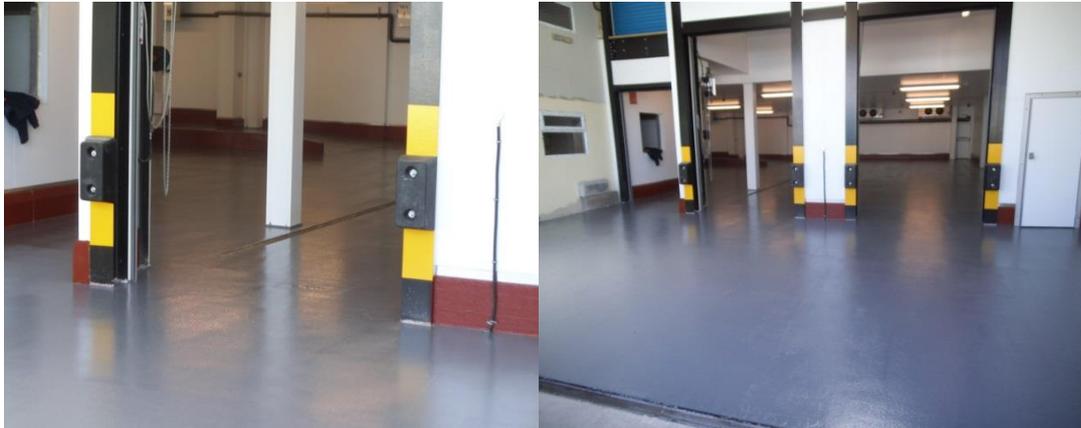
[Image 5- Completed application]

[Image 6- Completed application]
