Title: Diesel Tank Repair Gives Trains a New Lease of Life
Subtitle: Cold-bonding polymeric techniques prove their advantages over welding

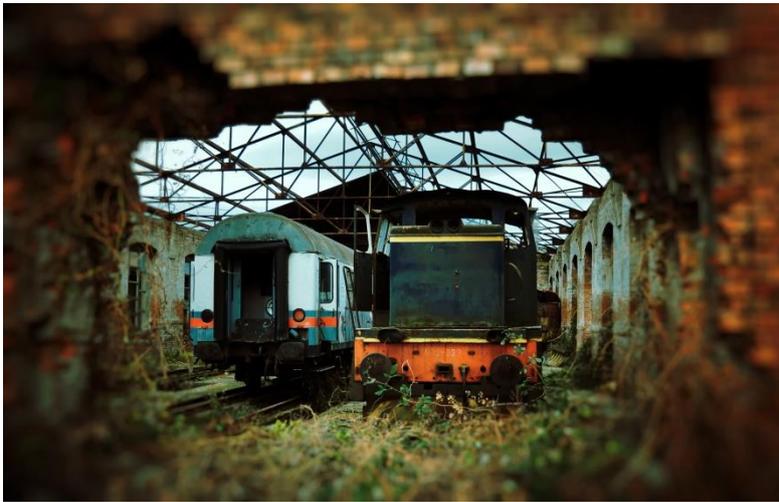
When left in sidings, trains are subjected to the effects of corrosion and vegetation

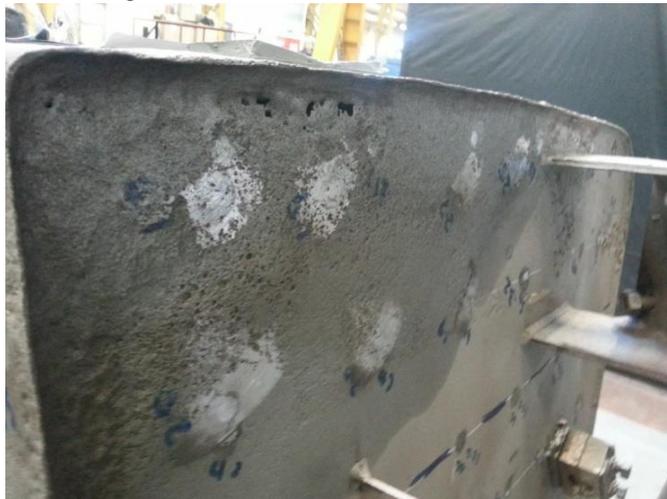
Bottom of corroded diesel tank featuring pitting and holes

During the refurbishment process, the company identified a recurring problem with the diesel tanks. Originally, the undersides of all diesel tanks were covered with fibreglass as a protective barrier against sparks flying up from the tracks. Critically, moisture would enter the gaps between the fibreglass and the steel tank, causing corrosion of the metal; in some instances this appeared as pitting or even holes. Their present repair method comprised of grit blasting the fibreglass away from the diesel tanks and welding steel plates over the weakened areas. However, subsequent pressure testing revealed that welding was causing further cracks or weaknesses in the steel around the various HAZ (heat-affected zones). These weaknesses were compounded further by additional weld repairs and numerous pressure tests, before the company was satisfied with the final outcome. This proved to be both time consuming and expensive.

Therefore, the company chose an alternative repair method, using a cold-applied solution to cold-bond a metal plate over these defects. This ensured that further damage from hot work did not compromise and slow the repair process, removing the threat of HAZ. However, eliminating hot work was not the only advantage of using a paste-grade, epoxy-based repair material. Notably, certain cold-applied systems can provide superior benefits, such as corrosion resistance and levels of adhesion, bonding to a variety of different substrates including most common industrial metals. Fundamentally, one of the biggest advantages of a composite repair solution is that the paste-grade material acts as a barrier between the new and old metal. Compared to welding, this negates the potential for bi-metallic corrosion, assuring the integrity of the metal tank.

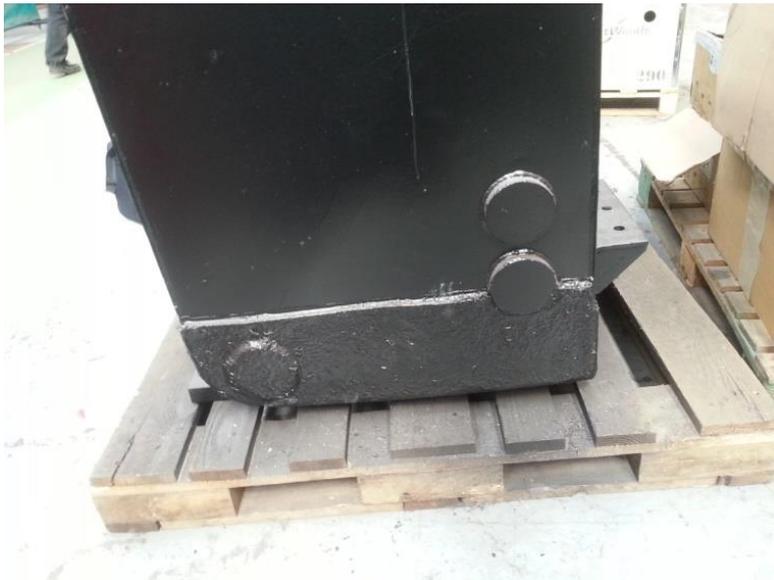
Diesel tank restored using a cold-applied solution

Following the cold-bonding, the tank was subsequently pressure testing and significantly passed first time, restoring the diesel tanks to full working condition. Finally, the repair was coated with GRP (Glass-fibre Reinforced Plastics) and painted black, in line with the remainder of the tank. Significantly, the customer was satisfied with the speed of the process in comparison to their traditional repair method. This allowed the repaired tanks to be refitted onto the trains far quicker, whilst also offering a long-term solution for their initial problem. This cold-applied solution has since been incorporated into their authorised specification for all diesel tank repairs and is now a company approved repair method.

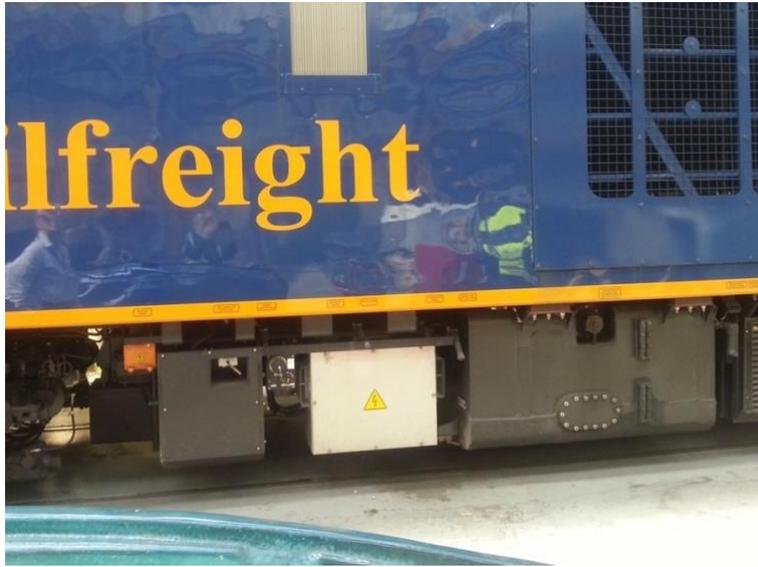
Repaired diesel tank fitted onto refurbished train
