A flexible solution for a tough problem:

What are the solutions available for conveyor belt repair?

Common methods for conveyor belt repair

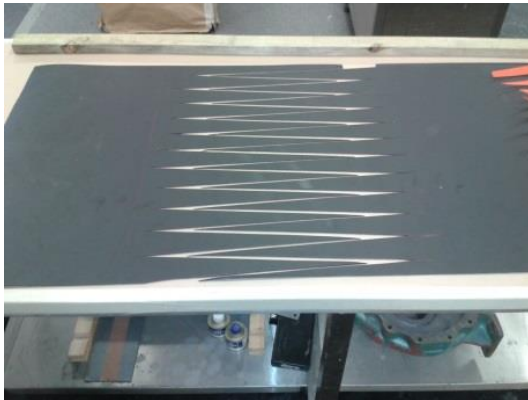
Pic 4. Split belt

2. Finger splicing a joint

The split joint is laid onto a flat surface and all surfaces of the fingers to be bonded are individually wet out with the Belzona product. The fingers of the joint are aligned using a straight edge and a final surfacing layer of Belzona material is applied before wrapping in polyethylene sheet and clamping firmly in position. Once cured, any excess material can be removed with a sharp knife. All masking tape is removed immediately after application and before the Belzona material cures.

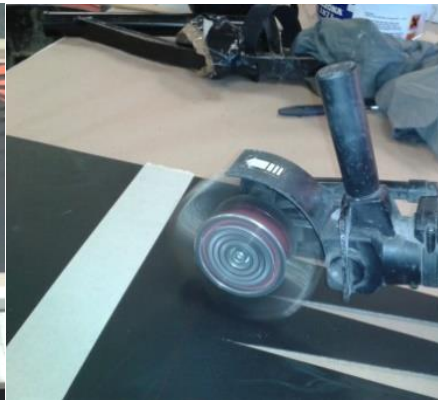
Pic 5. Preparation of belt

The belt is first cut out, prepared and treated with the appropriate conditioner to achieve maximum adhesion to the belt substrate. Masking tape is placed just inside the conditioned area and the Belzona flexible material is mixed in accordance with the instructions for use. The following specific application know-how should be followed.
