## No Matter How Challenging, Keep the Ore Flowing

### Hazelton VDS slurry pump repair

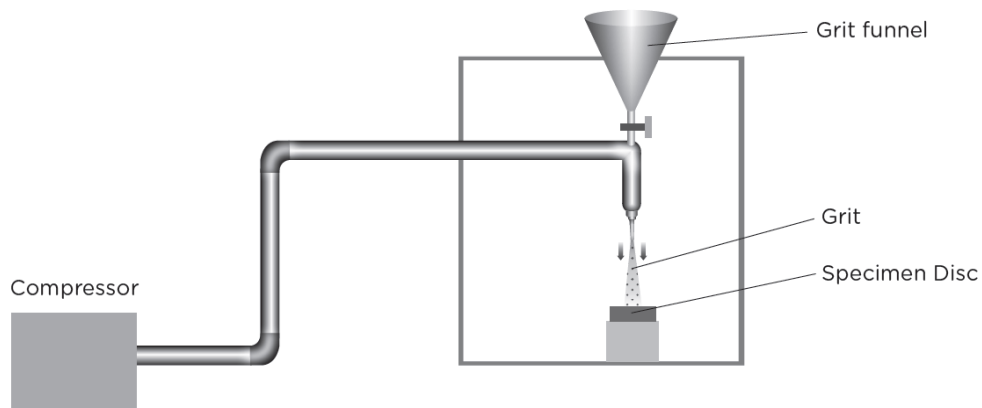
### *Belzona Grit Blast Abrasion Test Program*

To measure the impingement abrasion resistance of their materials, Belzona runs a grit blast abrasion test as part of their abrasion/erosion testing program. This is an in-house testing method where a cast specimen disc of the cured epoxy composite is pre-weighed and placed at a set distance from the blast nozzle. The sample is held at an angle, 30° or 90°, to the nozzle then the abrasive chilled iron grit is fired using an air powered blast pistol at around 5.5 bar (80 psi). The erosion resistance of the material will be determined from the associated volume loss.

When the G34 chilled iron grit was fired at 75 psi and with a 90° angle, Belzona 1812 (Ceramic Carbide FP), an abrasion resistant lining based on high molecular weight polymers and oligomers incorporating ceramic aggregates, exhibited a volume loss of just 8mm<sup>3</sup>.

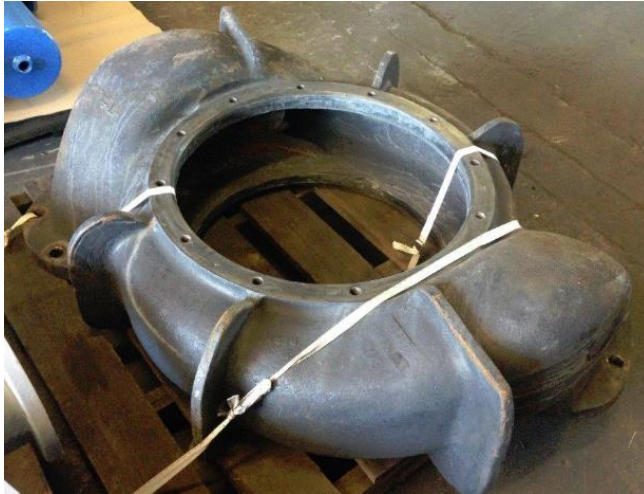
Pump casing disassembled for repair

Since the pump is constructed of Ni-Hard, a white cast iron alloyed with nickel and chromium, abrasive blasting of the substrate is conducted to Swedish Standard SA 2½ with aluminium oxide, a very hard and sharp ceramic aggregate, in order to achieve the required surface profile and avoid contamination of the substrate.

In addition, customised templates are affixed to the impeller ring and discharge port openings of the casing to serve as a mould in order to restore the internal diameter and also to ensure correct alignment by enabling the applicator achieve an even coating thickness throughout the surface of the repair area. Once all arrangements are completed and prior to the application of the Belzona materials, the repair areas are thoroughly cleaned.

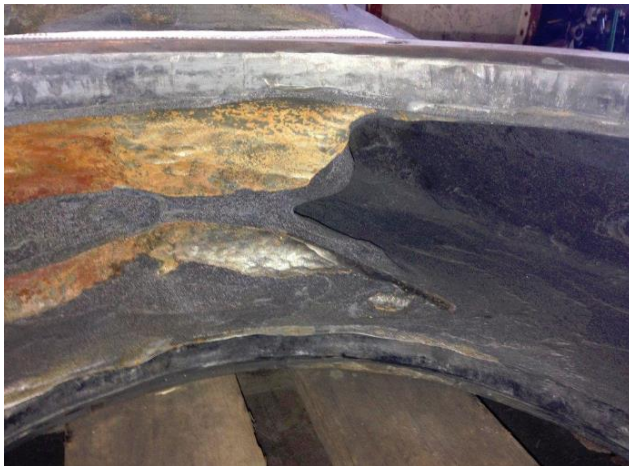
In order to provide a holistic repair to the casing of the Hazelton slurry pump that commonly suffers extreme wear on both cut waters, rendering it unsuitable for use, the polymeric compounds should offer long-term erosion protection. The materials need to be highly durable, satisfy the need for high abrasion resistance under immersed conditions at high temperatures and provide excellent mechanical strength.

Profile loss of pump cutwater

The extremely worn cutwaters that are commonly reduced by approximately 100 mm are repaired with Belzona 1311, a paste grade ceramic filled epoxy-based repair composite for rebuilding and re-profiling of damaged areas. Once cured, the cutwaters are shaped to the required dimensions using an angle grinder.

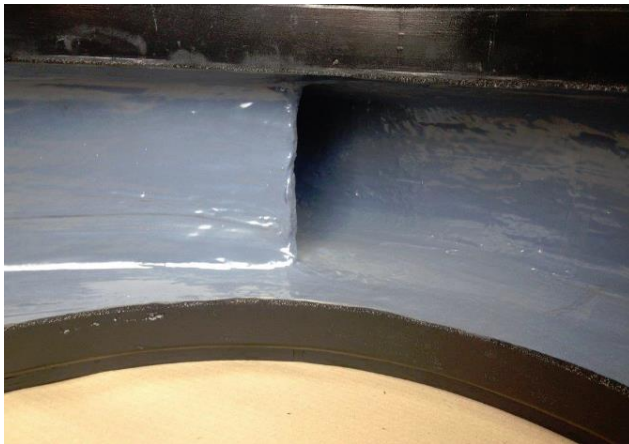
Pump cutwater rebuilt and protected against abrasion and high temperature

Belzona 1321, a ceramic-filled epoxy coating designed to protect against moderate abrasion, is applied to the entire casing internals as a priming coat to assist adhesion to the Ni-Hard substrate. Belzona 1321 exhibits excellent bonding to the cast iron surface and cures with no signs of shrinkage since the system is 100% solid.

Belzona 1812, an epoxy-based composite material that has been formulated with highly hard ceramic aggregates closely packed in a polymeric binder, is then applied at a thickness of approximately 6 mm utilizing the templates previously installed.

A final layer of Belzona 1391, ideal for equipment that operates at high temperatures under immersion, will be also applied throughout the entire pump internals to provide additional heat resistance. Once the final coat is cured, the templates are removed using jacking bolts, and all extruded material is ground off. The pump externals are then coated with Belzona 5891 (HT Immersion Grade) to protect the entire unit from the high temperature process fluids in the primary tailing sump.

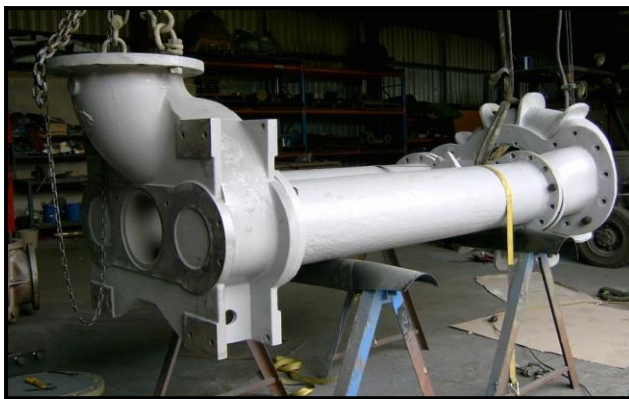
External surface protected against high temperature
